## 1. ORGANISATIONAL SET UP

The Kerala Engineering Research Institute is under the Directorate of Fundamental & Applied Research, at Peechi headed by the Director in the rank of Superintending Engineer. The Institute is under I.D.R.B of Water Resources Department under the Chief Engineer, Investigation & Design (IDRB), Thiruvananthapuram. It has two Divisions functioning at Peechi, i.e. the Hydraulic Research & Construction Materials & Foundation Engineering Division and another division namely the Coastal Engineering Field Studies Division at Thrissur, each headed by a Joint Director, an officer in the rank of an Executive Engineer.

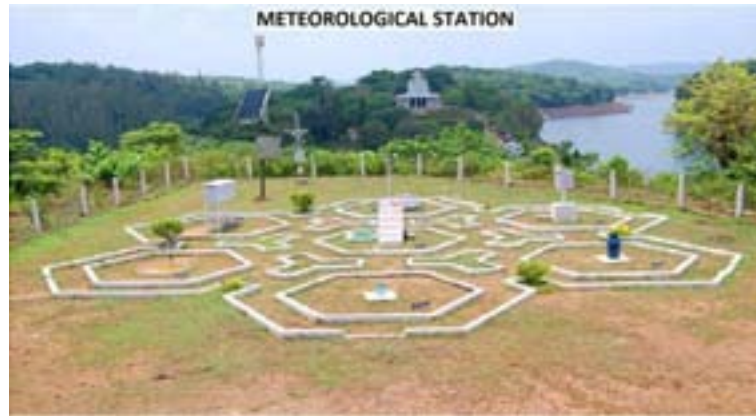
Weather observations are necessary to improve Meteorological services in the state and enhance the predictive capability of short and long-term information for weather forecasts and climatic changes. For the collection of meteorological data an Automatic Weather Station and a Manual Weather Station are functioning in Peechi dam premises.

An abstract of the Weather data collected from Automatic Weather Station for the period from July 2014 to March 2015 is given in Appendix – II.

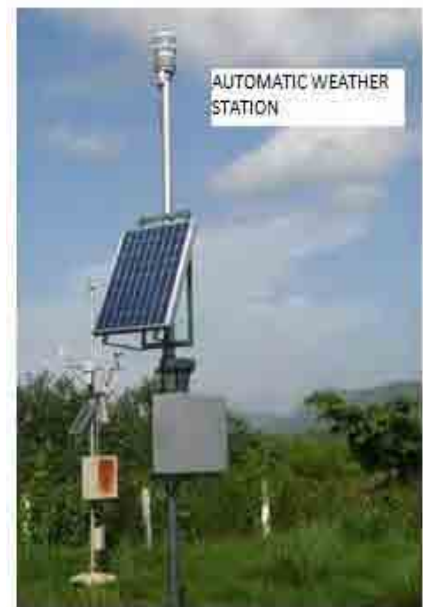
Time series observations are vital to improve the understanding of weather dynamics and its variability. The Automatic Weather Station plays an important role in providing short term and long-term time series weather observations. An automatic weather station is functioning in Meteorological Station since July 2014 with Remote transmission facility and a Solar Panel for uninterrupted power supply.

The Automatic Weather station collects data related to Air Temperature, Air Humidity, Barometric pressure, Ultrasonic Wind speed, Ultrasonic Wind Direction, Global radiation and Precipitation using different sensors. A Data Logger which is part of the Automatic Weather Station is collecting data in every 30 minutes and transferring it to a central server in every 2 hours using multiple protocols. These data can be accessed via internet using a software HYDRAS. The data collected can be used to gauge current weather conditions and to predict weather forecasts like temperature high/low, cloud cover and the probability of precipitation.

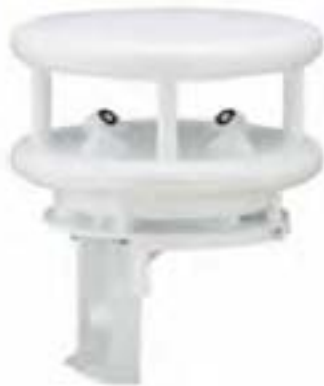
ULTRASONIC WIND SPEED AND DIRECTION SENSOR

1. Ultrasonic Wind speed, Ultrasonic Wind Direction & Compass
2. Global Radiation Sensor
3. Temperature , Humidity, Barometric Pressure Sensor
4. Rain Gauge
5. Data Logger

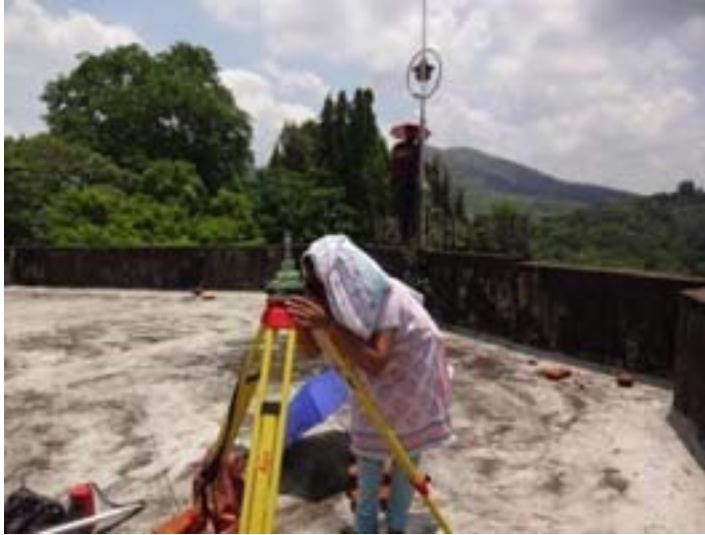
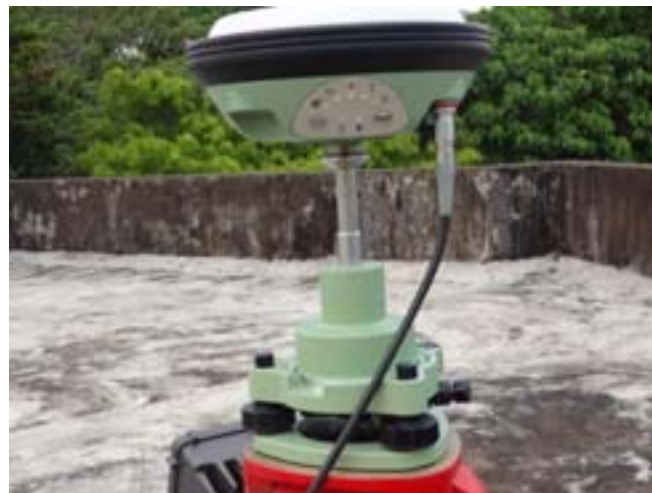
The Smart Station equipment which has been purchased as a part of modernization of KERI has been given to the Coastal Engineering Division. Using Smart Station the investigation works can be done efficiently by combining the conventional Total Station with GPS. So the work for determining the current profile of the dams Peechi, Meenkara, Pothundy, Chulliyar and Mangalam using the newly procured instrument has been included in the action plan for the year 2014-15 with. But the Chief Engineer (IDRB) has directed to do the survey work of Peechi Dam to find the 3D profile and the road survey from Peechi to Mannuthy. So the above work has been done and mapped. The 3D view of the Dam and the total plan of Dam, Garden and the roads in the KERI campus have been prepared.

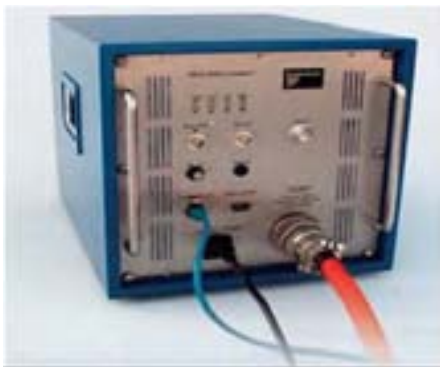
Top - side Unit

online data processing. The system is primarily designed for shallow geophysical surveys. The tolerance of the system for 100 kHz frequency is 0.02 m + 0.02% of water depth and for 10 kHz it is 0.04 m + 0.02% of water depth. The compact design without integrated industrial PC components results in an affordable and reliable instrument for sub bottom profiling applications.

Both the primary high frequency (HF) signal (100 kHz) and the secondary low frequency (LF) signal (6–12 kHz) are recorded. Penetration can reach up to 50 m in soft sediments. Advantages of the parametric acoustic system include: (i) narrow beam width at low frequencies; (ii) deep penetration with high resolution of sediment layers and objects, and (iii) accurate depth measurements with the high frequency signal. The variant SES-2000 compact is designed for shallow water depth applications near the shore and inland waters down to 400 m.

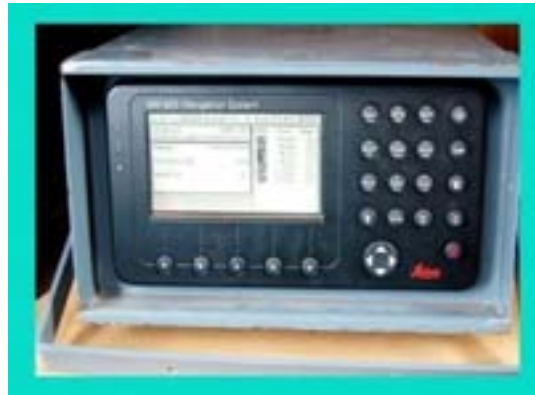
Plate-2 MX 420 Navigation System

DGPS Navigator (Refer Plate.2) is one such highly reliable, accurate, state of art device to get position by observing satellite. It can also track up to 12 satellites to achieve maximum positional accuracy. The DGPS receiver receives error correction from reference station and combines them with the received satellite signals to compute much more accurate self

position. The validity of error correction decreases with the distance from the reference stations, however they are valid up to 80 Km. The accuracy in position is less than 1m.

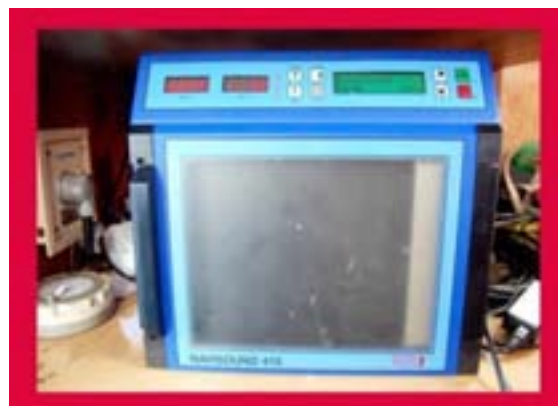
Plate-2. NS- 415 Echo-Sounder

Navitronic Echo-sounder NS 415 (Refer Plate- 3) is designed to measure under water depth up to 1200m. Accuracy of instrument is 1centimeter. A dual frequency echo-sounder is specified to distinguish between fluff top depth and the consolidated bottom. The high frequency (200 KHz) is used to detect the top of the mud/sediment. Under favorable conditions the low frequency signal (33 KHz) can penetrate into the bottom and reveal information about the bottom structure.

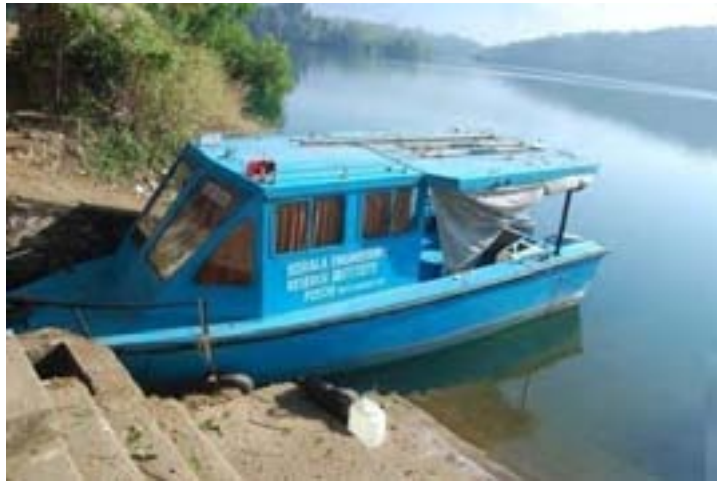
Plate- 5 Mobile Station (FRP Boat)

The mobile station setup is mounted on 'Fibre Reinforced Plastic' (FRP) boat (Plate.5) having two 60 HP petrol out board engines. The boat has dimension of 7.5mX 2.66mX 1.20m and 8 person capacity with the equipments.

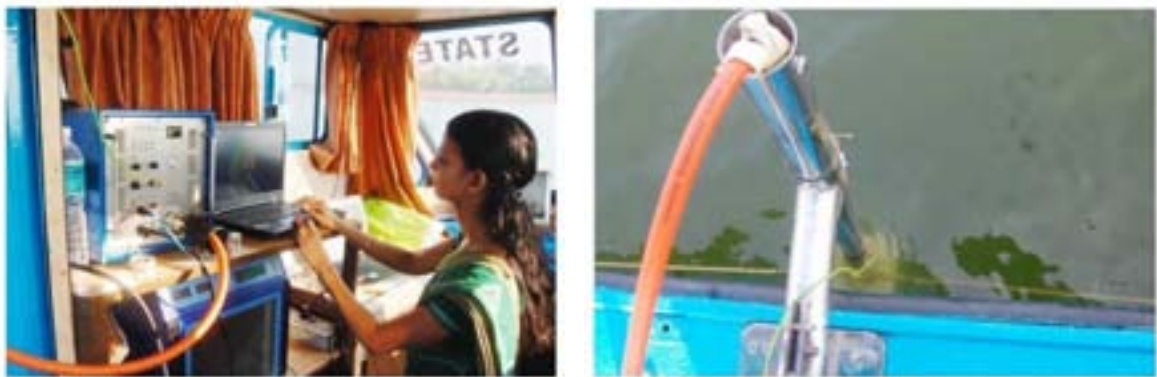
Fig.6 Data Collection Setup inside the boat

In this study, we used a new equipment the **SES-2000** parametric (non-linear) dual frequency echo- sounder. The instrument simultaneously transmits two signals of slightly different high frequencies; their interaction creates a new low frequency signal. It has a large bandwidth and a short signal length, which allows good use in very shallow water and results a high (~15 - 20 cm) vertical resolution at acceptable sub-bottom penetration up to 10 m or more. Some favourable near sub-bottom seismic and geological conditions permit to achieve a vertical resolution up to 10 cm. Parametric (non-linear) sound generation allows designing acoustical systems with small transducer dimensions and narrow sound beams at low frequencies. An Innomar SES-2000 parametric transducer has an active area of 20 by 20 cm and provides a beam width of less than four degrees (at 3dB), valid for all adjustable low frequencies between 5kHz and 15 kHz. The transmit directivity of the parametric sound beam does not show any significant side lobe characteristic, which reduces ambiguities during the interpretation of individual reflectors. Short transmit signals of single sinusoidal cycles without any ringing and high ping rates of up to 50 pings per second are further

advantages. They contribute to a high spatial resolution of this acoustical system and permit to apply it in a shallow basin. Innomar's software tool ISE provides near real-time processing of the collected SES data. The operation procedure can be tuned on-line. A value of the sound velocity in water is used to convert sound travel time to the depth. The depth values are screened online. Some advantage of the SES-2000 parametric (non-linear) dual frequency echo-sounder is the survey of small water reservoirs, which often requires the collection of sub-bottom data from small boats in water depths of down to one meter and to resolve thin layers of recent sedimentation due to damming. Furthermore, the determination of near surface structures, e.g. shallow fault zones, is of interest at the same time and can be achieved with the application of such a mobile parametric profiler system.

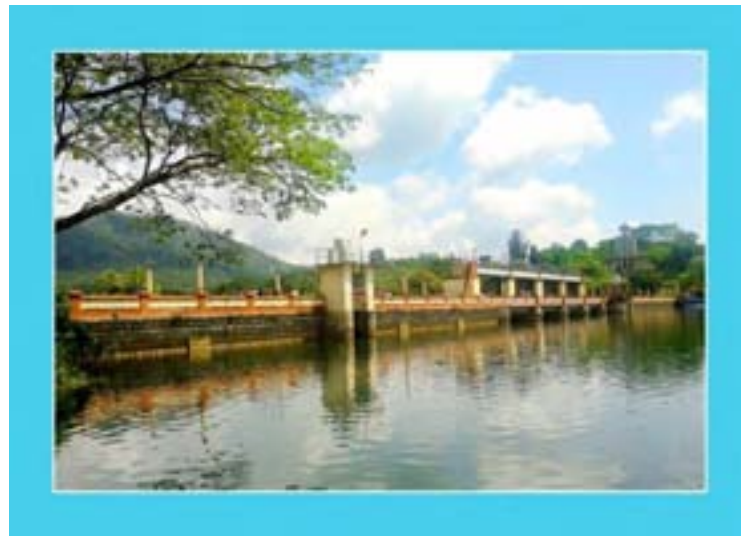
Peechi Project

The Peechi irrigation Project is one of the major irrigation project that utilizes the water of Manali River, one of the tributaries of Karuvannur River. It comprises of a storage reservoir at Peechi, two main canals, and a system of branch canals which criss-cross the ayacut.

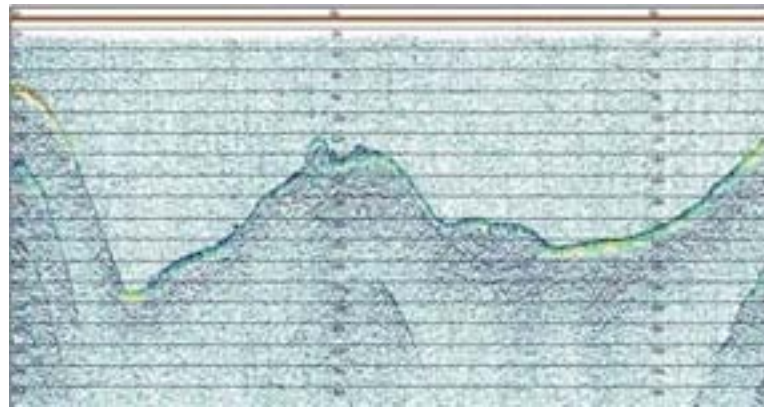
Sub bottom Profile of Marked portion

The edited data are then transferred to surfer using Data Exchange program. This exchanged data converts in to grid data by triangulation with linear interpolation method.

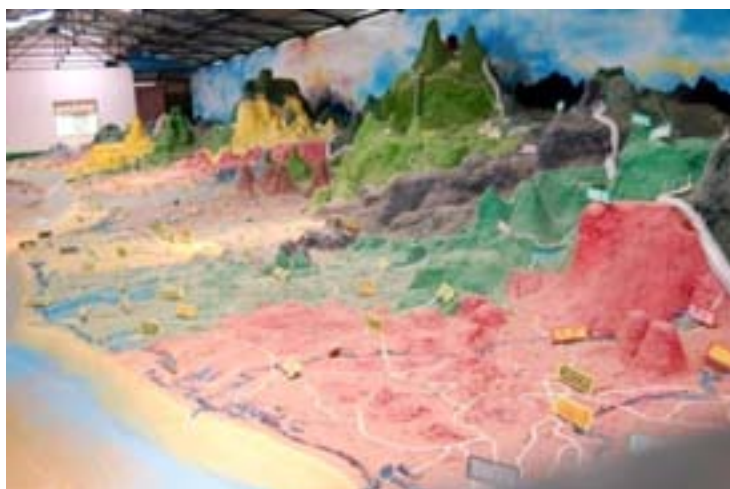
The Relief Model of Kerala

The Relief model of Kerala is a three dimensional physical model of the state of Kerala. Constructed to a horizontal scale of 1/16,000 and vertical scale of 1/1,000, this model clearly shows rivers, roads, railways, location of Irrigation and power schemes, important places and district boundaries etc. in the state. In short, the model gives an idea about both geographical and physical features of Kerala.

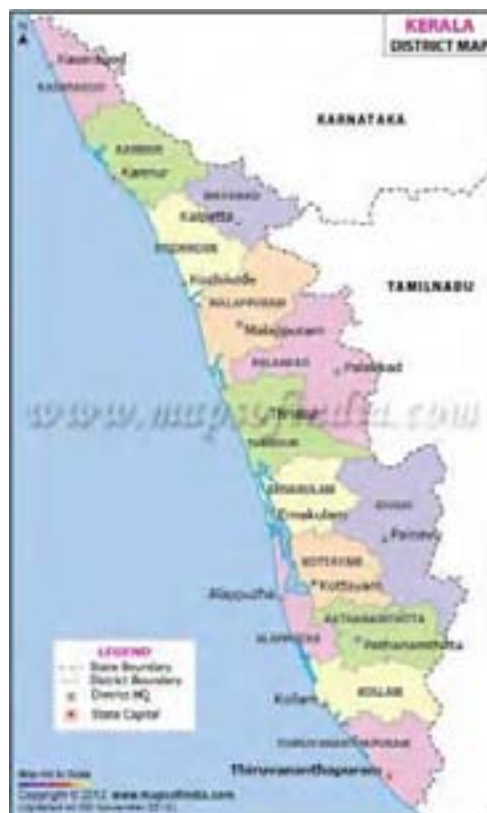
1. Map of Kerala state showing the location of simultaneous observation stations.

1.	KANNUVATHEERTHA	CPNO.103
2.	KASARAGODU	CP NO. 531
3.	KANJANGAD	CPNO. 727
4.	THALASSERY	CP NO.1067
5.	MELADY	CP NO. 2507
6.	CALICUT NORTH PIER	
7.	RAYAIRIMANGALAM	CPNO. 3613
8.	VELIYANKODE	CP NO. 3613
9.	PADINJARE VEMBALLUR	CP NO.973
10.	ANCHANGADY	CP NO. 3974

11.	KUZHUPPILLY	CP NO. 4047
12.	KANNAMALY	CP NO. 4329
13.	THANKI	BLS 485
14.	AMBALAPPUZHA	CP NO. 994
15.	ARATTUPUZHA	CP NO. 5185
16.	ERAVIPURAM	CP NO. 5550
17.	ANJENGO	CP NO. 5720
18.	KOVALAM	CP NO. 5927
