1. ORGANISATIONAL SET UP

The Kerala Engineering Research Institute consists of seven divisions functioning at Peechi as well as Coastal Engineering and Field studies Division at Thrissur and Quality Control wing of the Irrigation Department. Generally, the activities of each division can be categorized as falling under Routine activities, Fundamental studies and Revamping and Modernization. The routine activities and fundamental studies conducted by each division are enumerated in this chapter.

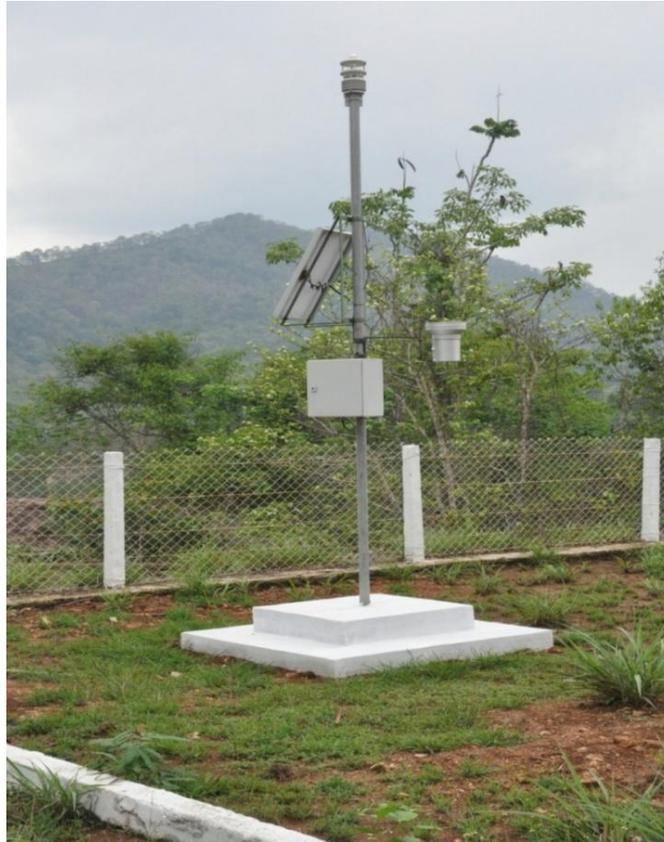
Components of Automatic Weather Station

The Automatic Weather station collects data related to Air Temperature, Air Humidity, Barometric Pressure, Ultrasonic Wind Speed, Ultrasonic Wind Direction, Global Radiation and Precipitation using different sensors. A Data Logger which is part of the Automatic Weather Station is collecting data in every 30 minutes and transferring it to a central server every 2hours using multiple protocols. These data can be accessed via., internet using a software HYDRAS. The data collected can be used to gauge current weather conditions and to make weather forecasts like temperature high/lows, cloud cover and the probability of precipitation.

1. Ultrasonic Wind speed and Direction sensor & Compass
2. Global Radiation Sensor
3. Temperature, Humidity, Barometric Pressure Sensors
4. Rain Gauge
5. Data Logger

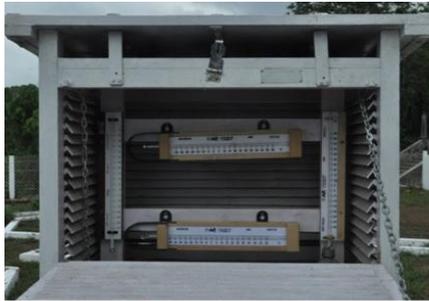
PSYCHROMETER

Relative Humidity is found out from the calibration graph (relative humidity table) connecting dry bulb temperature and the difference between wet bulb temperature and dry bulb temperature. It is expressed in percentage.

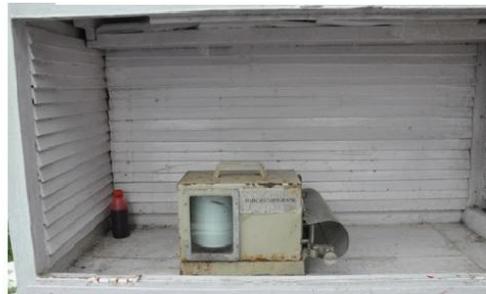
HAIR HYGROMETER

- Temperature – Max.& Min. Thermometers & Bimetallic Thermograph
- Relative Humidity – Psychrometer (Dry & Wet bulb) & Hair Hygrometer
- Rainfall – Standard Rain Gauge, Self Recording Rain gauge
- Evaporation – Land Pan Evaporimeter
- Wind Direction – Wind Vane
- Wind Speed – Cup Anemometer
- Bright Sunshine – Sunshine Recorder

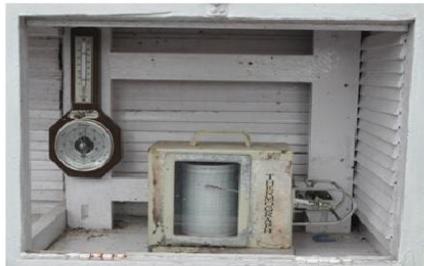
BIMETALLIC THERMOGRAPH

The standard, recommended maximum and minimum thermometers are two separate thermometers mounted (in a near-horizontal position) in a special device. The unit of measurement is degree Celsius. Recorded maximum and minimum temperatures are the highest and lowest values occurring during a specified period of time, such as 24 hours.

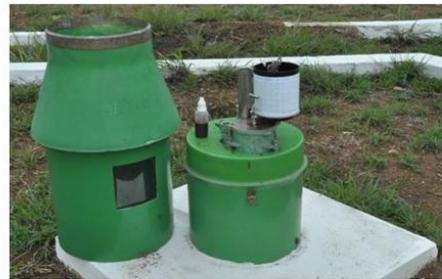
FLOAT TYPE SELF RECORDING RAIN GAUGE

Precipitation is defined as the liquid or solid products of the condensation of water vapour falling from clouds or deposited from air onto the ground. It includes rain, hail, snow, dew, rime, hoar frost and fog precipitation. The total amount of precipitation which reaches the ground in a stated period is expressed in terms of the vertical depth of water (or water equivalent in the case of solid forms) to which it would cover a horizontal projection of the Earth's surface. Snowfall is also expressed by the depth of fresh, newly fallen snow covering an even horizontal surface.

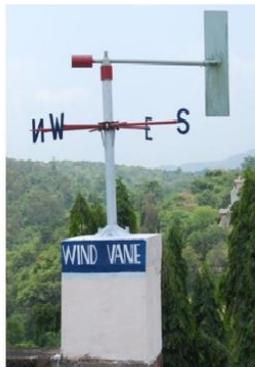
WIND VANE

Wind observations or measurements are required for weather monitoring and forecasting, wind-load climatology, probability of wind damage and estimation of wind energy. It is taken at a fixed location using 2 parameters; wind speed and wind direction. Surface wind is usually measured by a wind vane and cup or propeller anemometer. Wind Vane is used to find the wind direction and it is measured in degrees clockwise from north. Cup anemometer is used to find the wind Speed and is measured in kilometers per hour.

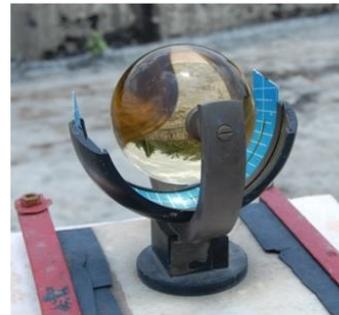
SUNSHINE RECORDER

lens to focus the sun rays on a specially designed tape. When the intensity exceeds a pre determined threshold, the tape burns. The total length of the burn trace is proportional to the number of bright hours. Duration of sunshine is in hours per day.

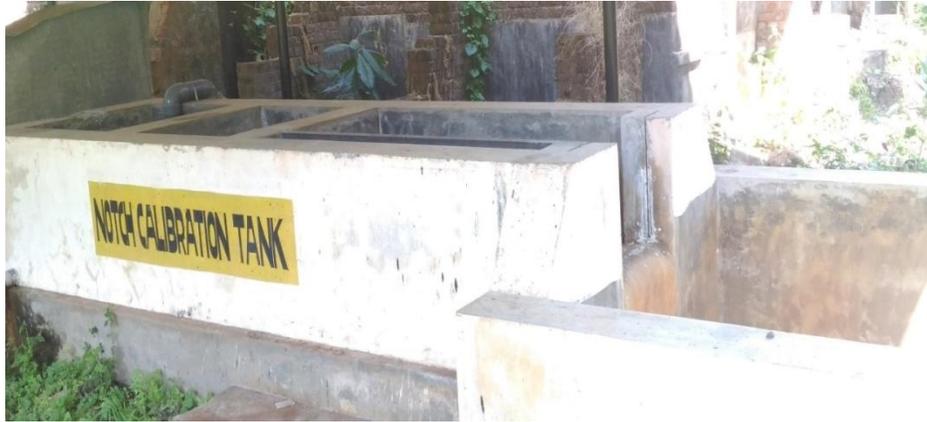
The notch calibration tank situated at outdoor Model Area I is generally used for the calibration of notches from received from various irrigation projects of Kerala. In 2017-18 span two triangular notches received from Pothundy dam were calibrated.

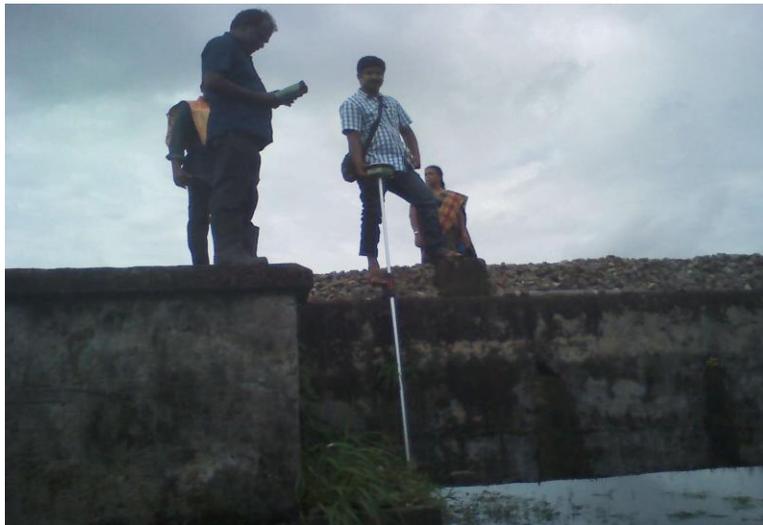
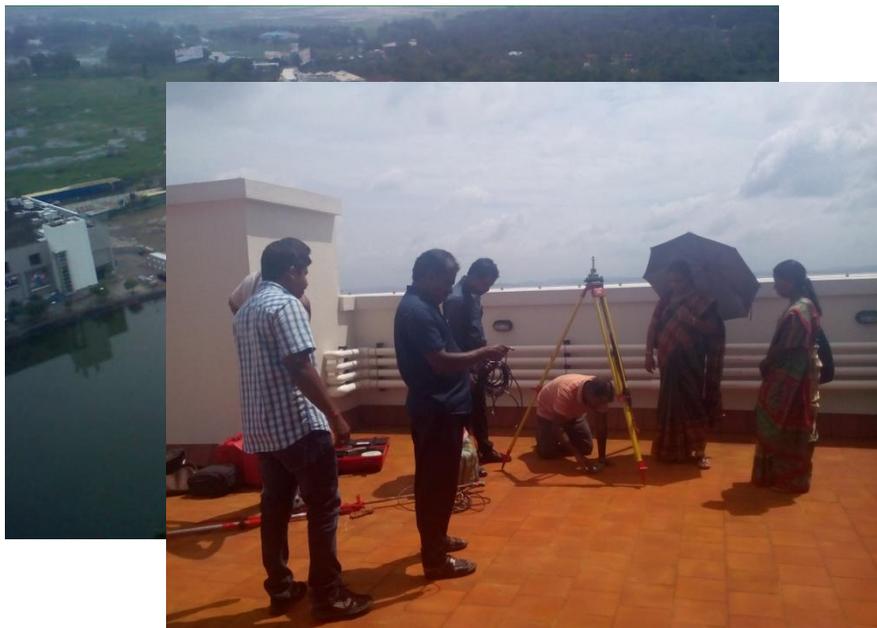
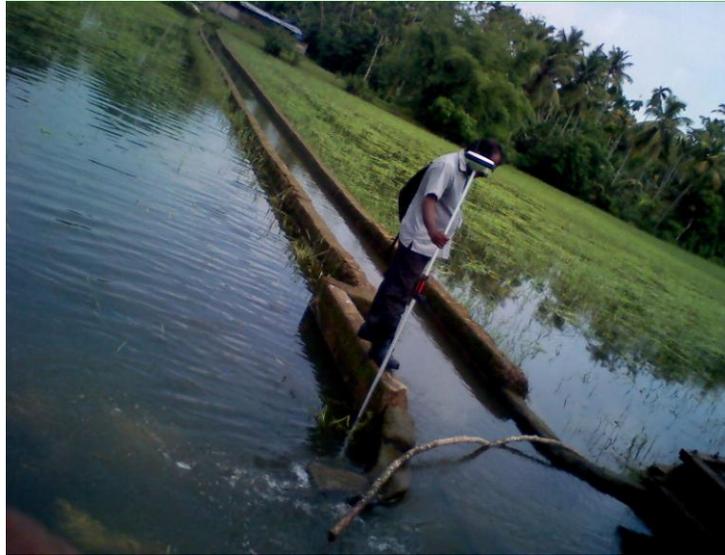
This estimate is prepared based on the request received from the Executive Engineer Irrigation Division, Thrissur. The purpose of this investigation survey was to assess the possibility of construction of a Regulator/Check Dam to store the water in summer season. The proposed site is in Puzhakkal River approximately 400m downstream of PWD Bridge at Puzhakkal in front of Sobha City in Kunnampulam–Thrissur Road. The position (i.e., latitude and longitude) of these sites has been fixed and connected with Mean Sea Level (MSL). Required cross sections and longitudinal section of river and banks has been plotted for designing the structure.

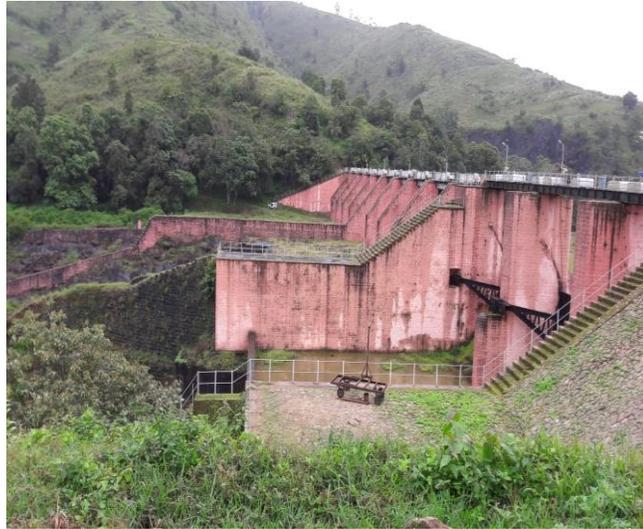
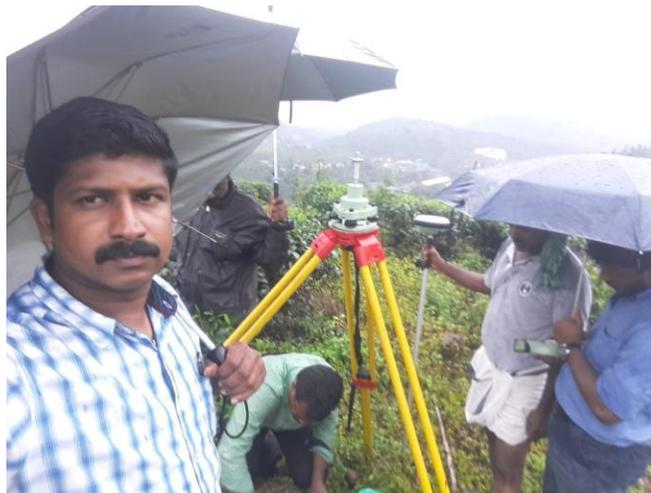
- *Located a permanent benchmark connected to MSL at Central Water Commission, Vandipperiya.*
- *Located a higher altitude point near Vallakkadavu (near CSI church/earthquake office) from where both Mullapperiya Dam and Vandipperiya is visible and Base station set up there.*
- *Altitude of base is corrected with respect to the permanent bench mark at Vandipperiya.*
- *Bench Mark Stone at Mullapperiya is connected from the corrected base station using Rover GPS.*

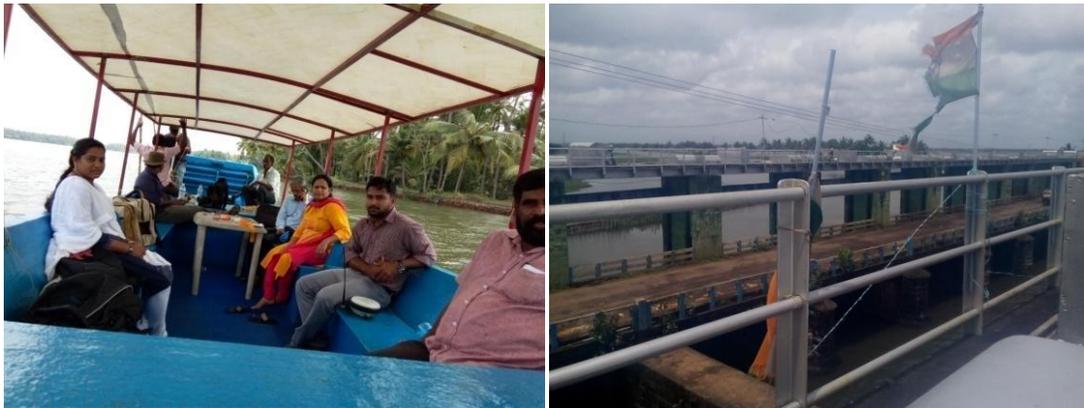
- *Fixing of position (i.e., latitude and longitude) of these sites.*
- *Connecting the site with Mean Sea Level (MSL)*
- *Conducted survey in river and bank for cross sections at particular intervals(at 30m interval for a length of 200m in u/s, 50m interval for next 500m, 250m interval for a total of 3.3km including d/s 1km and u/s balance 2.3km) for Designing the structure.*

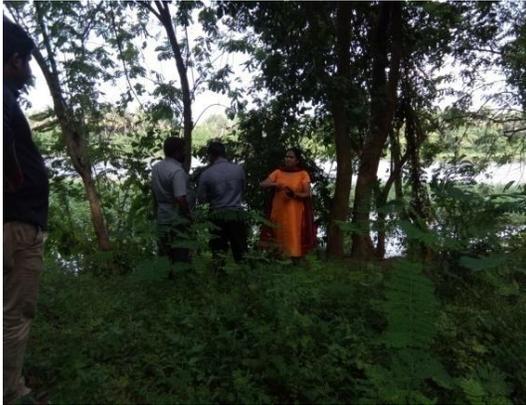
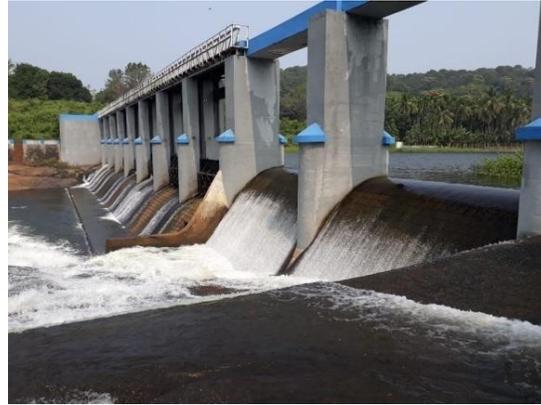
- ❏ *The top level of existing Cheerakuzhi weir has been connected in order to determine the effect of back up water in the proposed structure when Cheerakuzhi Weir is in FRL.*
- ❏ *The position of the site has been fixed(i.e., latitude and longitude),survey has been carried out for finding the required cross sections and longitudinal section of river and banks at particular intervals(30m, 50m & 100m)for designing the structure.*

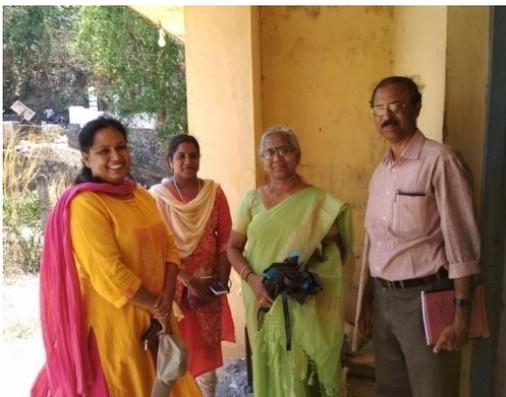
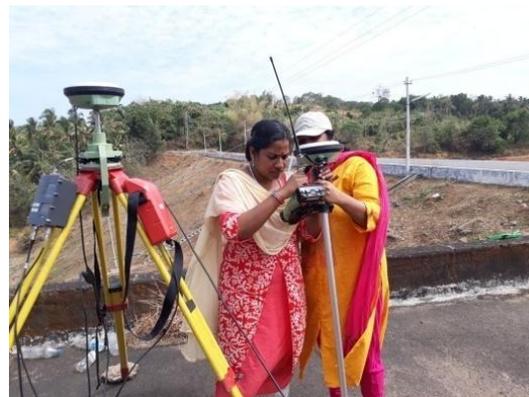
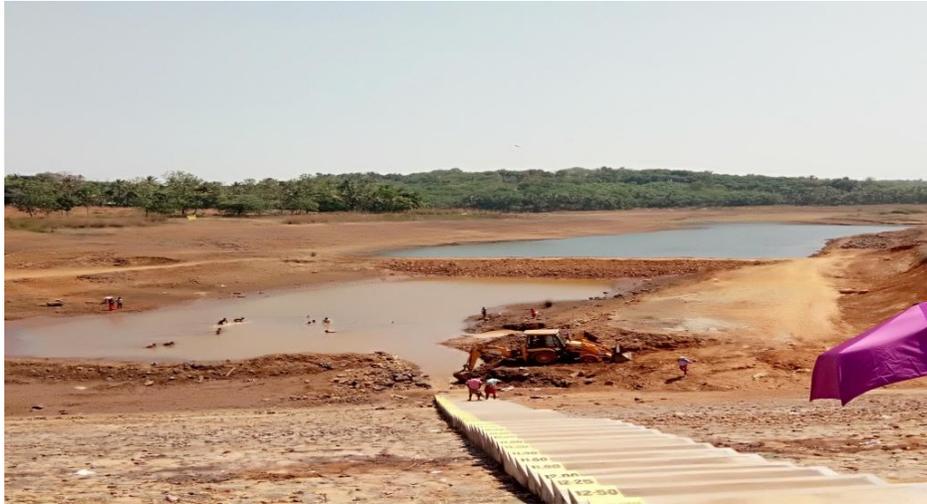
- Existing dam structure and associated features has been plotted.
- Entire area (in water and in land portion) at FRL has been surveyed in cross sections at 25m intervals with points at 2m intervals.
- The site has been connected with MSL from permanent bench mark available at Shobha City nearly 16km away, where we had established a permanent bench mark for a work under this division.

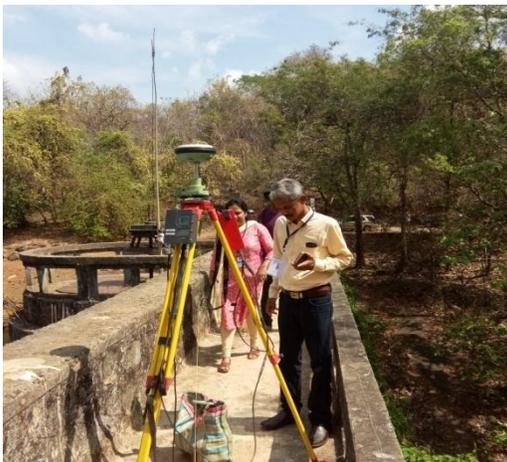
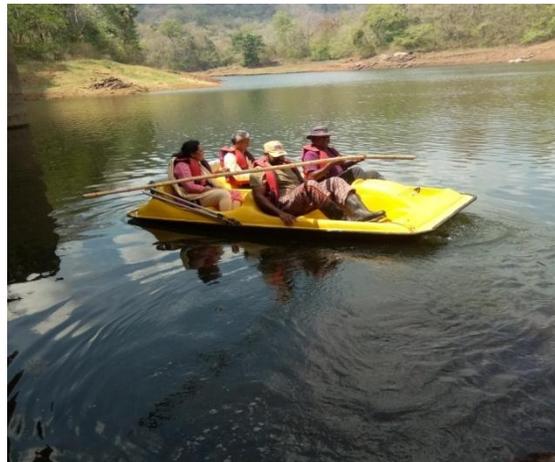
- Existing dam structure and associated features has been plotted.
- Entire area (in water and in land portion) at FRL has been surveyed in cross sections at 25m intervals with points at 2m intervals.
- The site has been connected with MSL from permanent bench mark available at Cheruthuruthy Bridge, where we had already established a permanent bench for a work under this division.

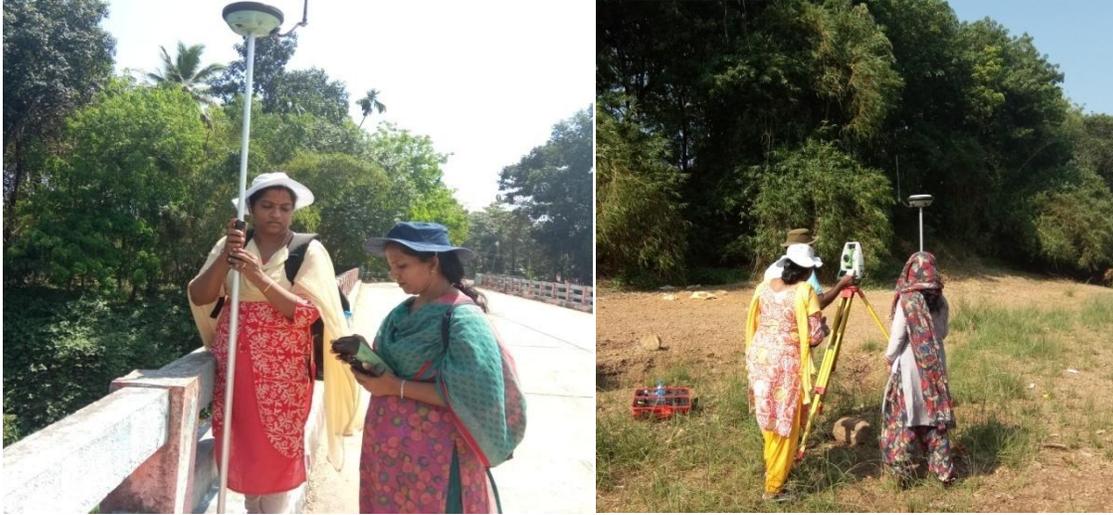
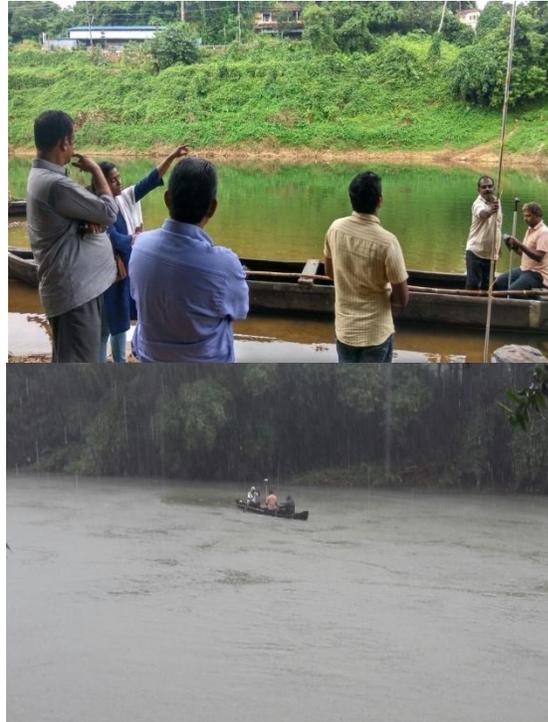
- ✚ The survey has been conducted from 800m downstream of proposed structure till it meets the site for proposed structure at Pullukuthy, which is 6.8km upstream.*
- ✚ River bank has also been surveyed for ascertaining enough bank height for water storage.*
- ✚ Plan, Cross sections, longitudinal section and contour maps at 2m interval have been prepared as per design requirement.*
- ✚ Roads, buildings and other permanent structures have been plotted.*
- ✚ The existing PWD bridge is only 180m upstream of proposed site.*
- ✚ The bed level varies from -0.30m to +1.26m at proposed site.*
- ✚ The ground level at banks at proposed site is above +9.00m.*
- ✚ The bank height is more than +5.00m throughout the surveyed stretch except some places where streams meets the main river.*

Sand mining on the river bed has led to irregular bed levels and due to this the longitudinal section is not showing natural slope.

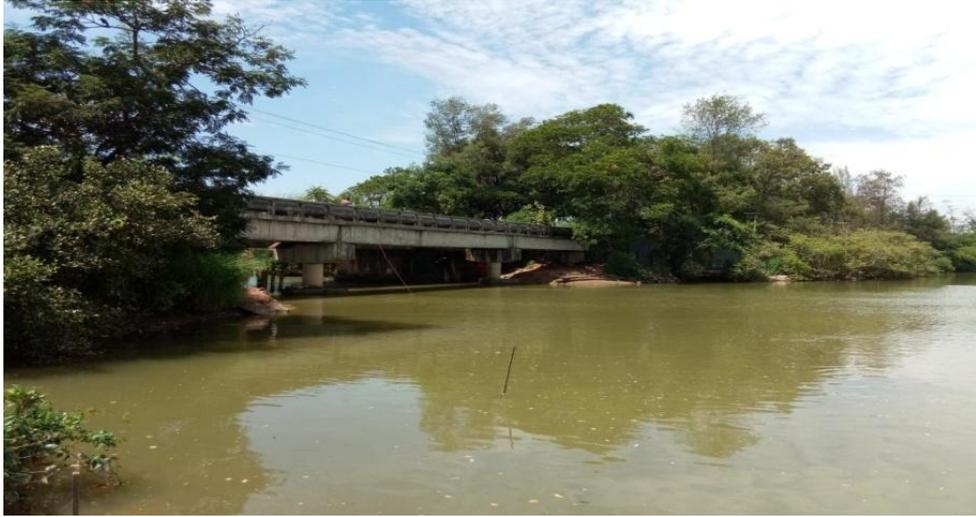
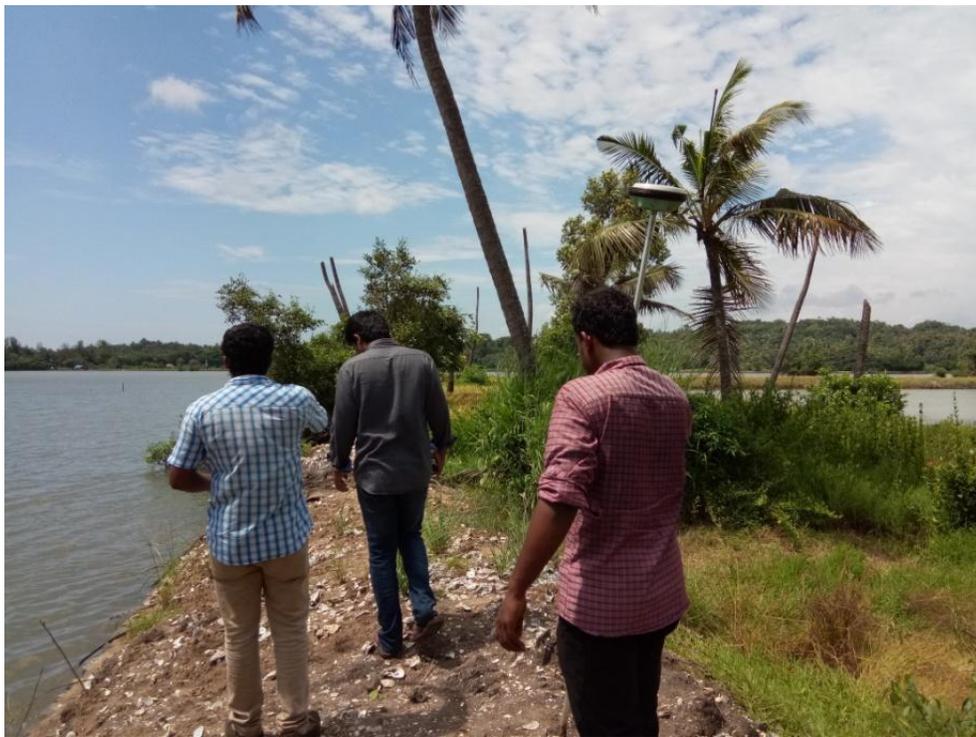
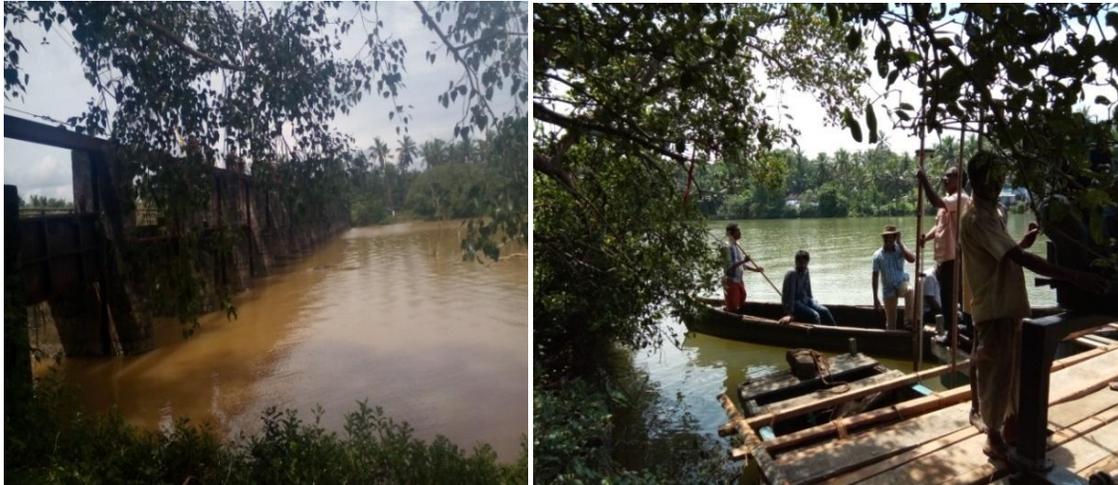
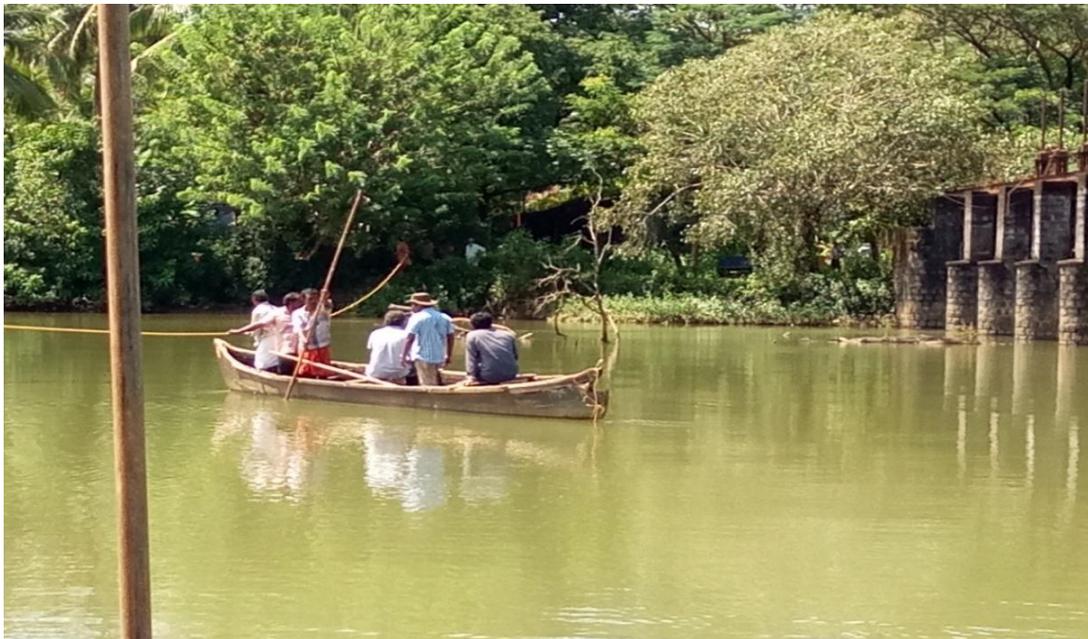
- *The survey has been progressed from proposed site towards upstream for about 5.4km and downstream about 1.1km.*
- *River bank has also been surveyed for ascertaining enough bank height for water storage.*
- *Plan, Cross sections, longitudinal section and contour maps at 2m interval have been prepared as per design requirement.*
- *Roads, buildings and other permanent structures have been plotted.*
- *The existing Regulator cum Bridge is only 17m downstream of proposed site.*
- *The lowest bed level is -4.501m at proposed site.*
- *The ground level at banks at proposed site is above +0.50m.*
- *There is not much change in bed level in this stretch of survey and hence a flat slope is observed.*

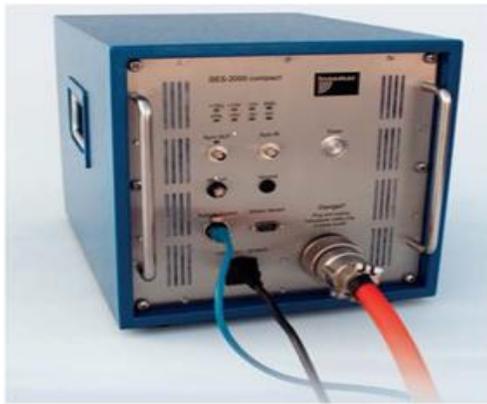
Fig.1 Top-side Unit

The system SES-2000 Sub-bottom profiler, which is a mobile parametric sediment sounder, was used for bathymetric and sub-bottom profiling survey. The SES-2000 hardware component and transducers are shown in Fig. 1 & 2.

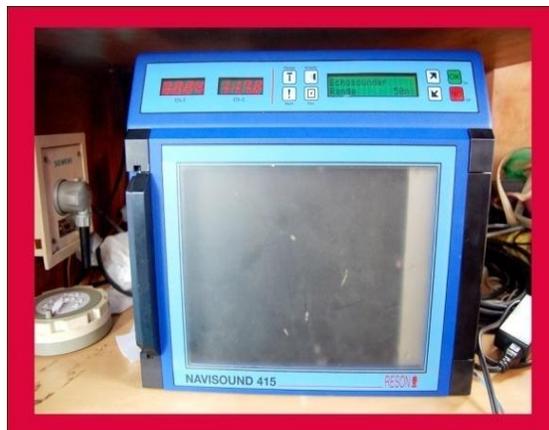
Fig.4 Echo Sounder

Navitronic Echo-sounder NS 415 is designed to measure under water depth up to 1200m. Accuracy of instrument is 1centimeter. A dual frequency echo-sounder is specified to distinguish between fluff top depth and the consolidated bottom. The high frequency (200 KHz) is used to detect the top of the mud/sediment. Under favorable conditions the low frequency signal (33KHz) can penetrate the bottom and reveal information about the bottom structure.

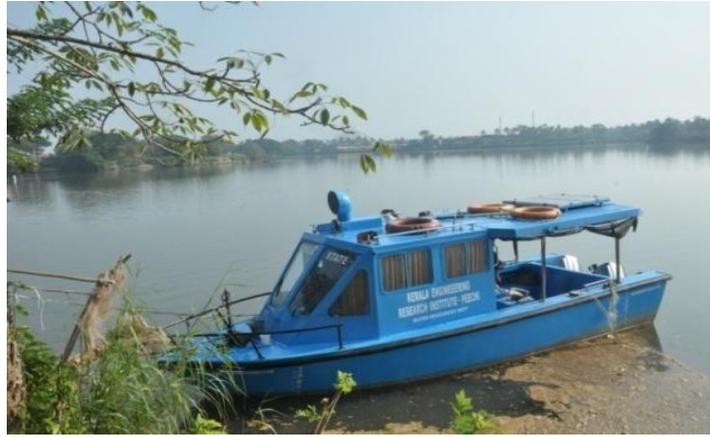
Fig.5 FRP Boat

A Fibre Reinforced Plastic (FRP) boat with two 60 HP petrol out board engines is used as the Survey Boat. The boat has dimension of 7.5m x 2.66m x 1.20m and 8persons

capacity with the equipment. The boat with all the survey equipment is referred as the 'mobile station'. For the power supply, two solar panels of 80Watt each are mounted on the roof of the boat.

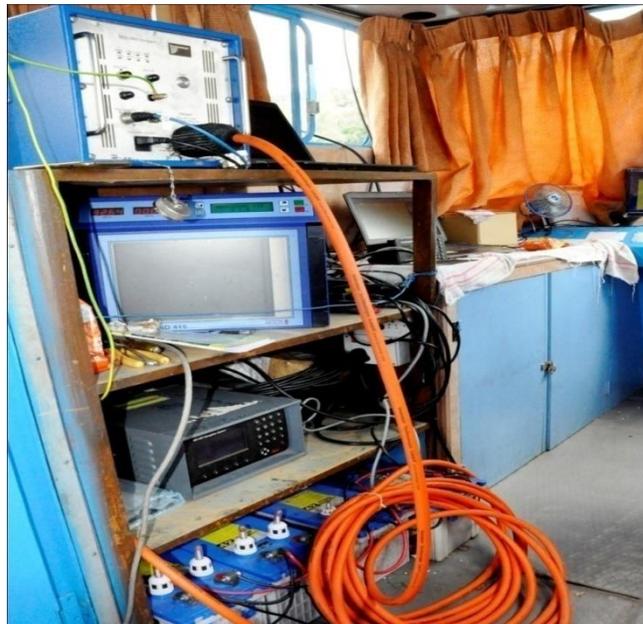
Fig.6 Equipment set up inside the Boat

The mobile station consists of the DGPS and its antenna, Echo sounder, Sub Bottom Profiler and the transducers, etc., is mounted on the FRP boat. The transducer of Sub Bottom Profiler is permanently fixed at the center of the boat. The transducer of Echo sounder is connected to the left side of the boat and is detachable. Proper connections are made between these equipment and the laptops for the data collection. The boat is sailed along the planned track with a speed of 3 to 4 knots. The data from the Echo sounder and Sub Bottom Profiler is collected simultaneously through two laptops as shown in fig.7.

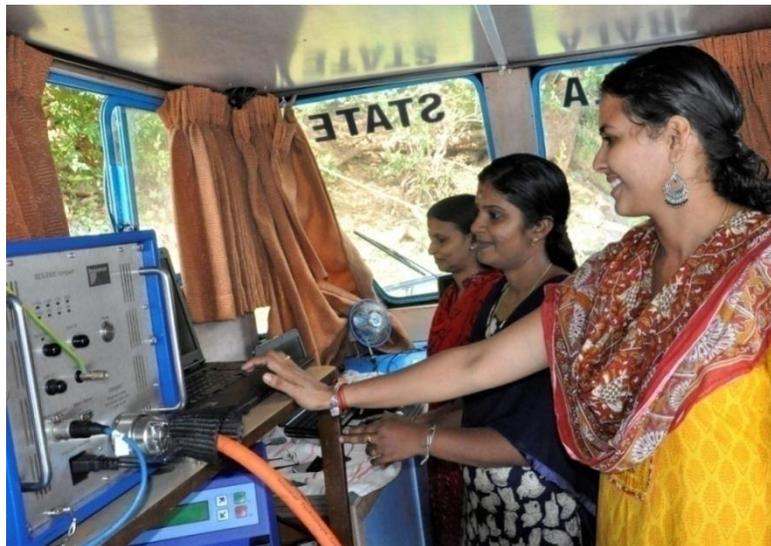
Fig.7 Data Collection set up inside the Boat

For IBS Survey, the laptop loaded with Navisoft survey software is used. Navisoft is used for the Planning and Presentation, data collection and the data processing. The Navisoft Survey Module is used to collect the depth data from the echo sounder which is linked with the position data. The data is collected at the required interval and logged as “PRD” format data for further analysis.

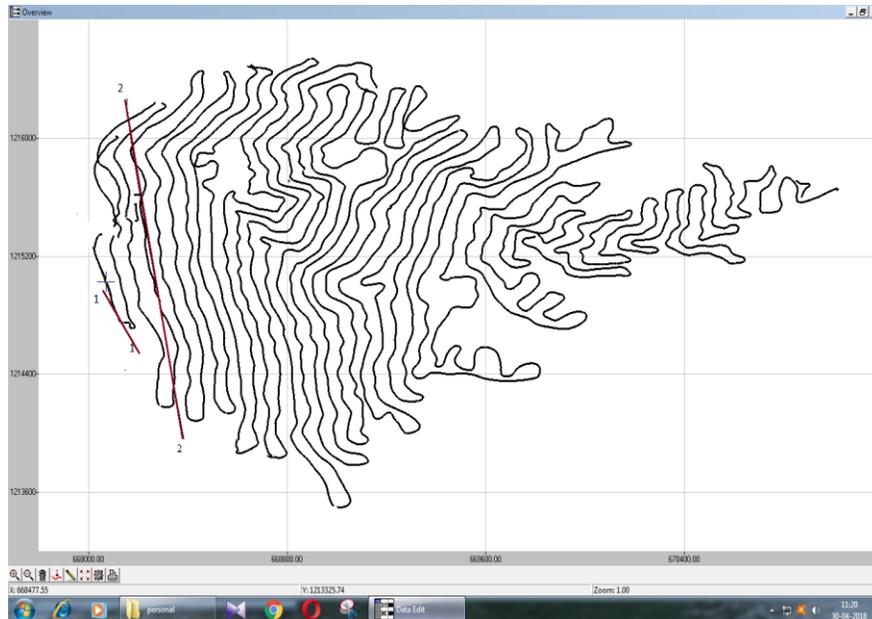
Fig.12 Plan of Kanjirapuzha Reservoir showing sections surveyed

The profiles show the depth of water at different locations along the track marked in the profile map of Kanjirapuzha Reservoir, and is shown in Fig.13 to Fig14.

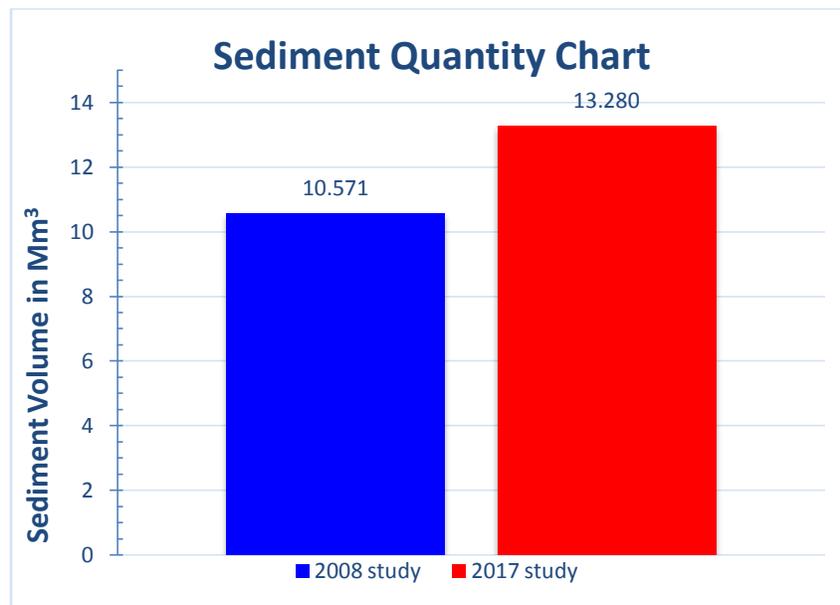
Fig.16 Increase in Sediment quantity

The survey is carried out at the permissible maximum water level of 96.0m. The original water holding capacity at this level is 62.44 Mm³. As per the current IBS study the volume at the same level is estimated as 49.16 Mm³ and the corresponding water spread area is 5.05Sq.km. Total capacity reduction of the reservoir is 13.28Mm³ in 37years, i.e., the reduction in capacity at the specified level is 21.27%. The capacity reduction is due to the sediment deposit.

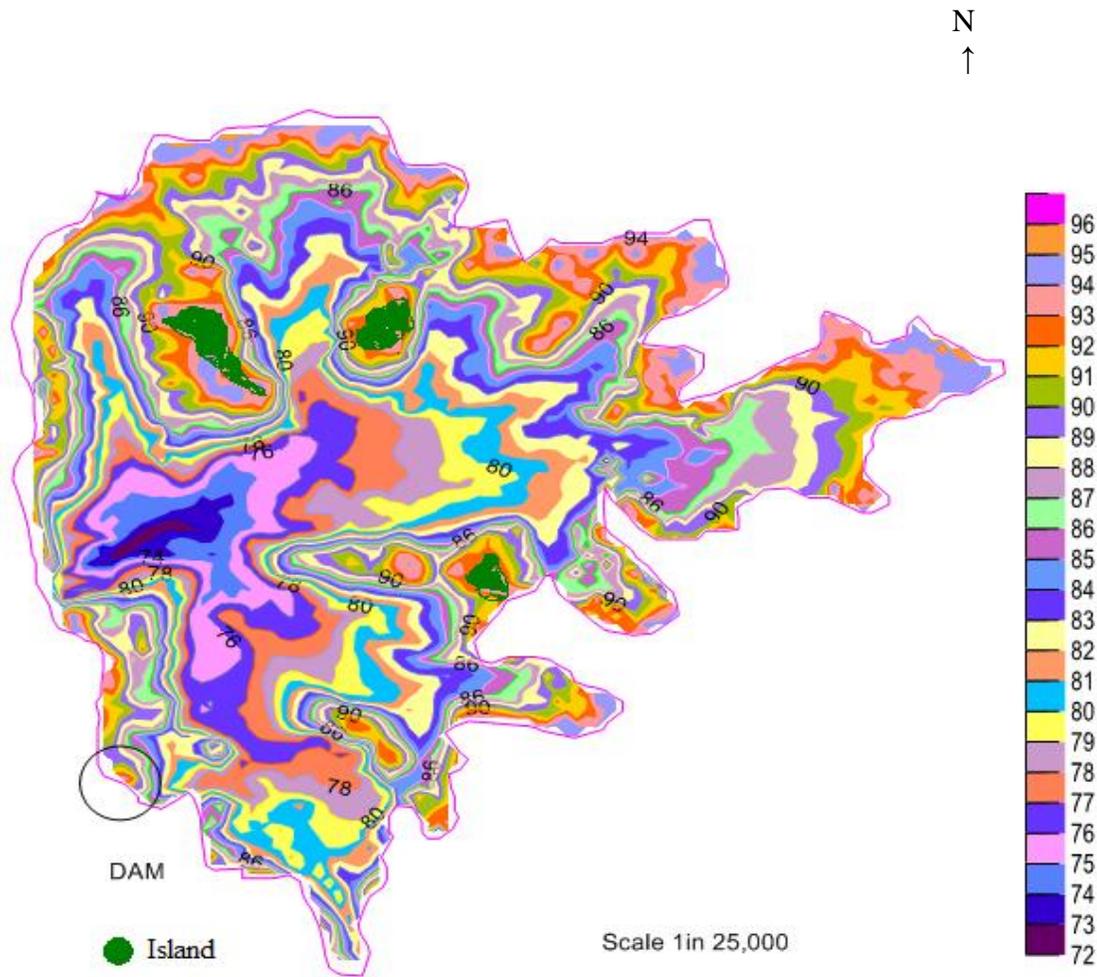
Fig.17 Contour Map based on IBS Survey

The contour map of water spread area is shown in Fig 17 at an interval of 1m

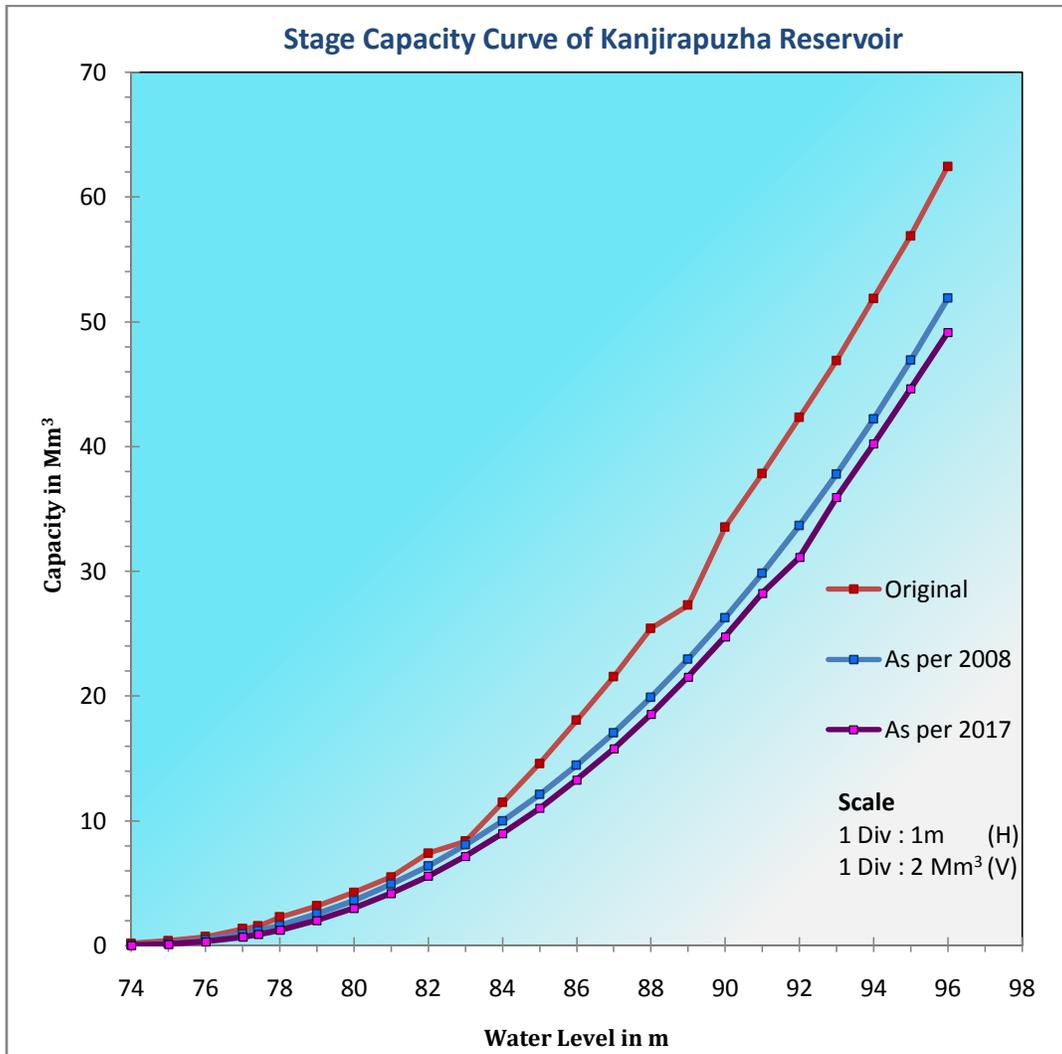
Fig.18 Water level v/s water holding capacity curve

The original storage capacity curve is compared with the same obtained from the IBS surveys in 2008 and 2017 as shown in Fig.18.

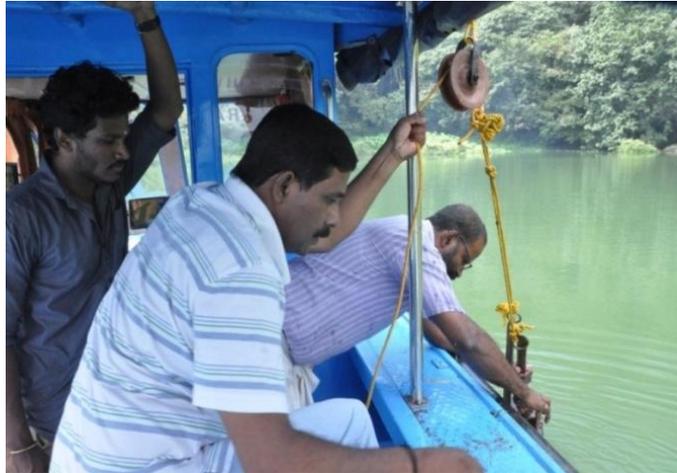
Fig.20 Soil sample collection

Disturbed soil samples were collected using grab type mud sampler (only surface soil) from 13 locations in the reservoir. The sample collection locations are shown in Fig.20. Undisturbed samples cannot be collected using this type of sampler. These soil samples were analyzed in Soil Mechanics and Foundations Division, KERI, Peechi.

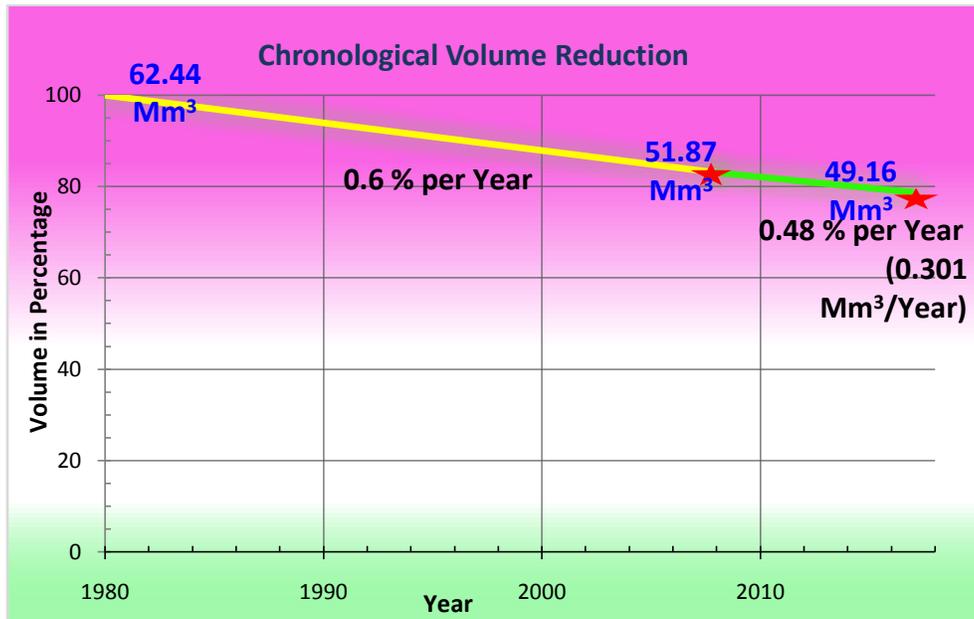
Fig.23 Chronological Volume Reduction

The graphical representation of reduction and rate is shown in Fig.23

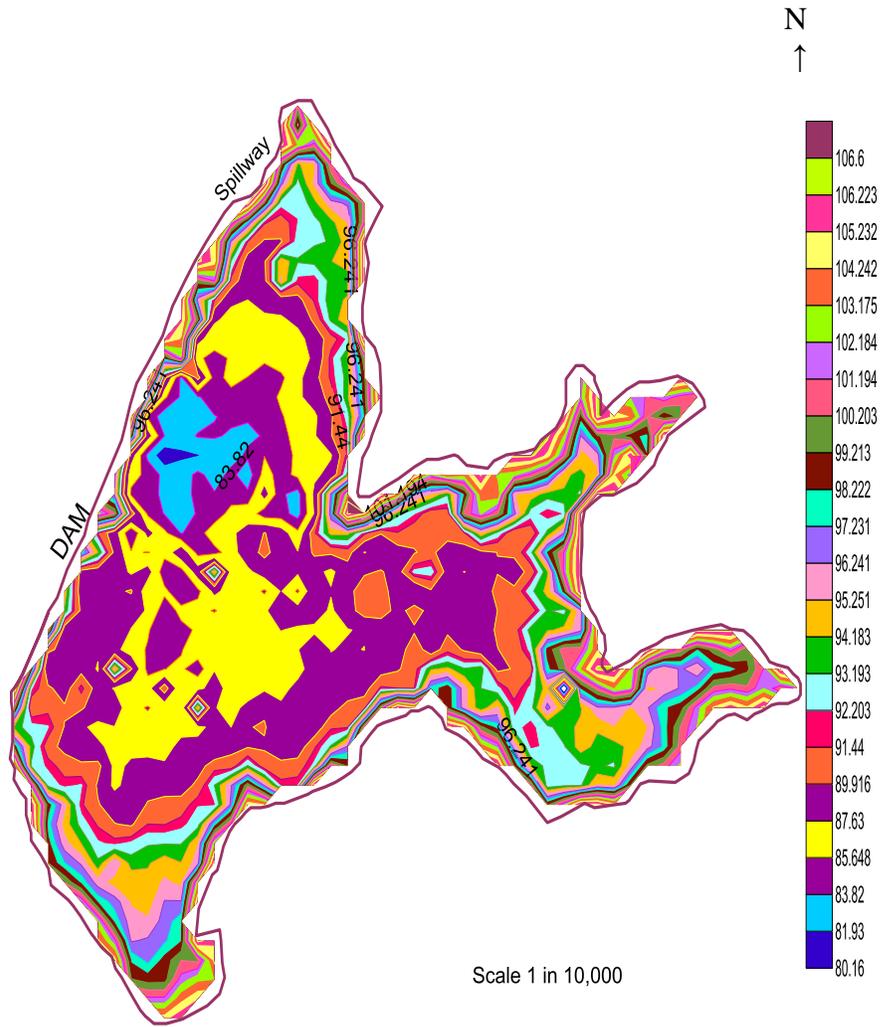
Fig.29 Contour Map based on IBS Survey

The contour map of water spread area is shown in Fig. 29.

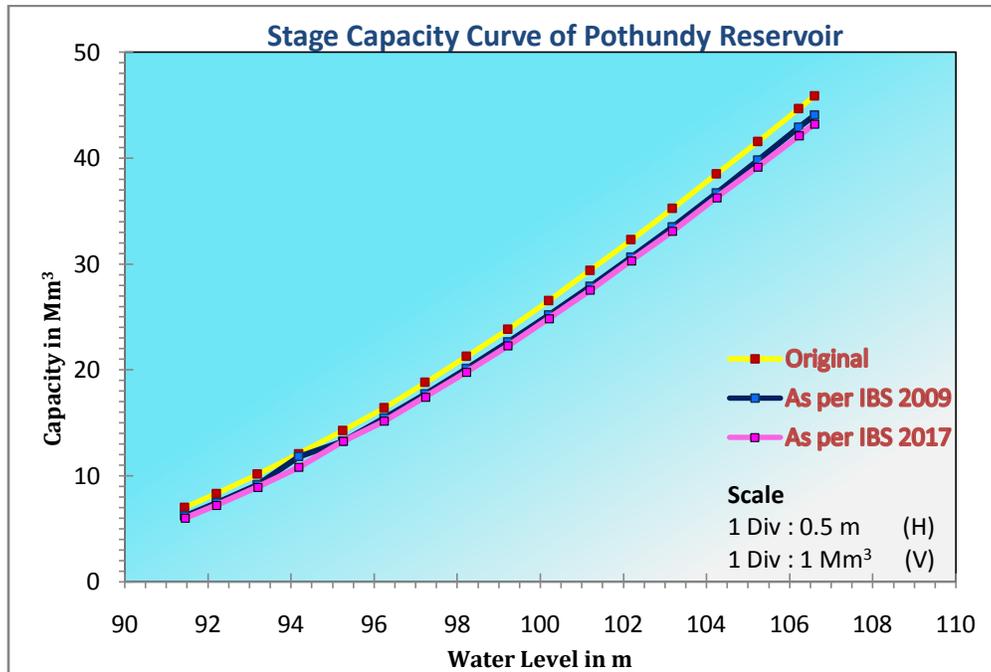
Fig.30 Water level v/s water holding capacity curve

The original storage capacity curve is compared with the same obtained from the IBS surveys in 2009 and 2017 as shown in Fig.30.

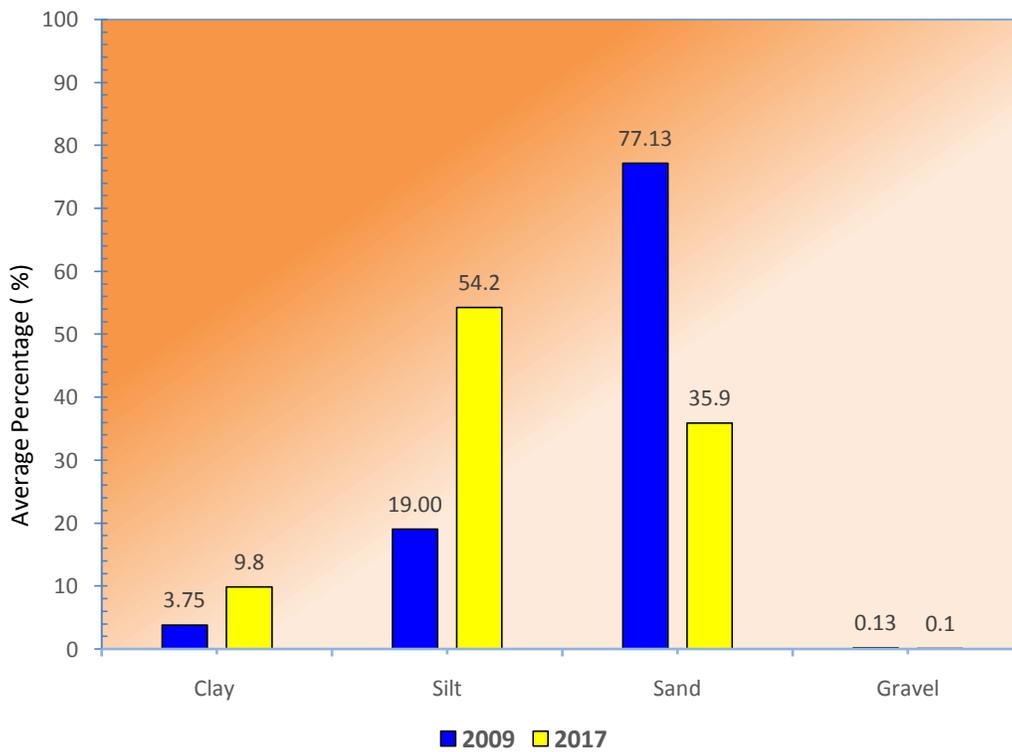
Fig.33 Comparison of Soil particle distribution as per two consecutive sedimentation studies

In the sedimentation study conducted in 2009, 8Nos. of disturbed soil samples were analyzed. In the present study 10Nos. of soil samples are analyzed. The samples for both the studies were collected from different locations. By comparing the results of two studies, remarkable variations are observed in the percentage of Silt and Sand. The details are shown in the bar chart given in Fig.33.

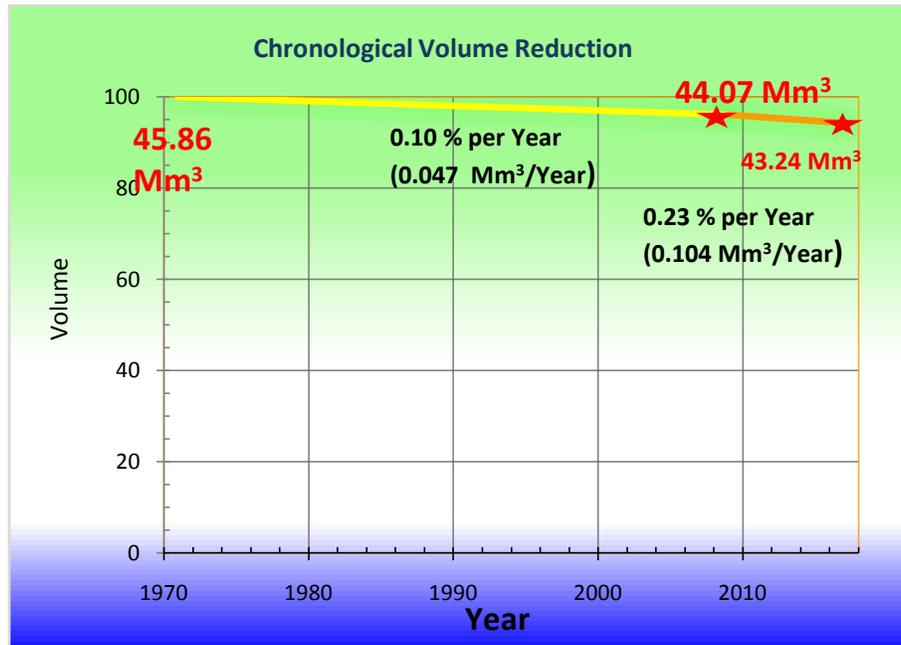
Fig.34 Chronological Volume Reduction

The graphical representation of reduction and rate is shown in Fig.34

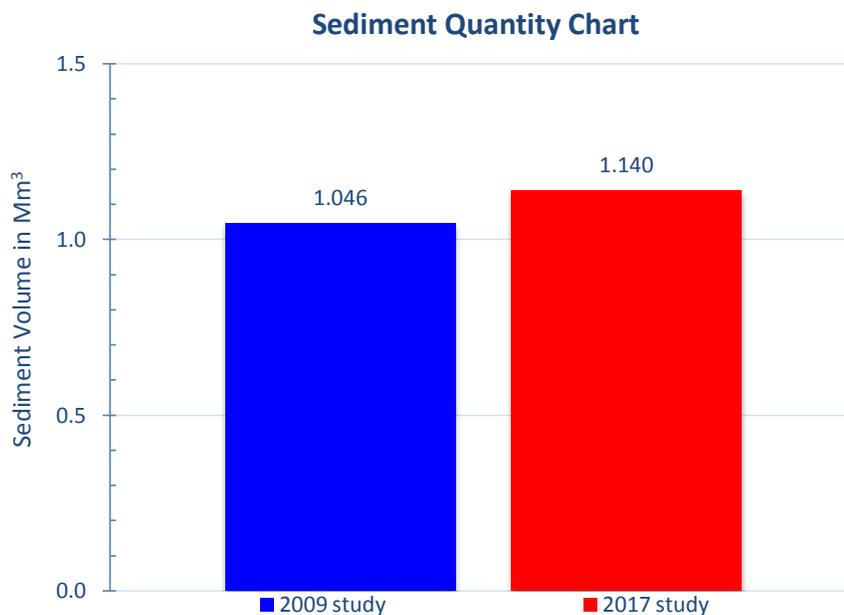
Fig.39 Increase in Sediment Volume

The survey is carried out at the water level of 147.37m. The original water holding capacity at this level is 4.589Mm^3 . As per the current IBS study the volume at the same level is estimated as 3.449Mm^3 and the corresponding water spread area is 0.96Sq.km . Total capacity reduction of the reservoir at this level is 1.14Mm^3 in 53years, i.e., the reduction in capacity at the specified level is 24.84%. The capacity reduction is due to sediment deposit.

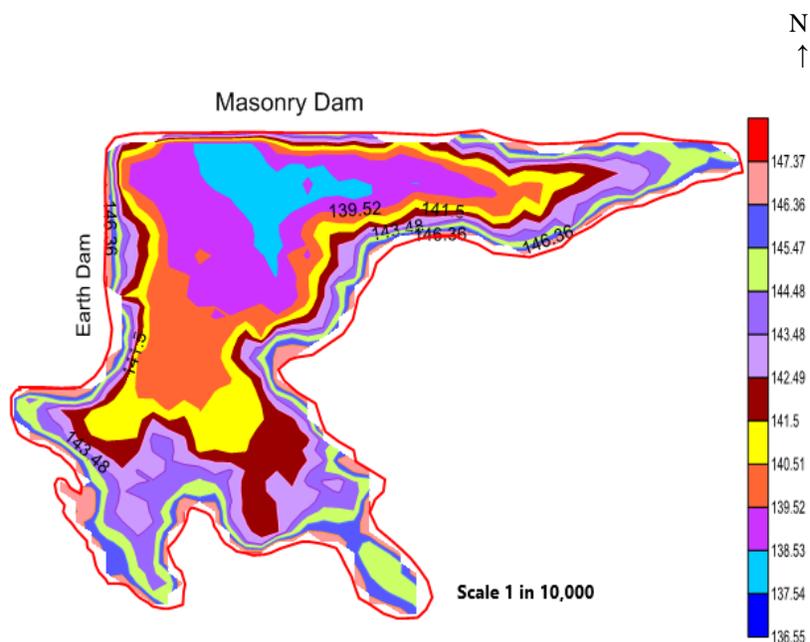
Fig.40 Contour Map based on IBS Survey

Table-9 shows the comparison in capacity of the reservoir at the water level of 147.37m between the two consecutive studies conducted in 2009 & 2017. The contour map of water spread area is shown in Fig 40.
