1. ORGANISATIONAL SET UP

The Kerala Engineering Research Institute consists of seven divisions functioning at Peechi as well as Coastal Engineering and Field studies Division at Thrissur and Quality Control wing of the Irrigation Department. Generally, the activities of each division can be categorized as falling under Routine activities, Fundamental studies and Revamping and Modernization. The routine activities and fundamental studies conducted by each division are enumerated in this chapter.

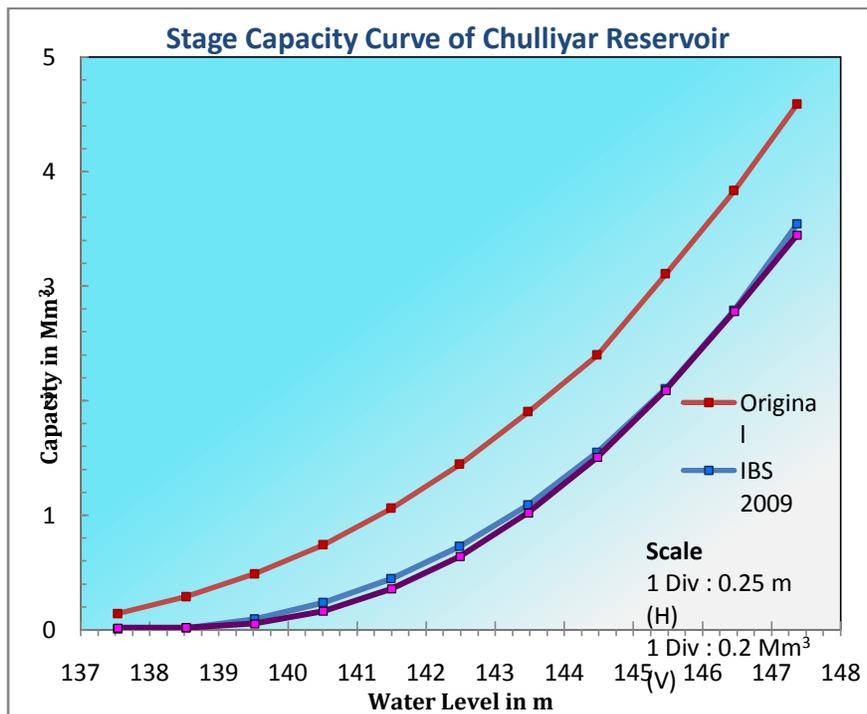
Fig.41 Water level v/s water holding capacity curve

The original storage capacity curve is compared with the same obtained from the IBS surveys in 2009 and 2017 is shown in Fig. 41.

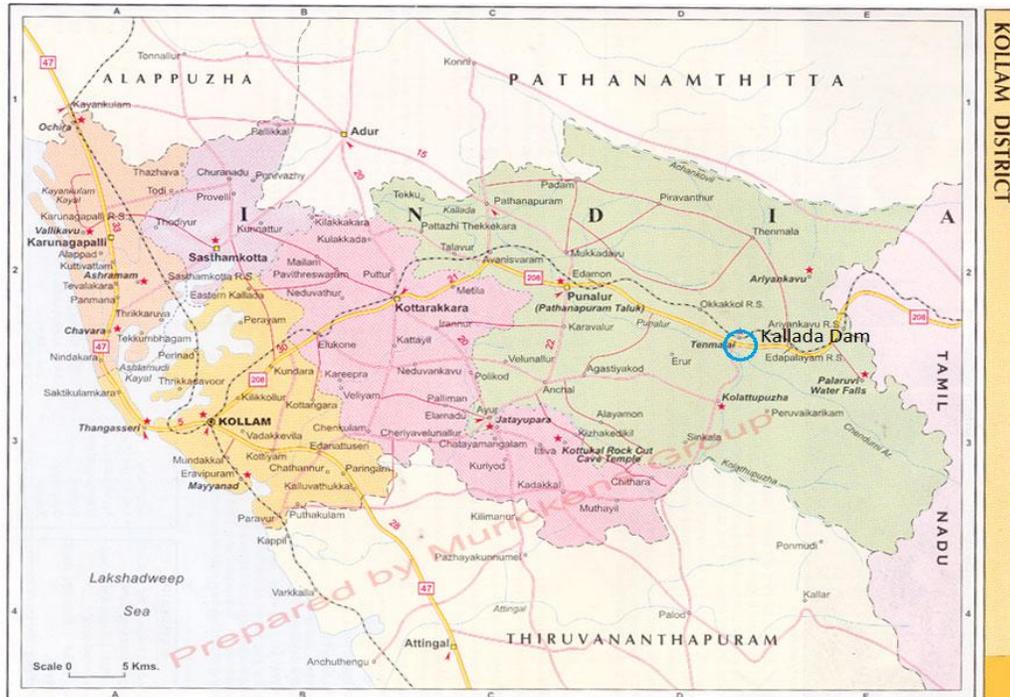
Fig.44 Location Map of Kallada reservoir

The location of the storage dam is at Parappan (Latitude $8^{\circ}57'16.558''$ North Longitude $77^{\circ}04'12.149''$ East). Here the three major tributaries of the river viz., Kulathupuzha, Senthuruni and Kazhuthurutti confluence to form the main Kallada River. The location map is shown in the Fig.44.

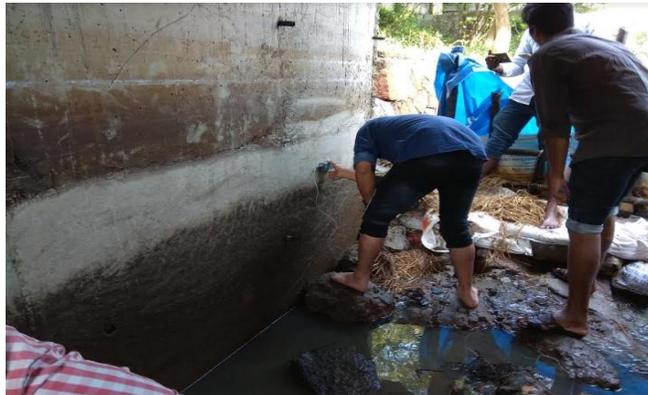
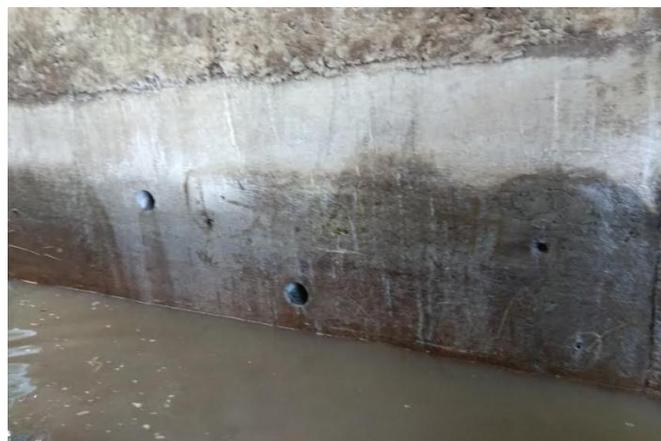
1. Concrete core sample collection at MavelikkaraKuttanad package – Flood control work of T. A. Canal North – Unnippalam Box culvert – Onattukara

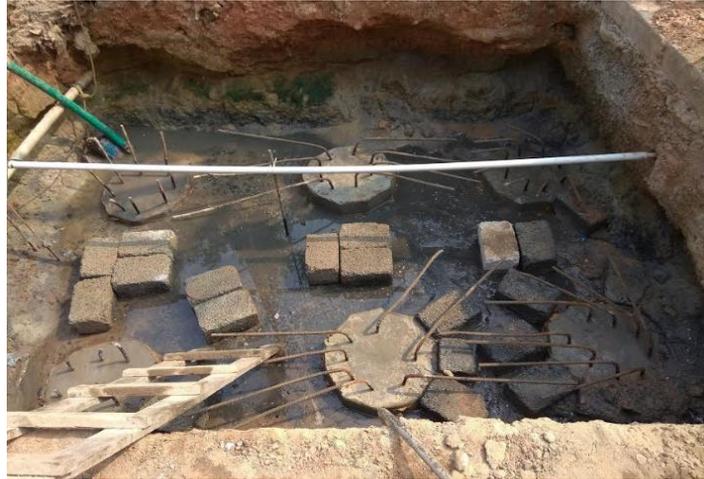
2. Pile Integrity Test (14 no piles) - Constructing Culvert in Kareethodu across Mannarkara road in Division No.47 & 48 of Kochi Corporation.

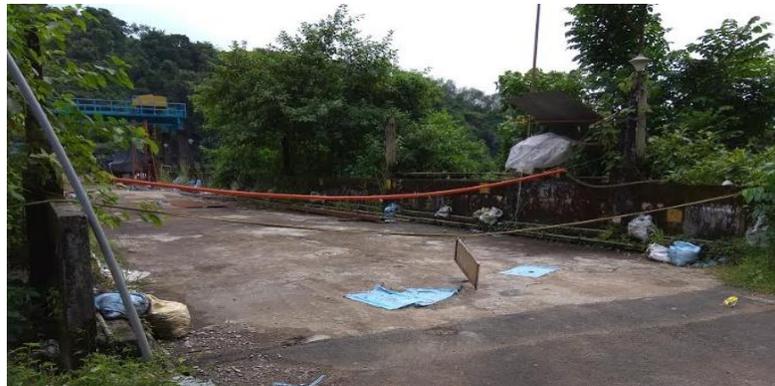
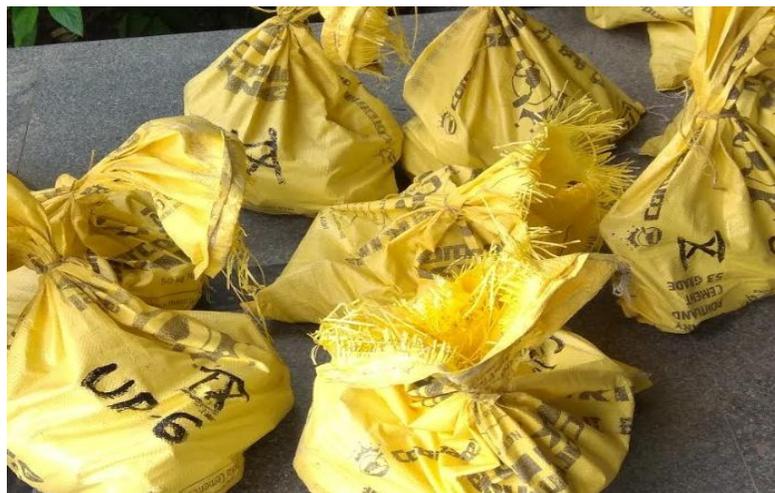
3. Kuttiyadi Dam Site core collection

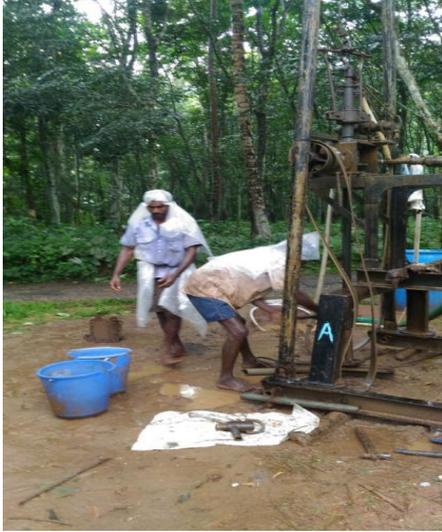
Boring work in right abutment in Paduthode site

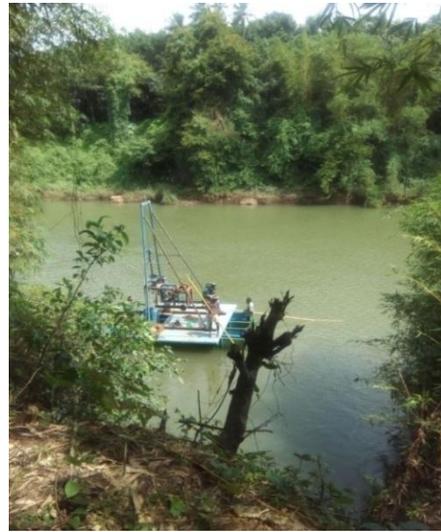
Boring work in stream in Paduthode

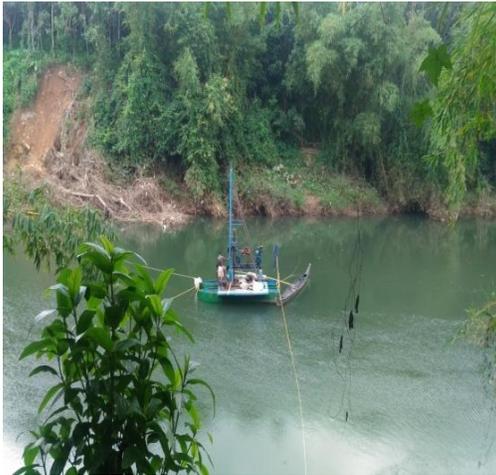
Boring work in stream middle portion Paduthode

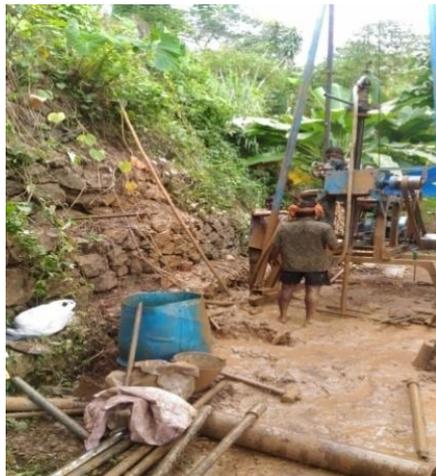
Boring works in Pullukuthy site

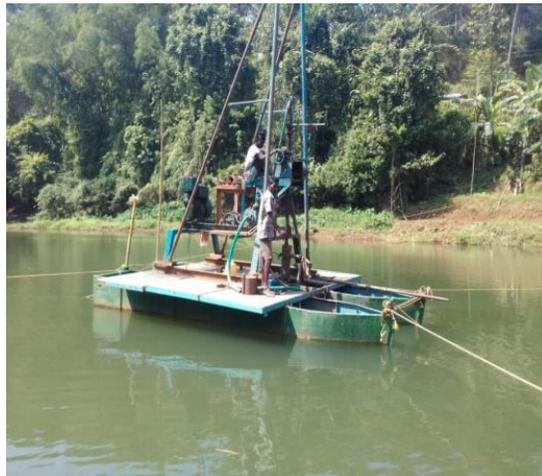
Boring works in stream portion Pullukuthy site

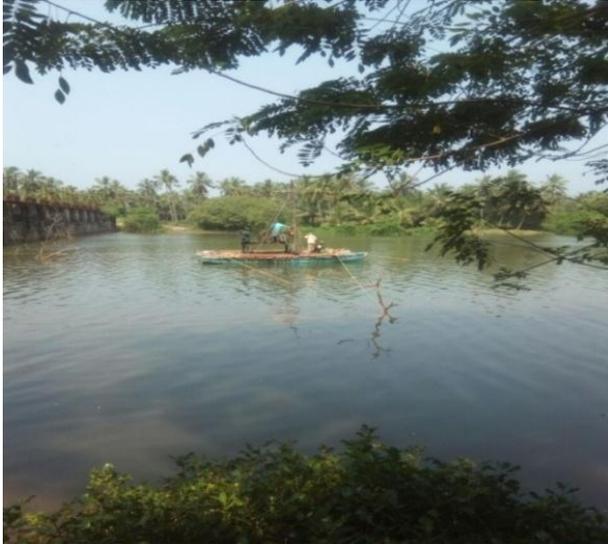
Boring in stream –Paraparam

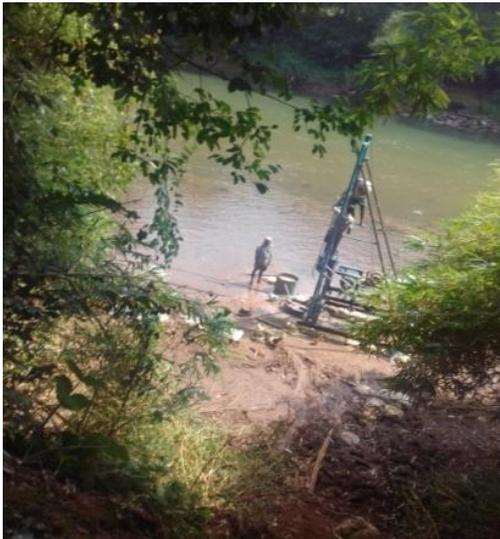
Boring in stream –Kulathoormozhy site

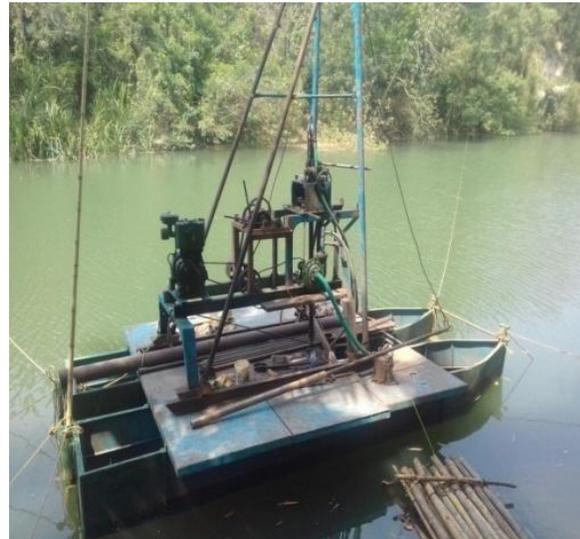
Boring in stream –Mavillakadavu site

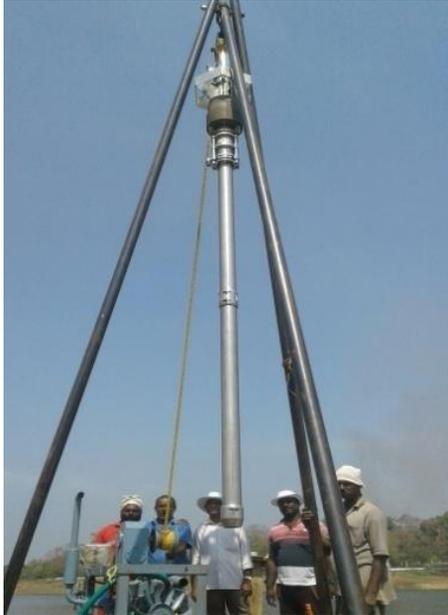
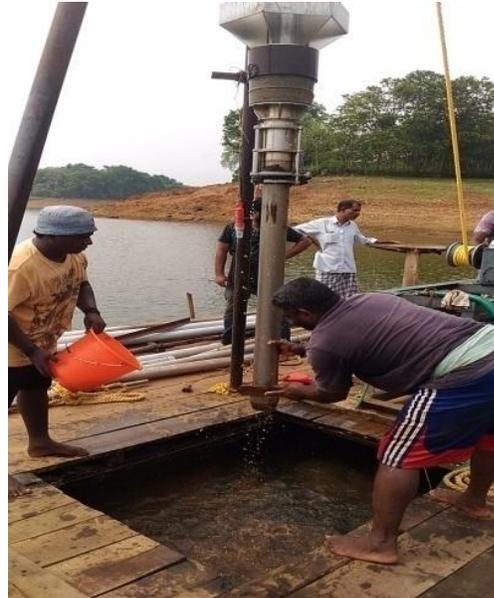
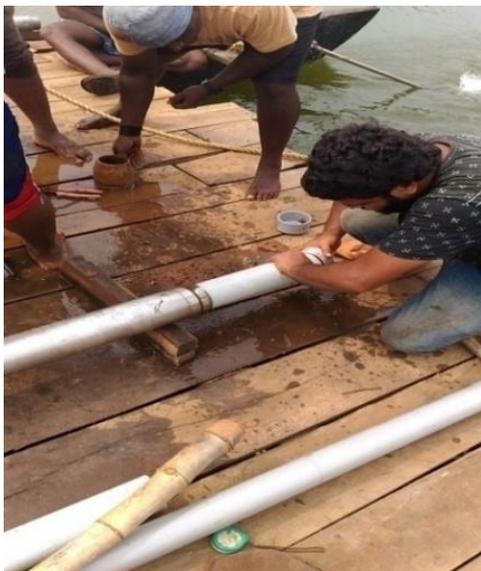
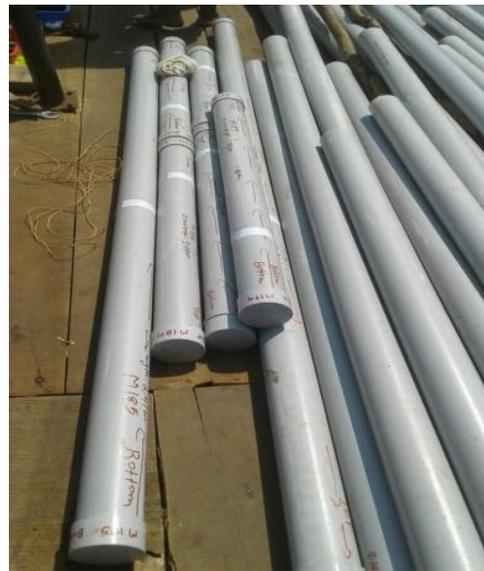
Gravity core sampling of sediments at Mangalam Dam
