1. ORGANISATIONAL SET UP

THE Kerala Engineering Research Institute is under the Directorate of Fundamental & Applied Research, at Peechi headed by the Director in the rank of Superintending Engineer with, two Divisions functioning at Peechi, i.e., the Hydraulic Research & Construction Materials & Foundation Engineering Division and another division namely the Coastal Engineering Field Studies Division at Thrissur, each headed by a Joint Director, an officer in the rank of an Executive Engineer.

A.1 Introduction

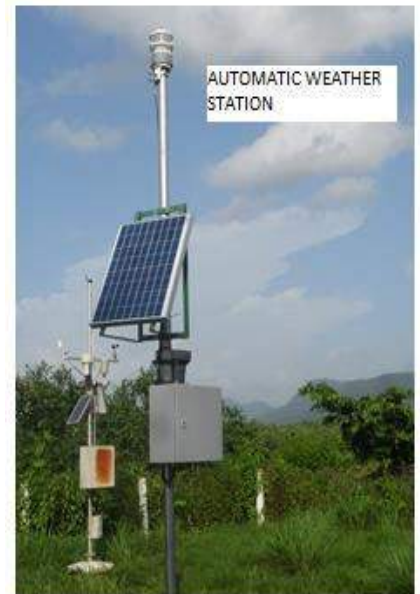
The Automatic Weather station collects data related to Air Temperature, Air Humidity, Barometric pressure, Ultrasonic Wind speed, Ultrasonic Wind Direction, Global radiation and Precipitation using different sensors. A Data Logger which is part of the Automatic Weather Station is collecting data in every 30 minutes and transferring it to a central server in every 2 hours using multiple protocols. These data can be accessed via internet using a software HYDRAS. The data collected can be used to gauge current weather

Components of Automatic Weather Station

1. Ultrasonic Wind speed, Ultrasonic Wind Direction & Compass
2. Global Radiation Sensor
3. Temperature , Humidity, Barometric Pressure Sensor
4. Rain Gauge
5. Data Logger

Time series observations are vital to improve the understanding of weather dynamics and its variability. The Automatic Weather Station plays an important role in providing short term and long-term time series weather observations. An automatic weather station is functioning in Meteorological Station since July 2014 with Remote transmission facility and a Solar Panel for uninterrupted power supply.

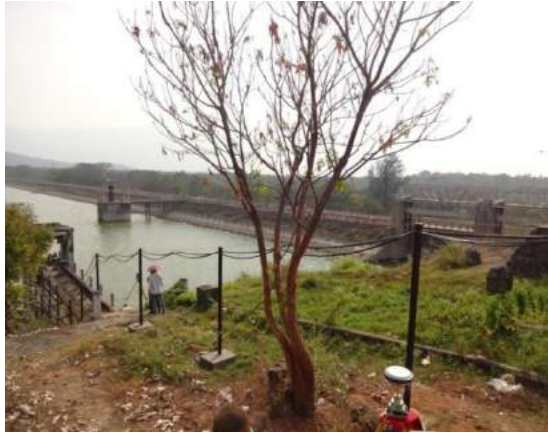
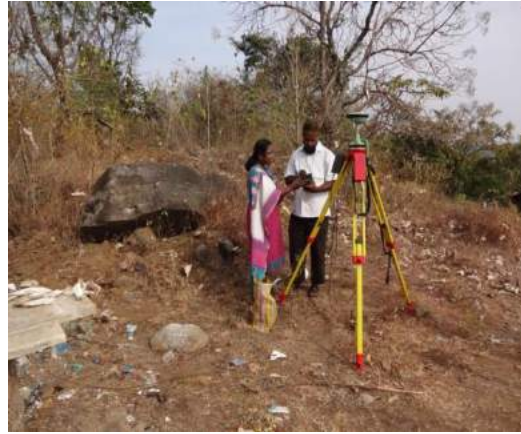
Using Smart Station the work for determining the current profile of the Meenkara Dam has been done. The dam and the premises have been plotted and the contour plan, level plan etc. has prepared. A 3D view of the dam has also been prepared.

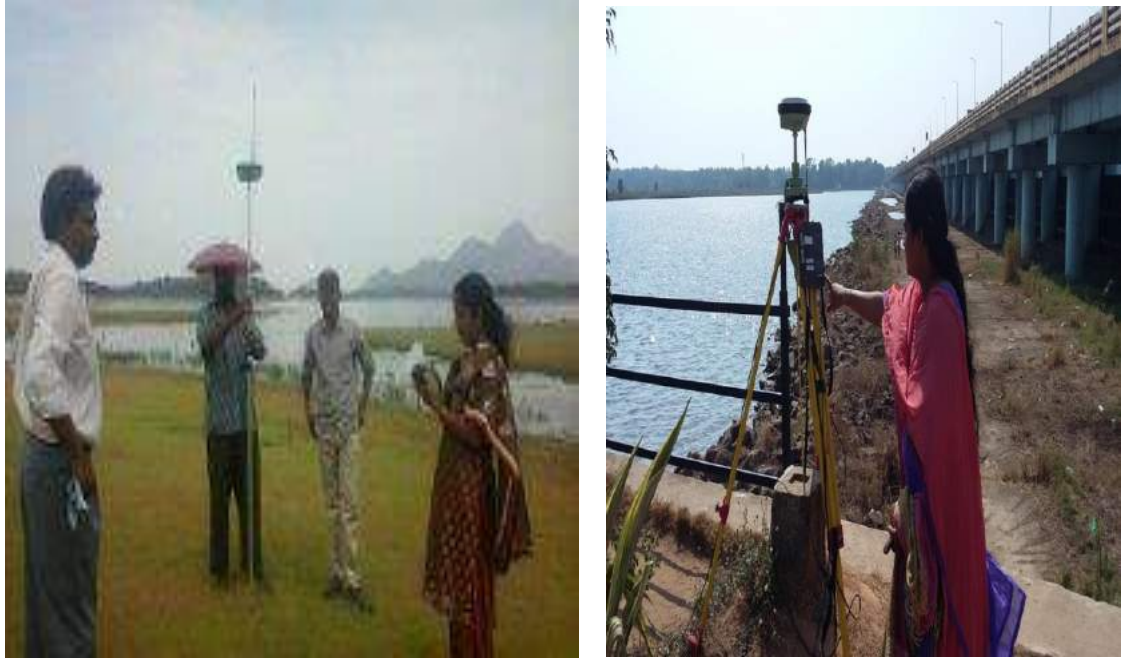
B.4.2.3 As per the request of the Assistant Executive Engineer, Chamravattom Project Subdivision No.1, Eswaramangalam the survey of downstream side of Chamravattom Regulator Cum Bridge has been conducted. The upstream side survey has been done by the Sedimentation division. In this work downstream side survey along 1km length of river has been done by taking cross sections at every 100m interval. Contour plan and cross sections has been plotted.

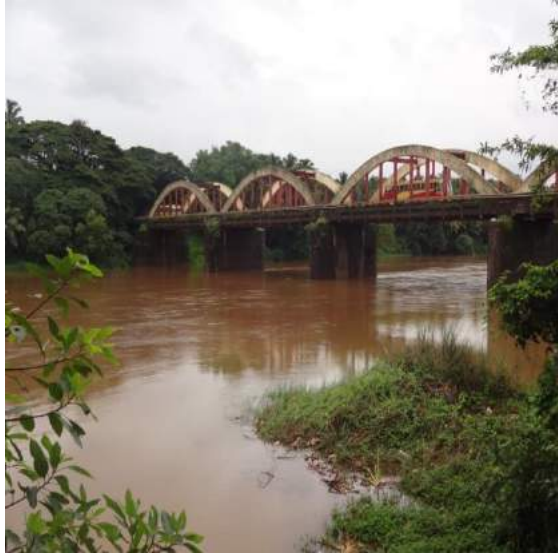
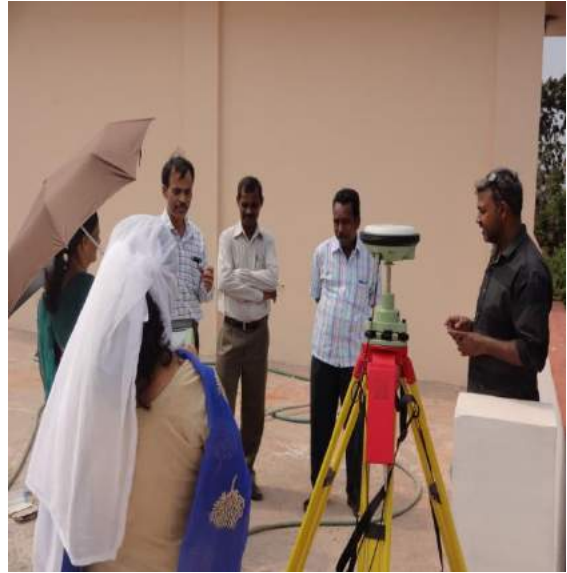
The proposal was for conducting survey of river and banks upto 50m at every 100m interval. Survey of 19km of the river starting from the coastal area has been done covering an area of nearly 469acre in land and 1131acre in river. The data has been collected and the contour drawings, plan, cross sections and longitudinal sections has been prepared.

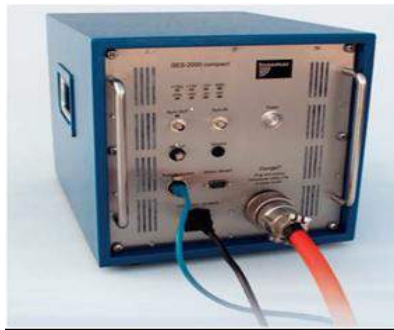
Fig.1 Top-side Unit

The system SES-2000 sub-bottom profiler, which is a mobile parametric sediment sounder, was used for bathymetric and sub-bottom profiling survey. The SES-2000 hardware component and transducers are shown in Fig 1.

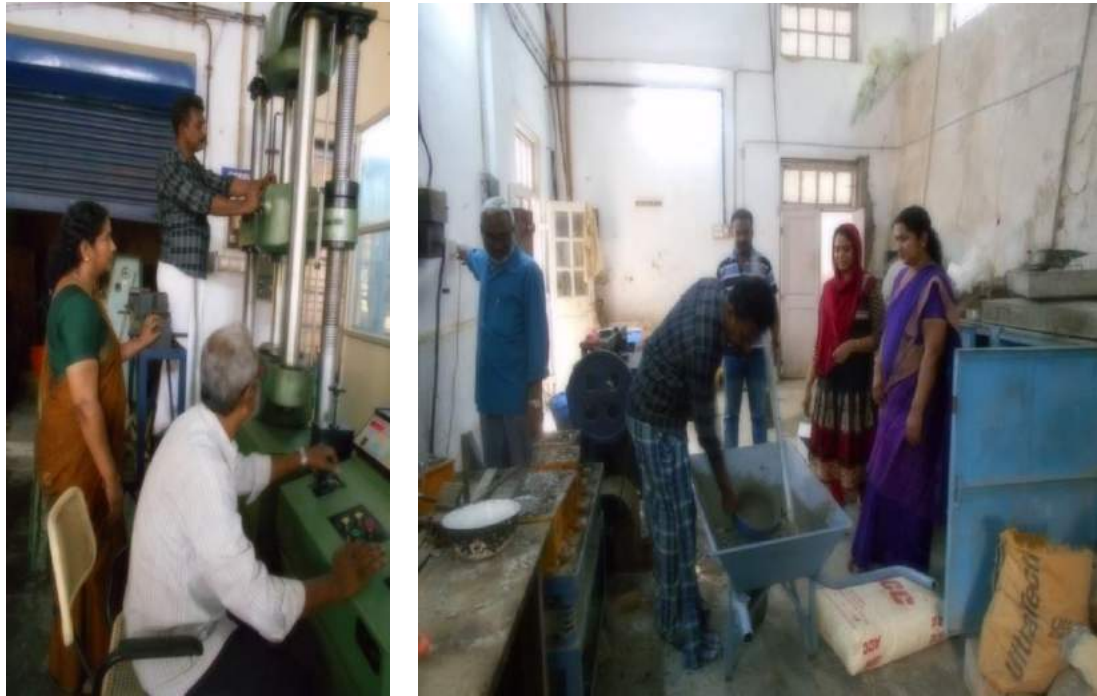
This lab is equipped with Rebound Hammer, Rebar Locator and Ultra Sonic Pulse Velocity Meter. These non destructive tests are being conducted to check the strength and deformation characteristics of the structure.

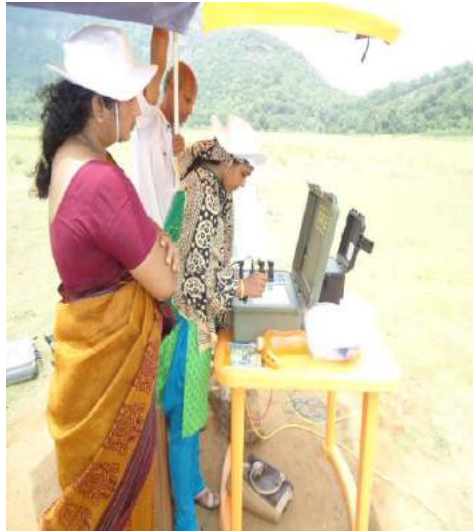
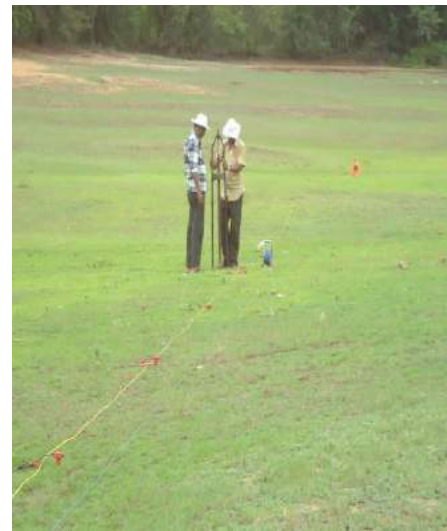
- 1) Conducting Geophysical studies with Engineering Seismograph - Malampuzha reservoir.

- 1) Conducting Geophysical studies with Engineering seismograph - Malampuzha reservoir

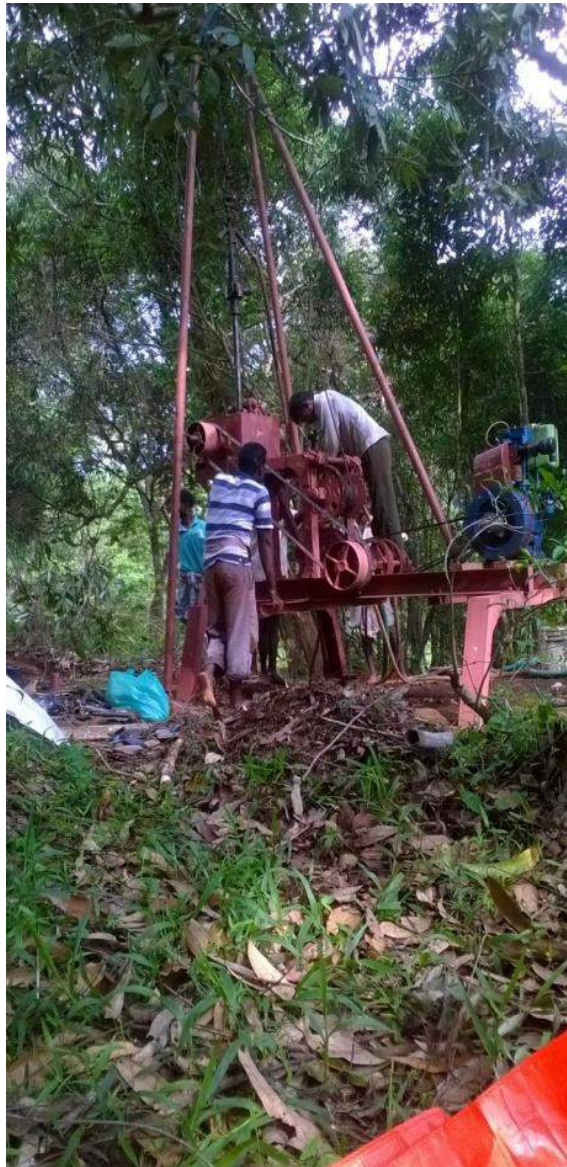
Setting of Boring plant at Mullaperiyar site

1. Purchased a Rotary Type calyx drilling rig with all accessories capable of drilling soil and rock.
2. Purchased one double stage screw pump with delivery pressure 10bar and discharge head 120MLC.

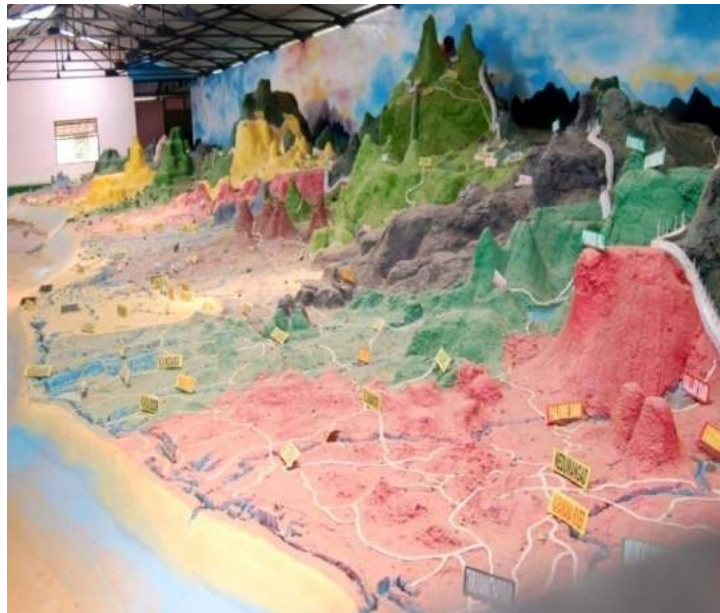
The Relief Model of Kerala

Constructed to a horizontal scale of 1/16,000 and vertical scale of 1/1,000, this model clearly shows rivers, roads, railways, location of Irrigation and power schemes, important places and district boundaries etc. in the state. In short, the model gives an idea of the topographical features of Kerala.

The Relief Model is marked with all the salient features of Kerala has always been the centre of attraction of visitors who come to Peechi.

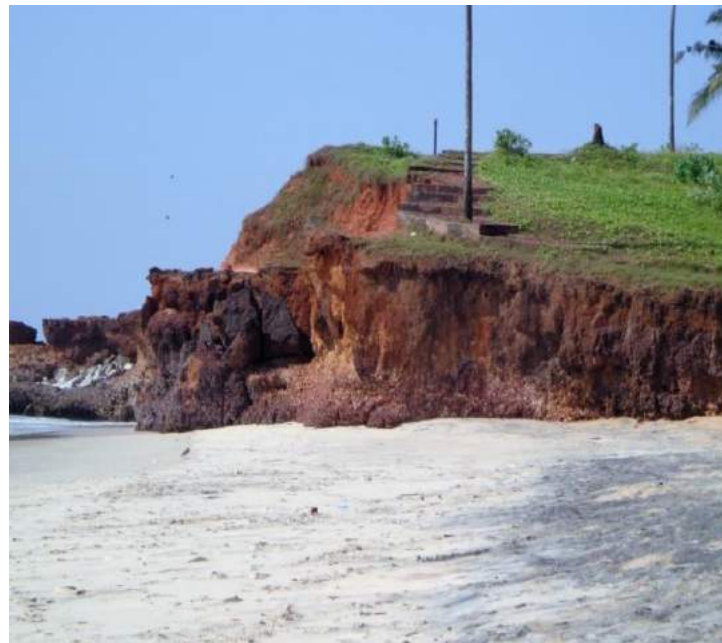
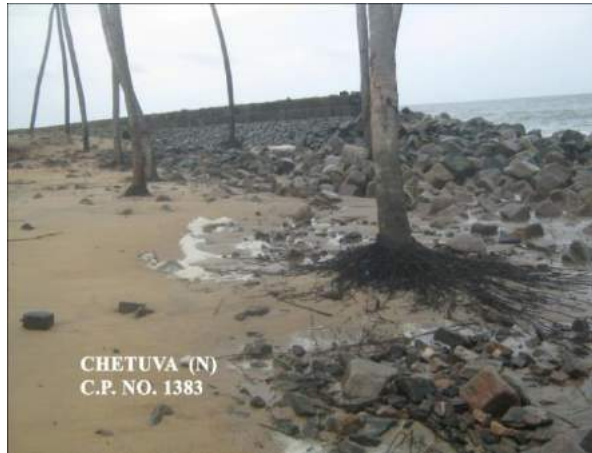
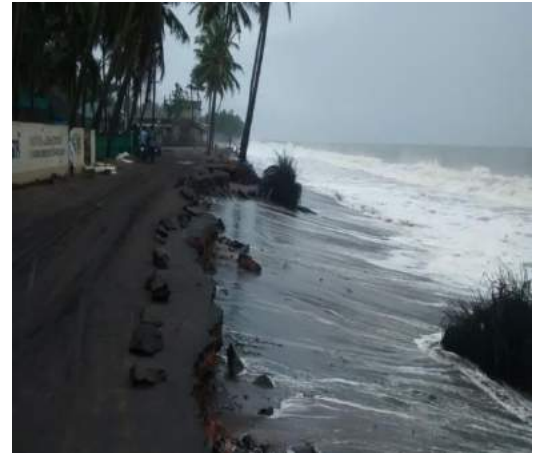
The details of damages at various places in the coastal beaches have been collected from time to time and photographs are taken to understand the details of erosion, coastal damages occurred during monsoon and drastic changes in the shore line. The details of damages caused during the year 2015 are listed in Appendix–VII.

During this year, no serious damages of sea wall were reported. The sea wall at C.P. No. 0000 to 0008 is in sunken position and some reformation work is going on. The dilapidated sea walls at C.P. No. 60 and 70 are reformed. The sea wall from C.P. No. 75 to 98 is almost in a dilapidated condition and this condition is becoming worse day by day. The sea wall from C.P. No. 212 to 218 is also in the same condition. The Varkala Cliff, a beautiful place, is slowly disappearing due to severe sea attacks. Hence, some urgent protection work is needed.
