KERALA ENGINEERING RESEARCH INSTITUTE

**Annual Report
2021-2022**

Kerala Engineering Research Institute, Peechi

Publication No. 84

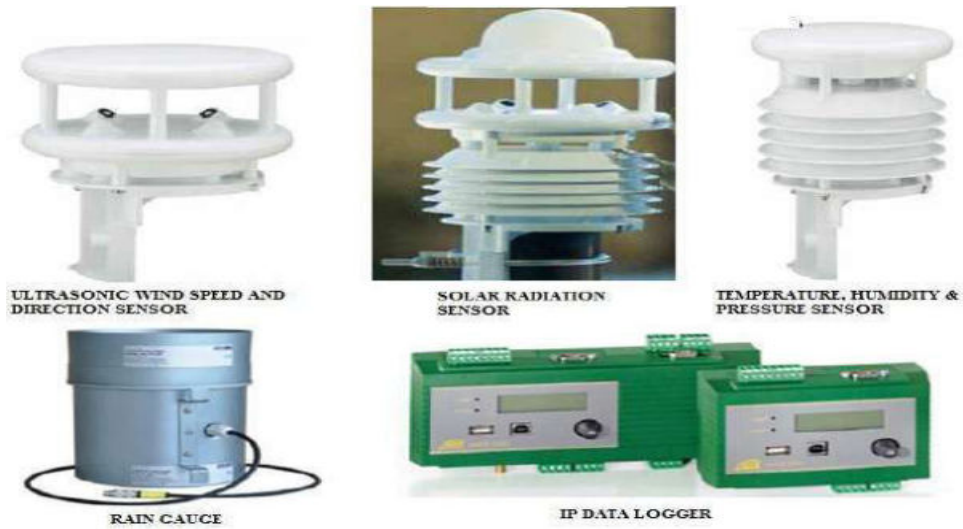
Automatic Weather Station - Instruments

1. Ultrasonic Wind speed and Direction sensor & Compass
2. Global Radiation Sensor
3. Temperature, Humidity, Barometric Pressure Sensors
4. Rain Gauge
5. Data Logger

The Automatic Weather station collects data related to air temperature, air humidity, barometric pressure, ultrasonic wind speed, ultrasonic wind direction, global radiation and precipitation using different sensors. These data can be accessed using a software HYDRAS. The data collected can be used to gauge current weather conditions and to make weather forecasts like temperature high/low, cloud cover and the probability of precipitation.

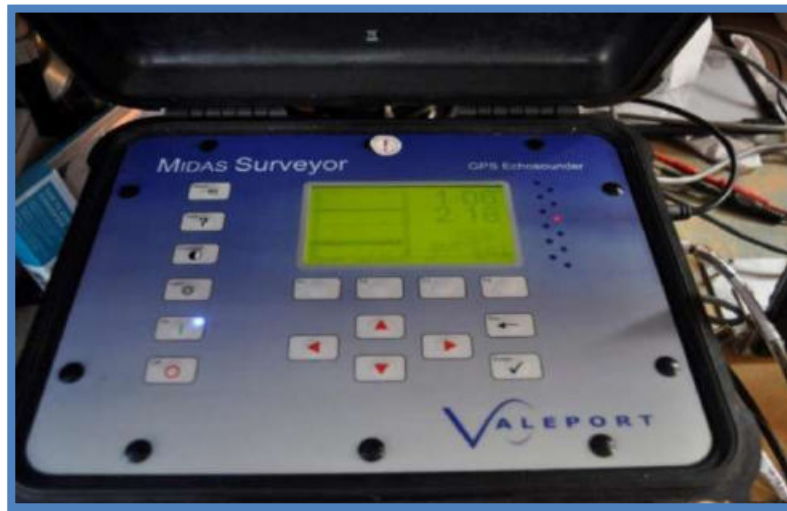
Fig 5 MIDAS Surveyor Echo Sounder

The MIDAS Surveyor is a revolution of small boat survey work with an integral GPS receiver (Fig 5). It logs and displays DGPS position data in WGS 84 or Local Grid. This Echo-sounder is designed to measure under water depth up to 1200m. Accuracy of instrument is 1centimeter. The dual frequency echo-sounder is specified to distinguish between fluff top depth and the consolidated bottom. The high frequency (200 KHz) is used to detect the top of the mud/sediment. Under favorable conditions the low frequency signal (33 KHz) can penetrate into the bottom and reveal information about the bottom structure.

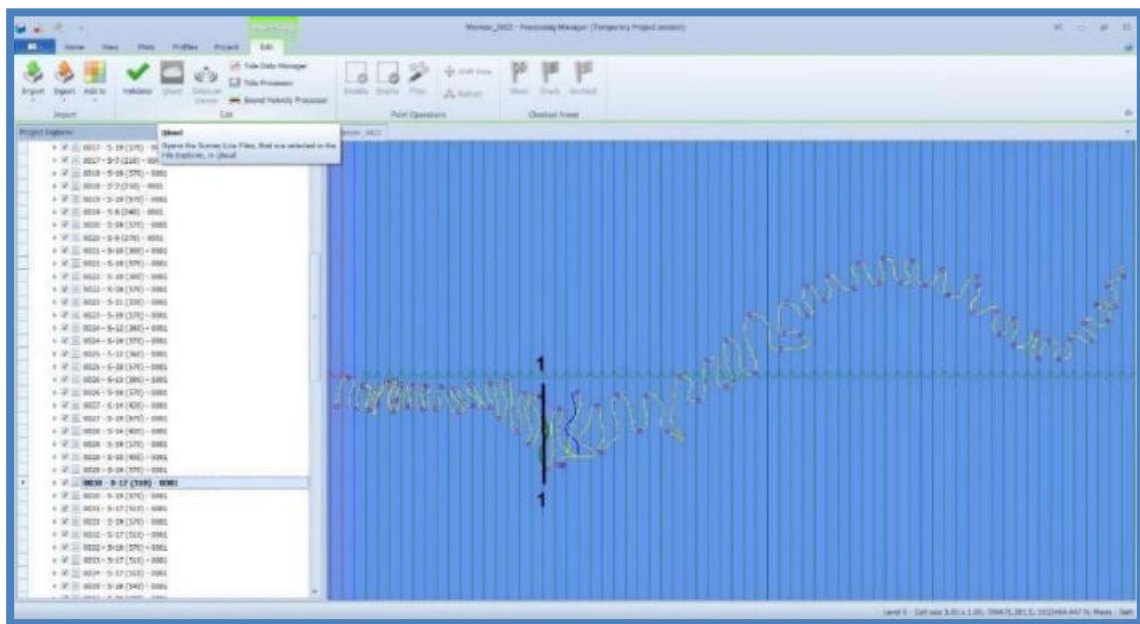
Fig 40 Plan of Maniyar reservoir showing the sections surveyed

validation has been completed. The present storage capacity, water spread area and the stage capacity curve has been found out. Report is under preparation.

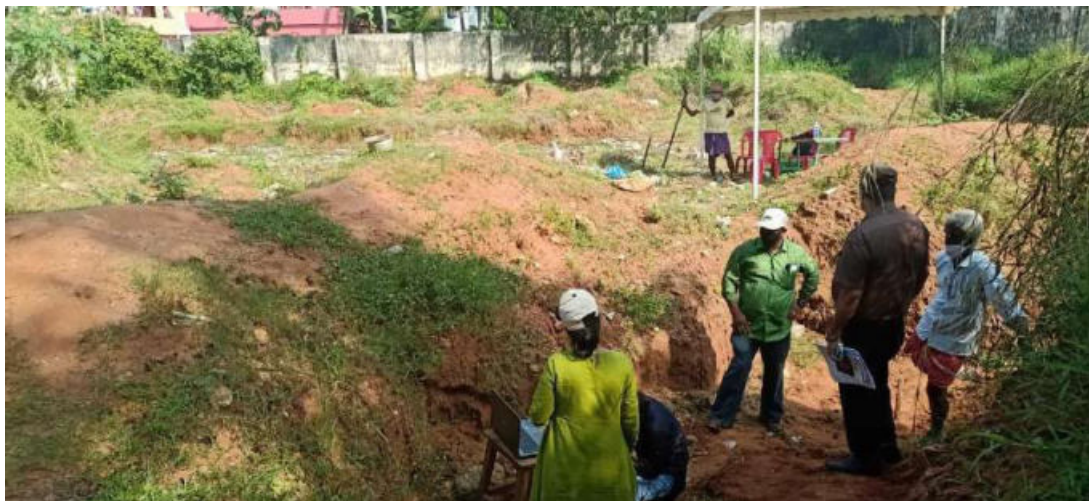
a. The Superintending Engineer, Thiruvananthapuram Corporation has requested to conduct Pile Echo Test (PET) on the pile group pertaining to the work ***Residential Training Centre at Attukal, Thiruvananthapuram Corporation***. There are 124nos piles were trimmed cleaned and the site was equipped for testing. Accordingly, the test was performed on 17.12.2021 and 18.12.2021. 124 no. of piles as per drawing given by the Superintending Engineer, Thiruvananthapuram Corporation vide Lt. E13/UPA/214/03 dated 07.10.2021 were tested.

These identification numbers are as per the above drawing available at site. The grade of concrete was reported as 1:2:4 as per Lt. E13/UPA/214/03 dated 11.03.2019. The casting of piles was carried out during the period 28.04.2007 to 12.01.2008. A velocity of 3300 m/s was chosen from the software.

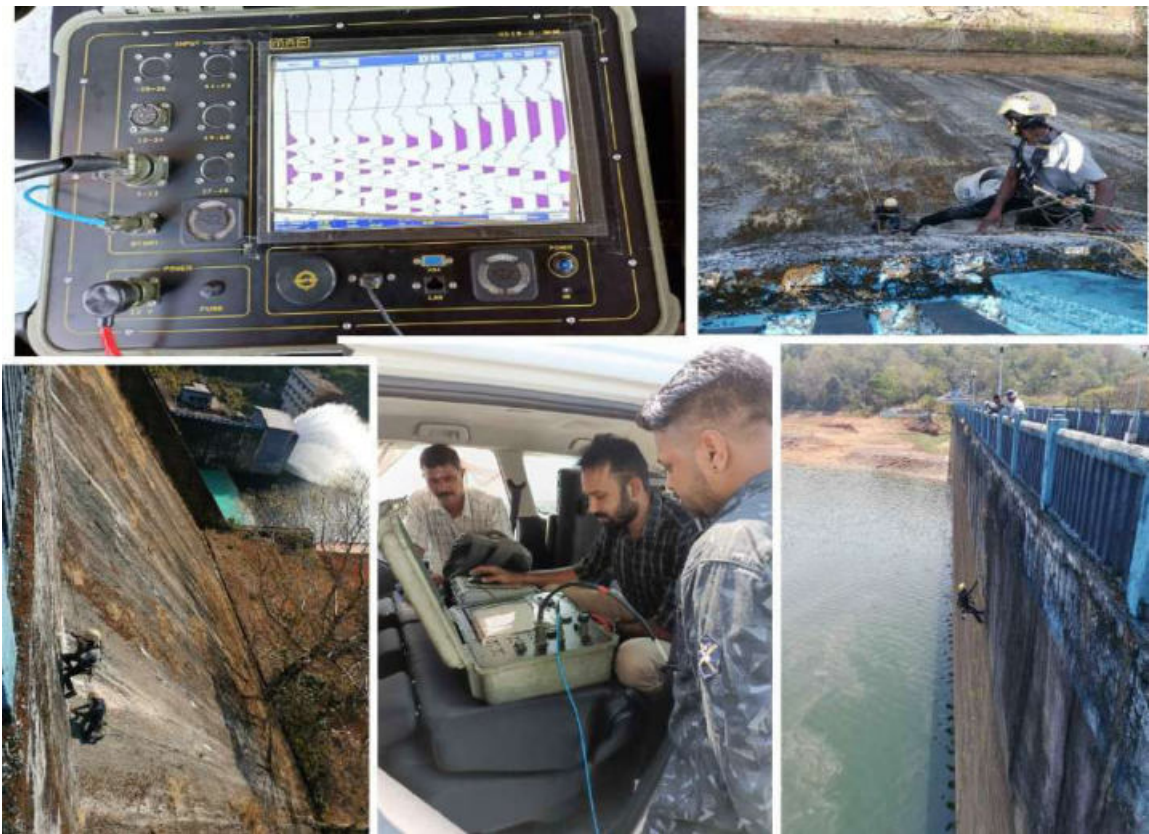
Fig 19. Seismic Tomography study at Chimoni Dam

Seismic tomography survey was conducted at Chimoni Dam on a study basis during March 2022.

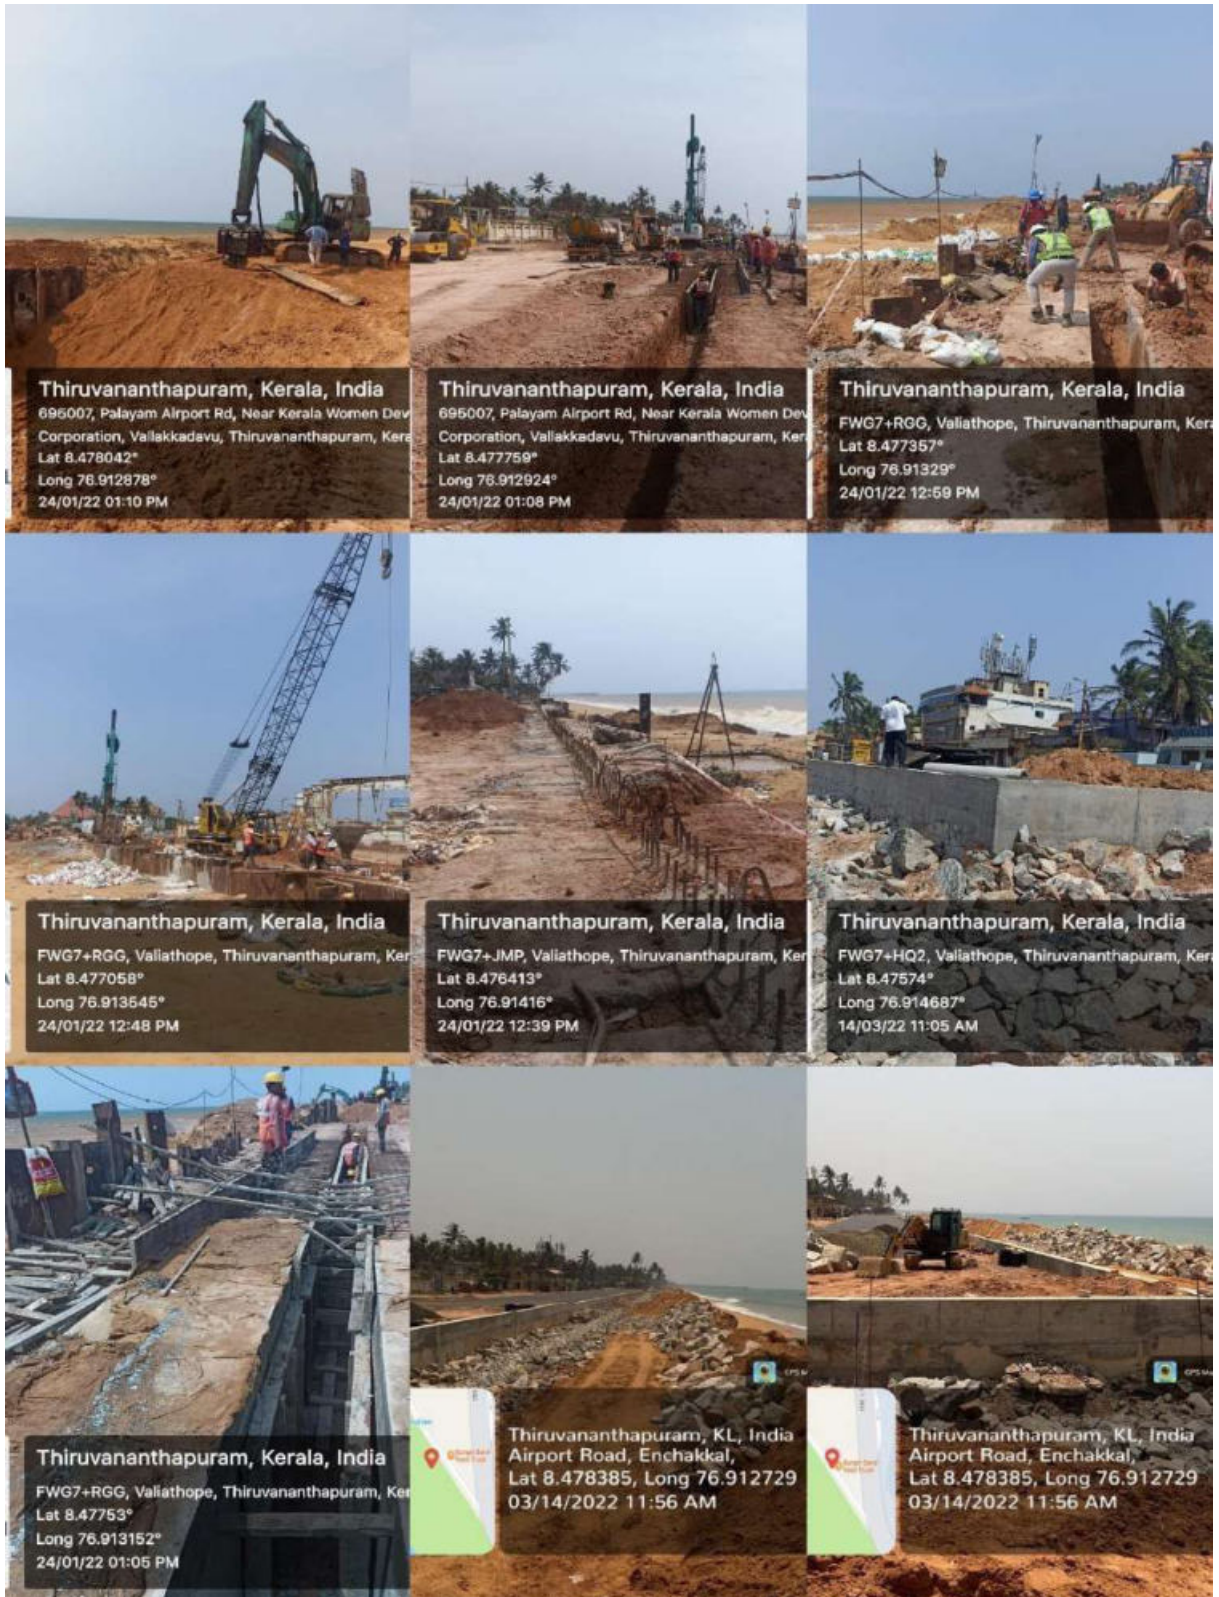
Construction of diaphragm wall going on photos at Sangumukham

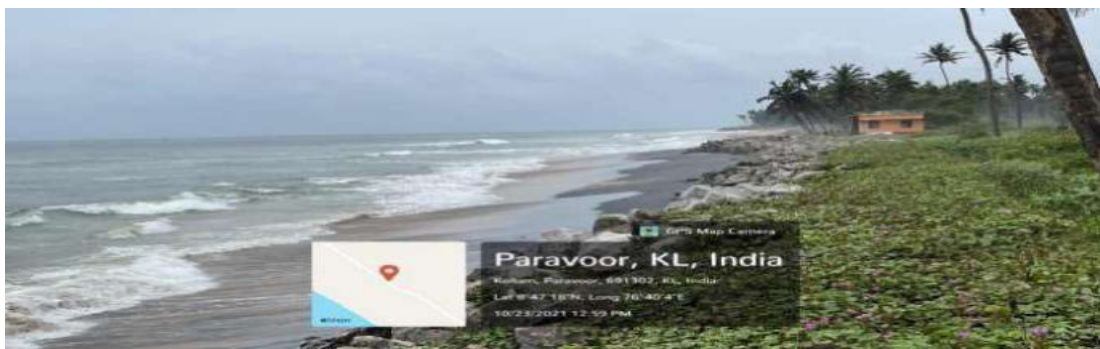
CP 289 (Paravoor)

Damaged and collapsed seawall at Paravoor
