KERALA ENGINEERING RESEARCH INSTITUTE

ANNUAL REPORT 2023-24

Publication No. 86

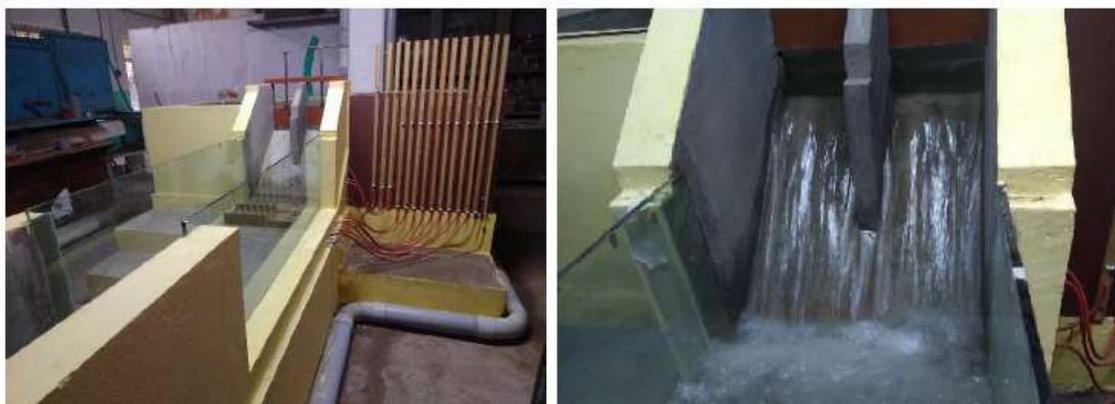
Model details

The flow simulation through the Ogee spillway was carried out for different discharges between the minimum to the maximum corresponding to the maximum water level in the prototype, with the corresponding tail water levels. Several trials were done and flow characteristics were observed.

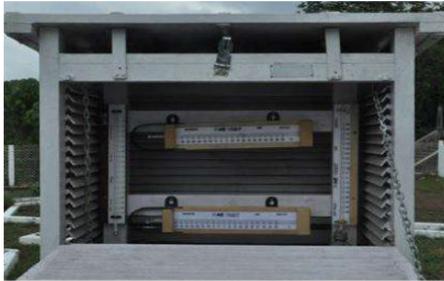
PSYCHROMETER

- Temperature – Max & Min Thermometers & Bimetallic Thermograph
- Relative Humidity – Psychrometer (Dry & Wet bulb) & Hair Hygrometer
- Rainfall – Standard Rain Gauge, Self Recording Rain gauge

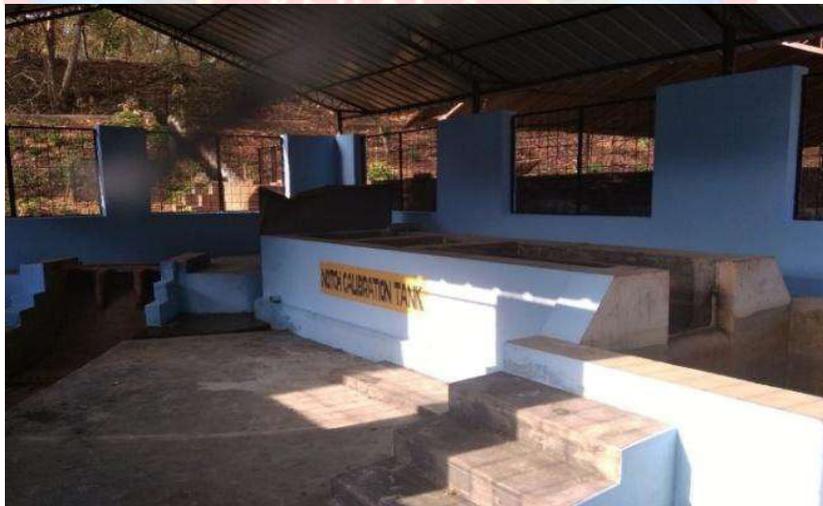
Notch Calibration Facility

Notches are used for measurement of discharge through open channels by placing or constructing them across the stream or channel. The discharge over notch is measured by measuring the head acting over the notch. The actual discharge and theoretical discharge will be equated using a suitable coefficient of discharge and a factor for the head of flow. The process of assessing these constants is called calibration. Once the equation relating discharge and head of flow over the notch is established by calibration experiment, the discharge at any point in a channel can be estimated by fixing the notch across the channel and measuring the head of flow.

The notch calibration tank situated at outdoor Model Area I is generally used for the calibration of notches received from various irrigation projects of Kerala. Notch calibrations have done for model study in this year.

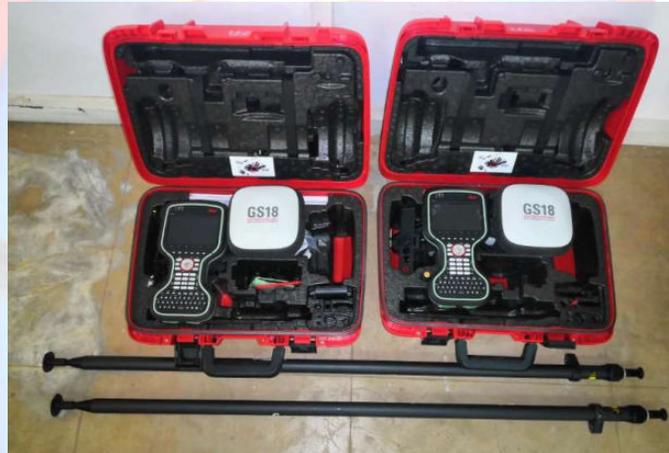
GS-18 T Base/Rover

Leica GS 18T is GNSS RTK rover and is a part of the Leica Geosystems self-learning GNSS series with advanced signal tracking technologies. With more constellation and L band, GS18T will have more satellites in canopy area. GS18T is fitted with Inertial Measurement Unit (IMU) based tilt sensor, so that no magnetic field can affect the positioning. This can work close to bigger concrete structures with larger reinforcement, Electrical installations etc. Due to the tilt compensating function, it is not required to hold the survey pole in vertical position, that is there is no need to level the bubble for measuring and staking of points. In this the sensor accurately and reliably measures the pole tilt and together with RTK or Smart Link, provides an accurate tilt compensated position. There is savings up to 20 per cent over conventional surveying practices due to the fact that no time is wasted by levelling the bubble. The IMU-based tilt-compensating RTK is applicable at large tilt angles of more than 30 degrees, where a 3D positioning accuracy of 2 cm is still achievable.

Leica GS 18T is integrated with a new Cinterion cellular modem that supports LTE (4G) as well as all existing networks. In Leica GS 18T, a self-learning GNSS sensor is being used, hence the best satellite signals and the best available correction data is chosen automatically. This in turn leads to the achievement of best possible position accuracy and quality. By incorporating sensor heading into 3D visualization of the surroundings, the user can easily orientate himself in the surveying environment, which improves productivity and user experience. The measurement engine in GS 18T is ME7 (measurement engine generation 7). This gives an ultimate performance in GNSS positioning.

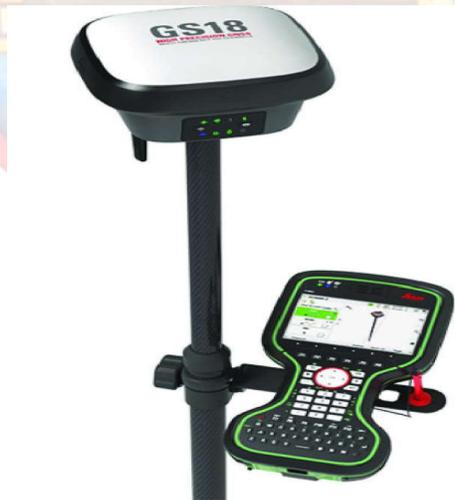
Leica GS18 T GNSS RTK rover with CS20 Field controller.

It includes latest features such as 555 channels, Multi-frequency, Multi constellation, L-band service etc. This allows tracking more satellites compared to GS14 in parallel channels. This sensor is supplied with most modern controller of Leica CS20 with specialized package software called Captivate. Captivate is the most field worthy software with more land survey features compared to CS10 controller.

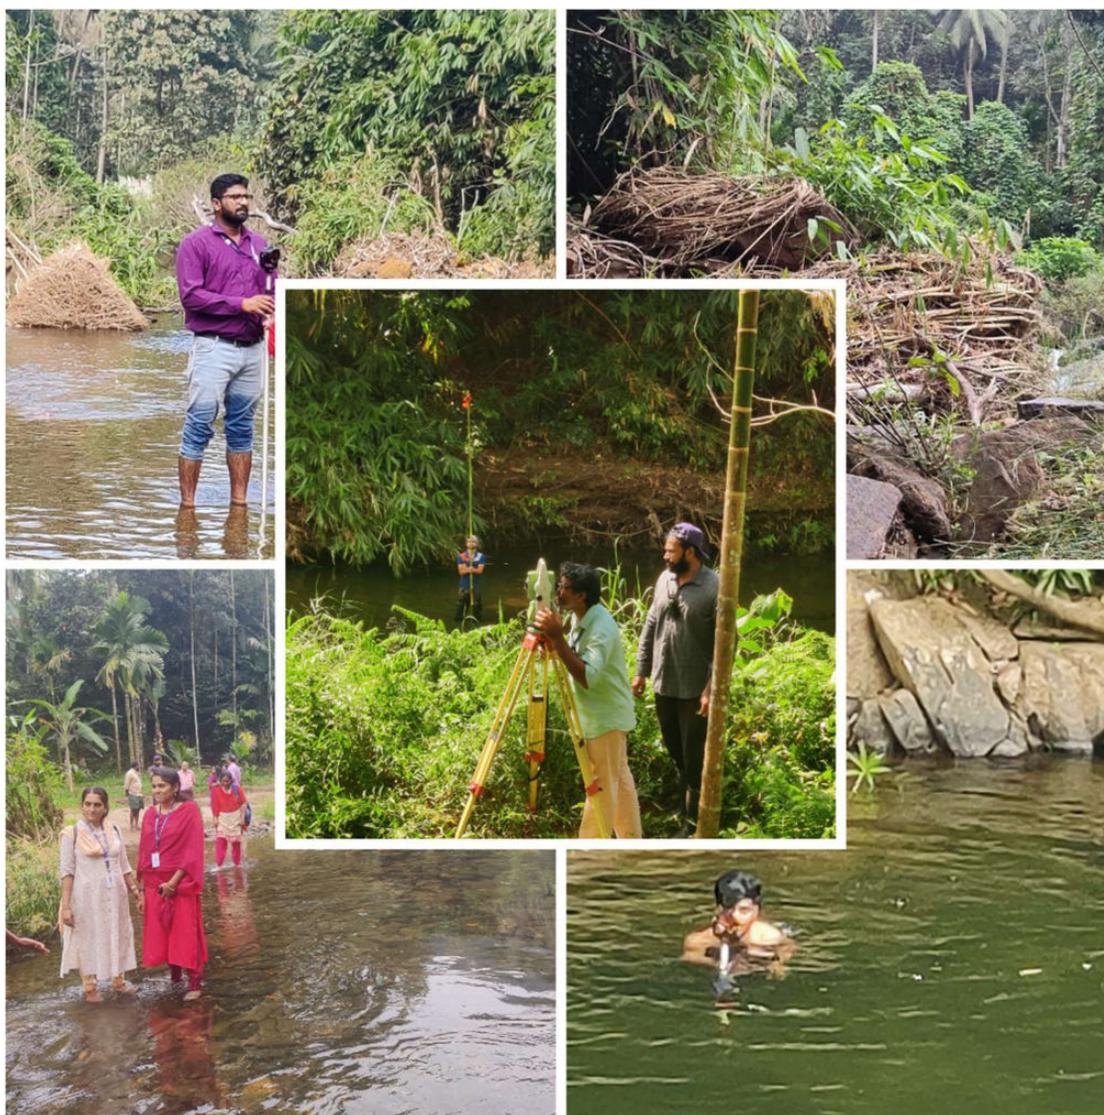
- The longitudinal section was plotted by connecting the points having minimum elevation in each cross section.
- Roads and other permanent structures are plotted in the layout plan.

- The lowest river bed level at the proposed location of the structure is +143.189m

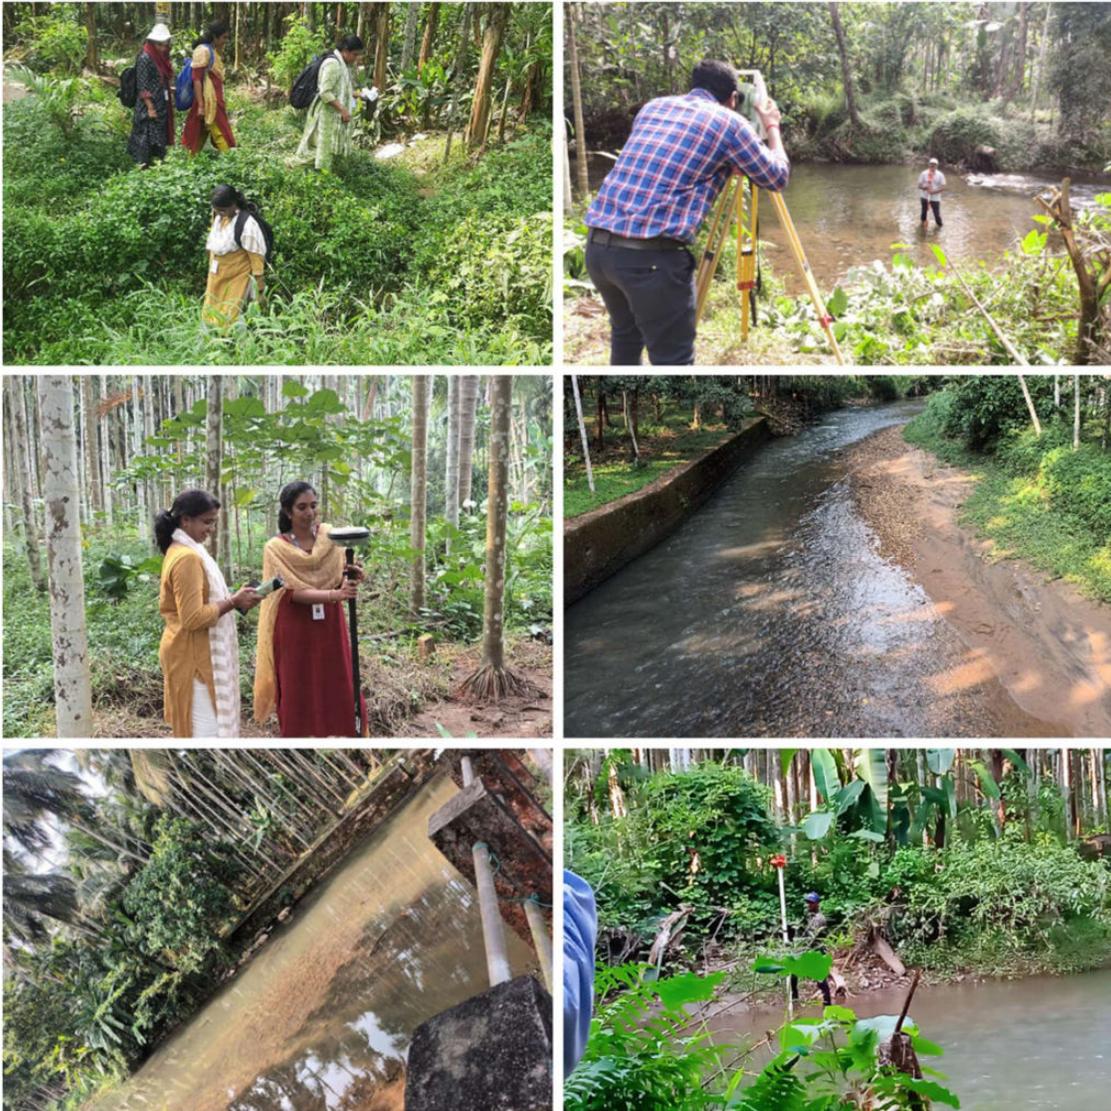
- The longitudinal section was plotted by connecting the points having minimum elevation in each cross-section.
- Roads and other permanent structures are plotted in the layout plan.

- The lowest river bed level at the proposed check dam location is +50.4104m.

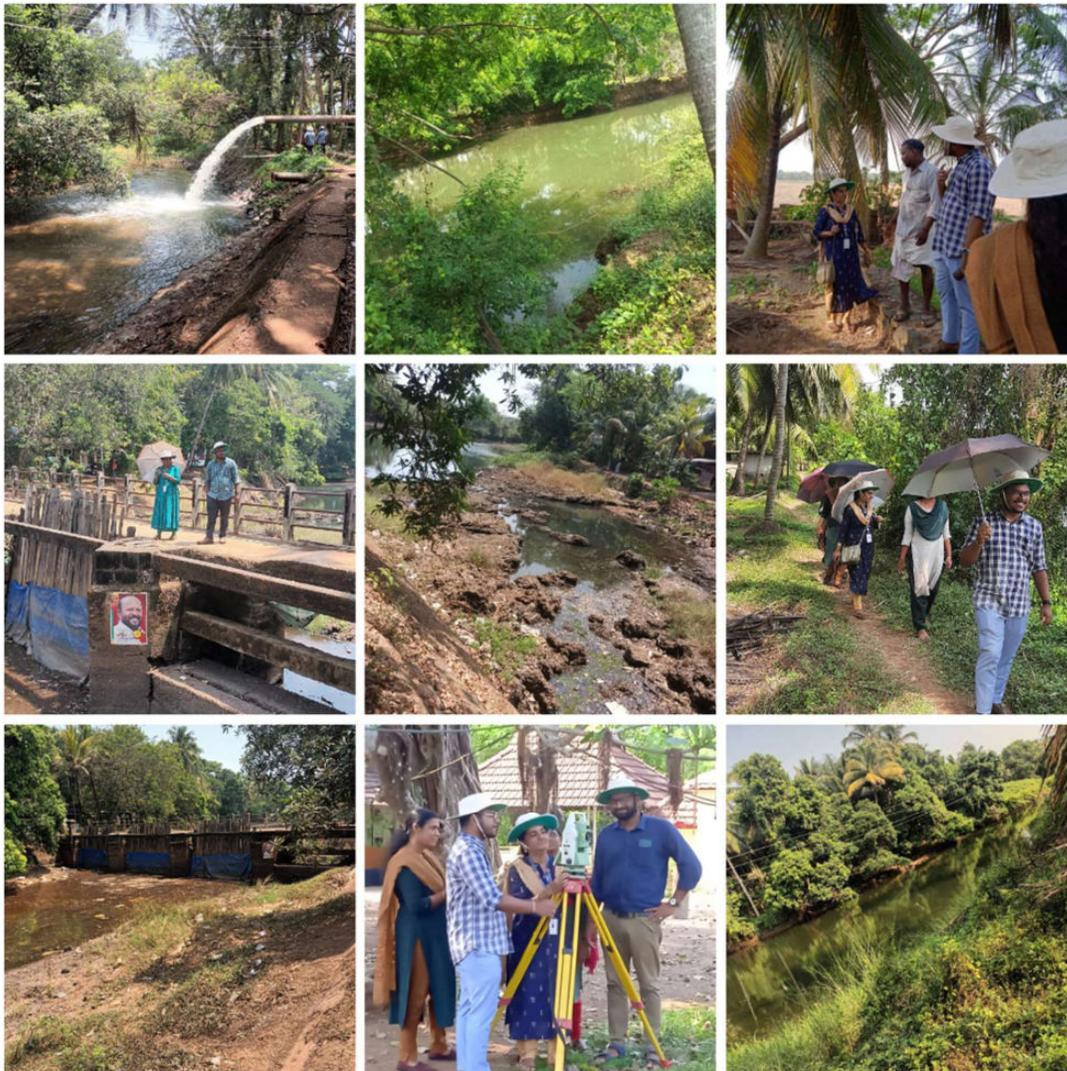
- Survey was conducted in the Aloor river and its both banks by taking cross sections at particular intervals (at 15m interval for a length of 60m u/s and d/s of the proposed location for the reconstruction of the structure, 50m interval for the next 500m u/s, 100m interval for the remaining u/s and d/s length)
- River bank was also surveyed for ascertaining enough bank height for water storage.....
- Layout Plan, Cross sections, longitudinal sections and contour map at 1m contour interval were prepared as per the design requirements
- The longitudinal section was plotted by connecting the points having minimum elevation in each cross section
- Roads, buildings and permanent structures are plotted in the layout plan
- The lowest river bed level at the proposed location for the reconstruction of the structure is +0.644m

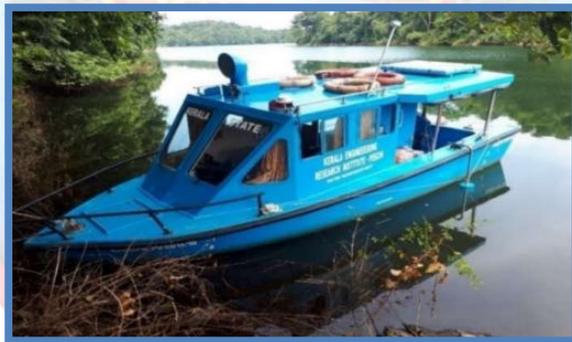
FRP Boat

Fiber reinforced Plastic (FRP) boat having two 60 HP petrol out board engines, dimension of 7.5m X 2.66m X 1.20m and 8persons capacity with the equipment is used for the survey. For the power supply, two solar panels of 80 watt each are mounted on the roof of the boat.

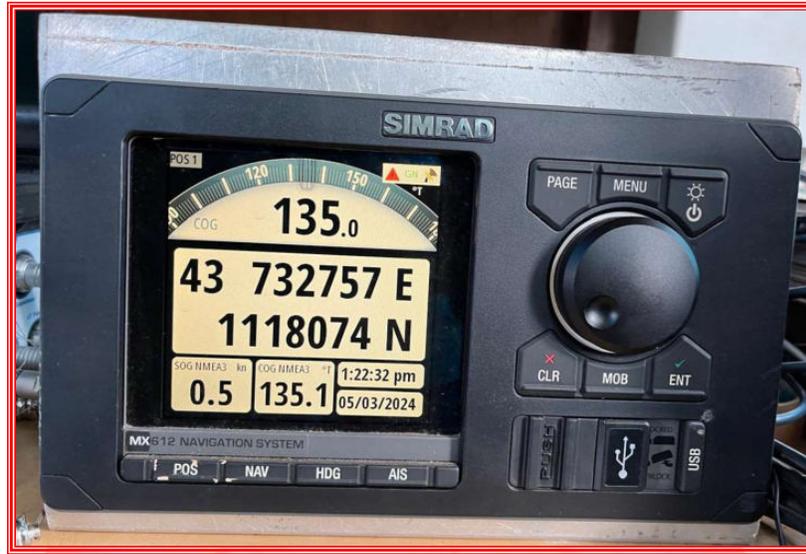
MX610 Navigation System

DGPS SIMRAD MX- 610 is highly reliable and it receives correction from a permanent reference station, which is approved by Govt. of India, Dept. of Light house and Light ship. It can also track up to 12 satellites to achieve maximum positional accuracy. The received position is transferred to Echo Sounder and Sub Bottom Profiler data collection laptop.

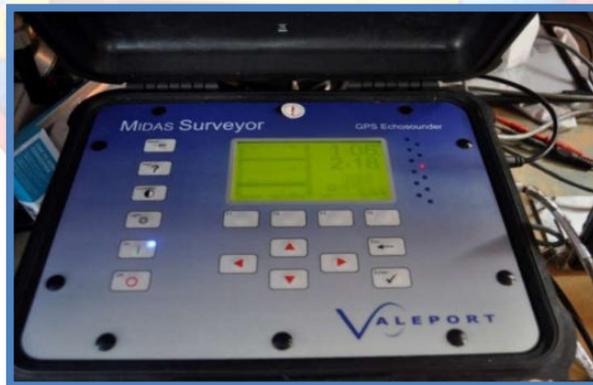
MIDAS Surveyor Echo Sounder

The MIDAS Surveyor is a revolution of small boat survey work with an integral GPS receiver. It logs and displays DGPS position data in WGS 84 or Local Grid. This Echo-sounder is designed to measure under water depth up to 1200m. Accuracy of instrument is 1centimeter. The dual frequency echo-sounder is specified to distinguish between fluff top depth and the consolidated bottom. The high frequency (200 KHz) is used to detect the top of the mud/sediment. Under favorable conditions the low frequency signal (33 KHz) can penetrate into the bottom and reveal information about the bottom structure.

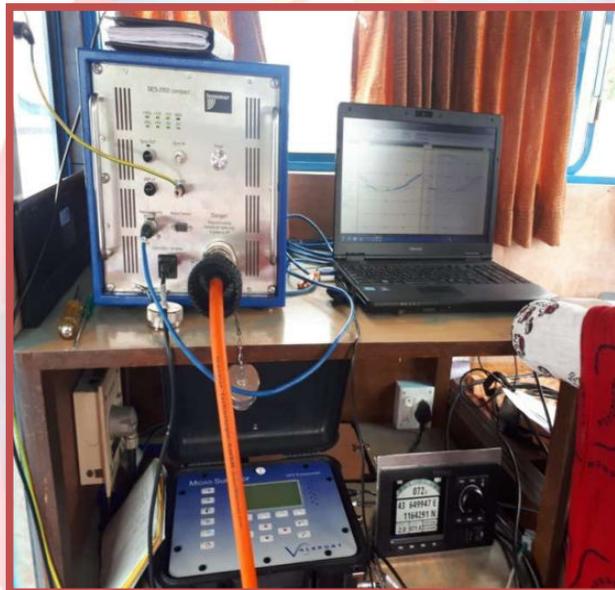
Equipment Set up inside the Boat

Mobile station set up for data collection is shown below.

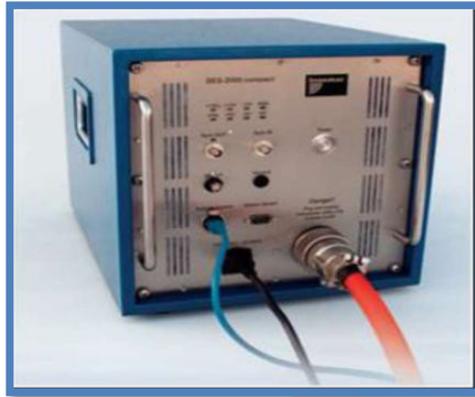
Top- side Unit

The system SES-2000 sub-bottom profiler, which is a mobile parametric sediment sounder, was used for bathymetric and sub-bottom profiling survey. The SES- 2000 hardware component and transducers are shown in Figures below. High frequency signal (HF -100 kHz) and the secondary low frequency signal (LF -6 to 12kHz) are used. The spatial distribution of sediment in each cross section can be analyzed

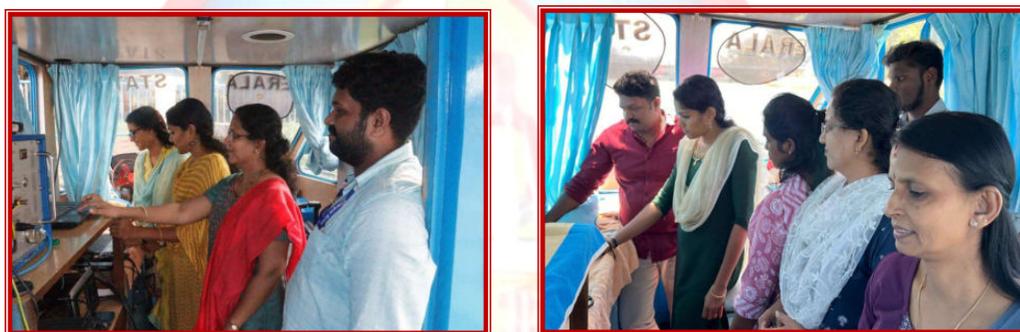
Data Collection inside the Boat

The mobile station consists of the DGPS and its antenna, Echo sounder, Sub Bottom Profiler and the transducers etc which are mounted on the FRP boat. The transducer of Sub Bottom Profiler is permanently fixed at the center of the boat. The transducer of Echo sounder is connected to the left side of the boat and is detachable. Proper connections are made between these equipment and the laptops for the data collection. By using the **Planning and**

presentation menu in **Qinsky software**, chart is prepared by taking UTM co-ordinate at two known points. With these co-ordinates of two points reference lines are drawn. Segment lines are drawn parallel to this reference line at a particular interval such that the entire reservoir area can be covered. The boat is sailed along the planned track with a speed of 3 to 4 knots. The data from the Echo sounder and Sub Bottom Profiler is collected simultaneously through two laptops. For IBS Survey, the laptop loaded with QINSY survey software is used. For Sub Bottom Profiler, the data is collected using laptop installed with SESWIN software. There are three modules in the QINSY Software: Data Acquisition, Data export/import.

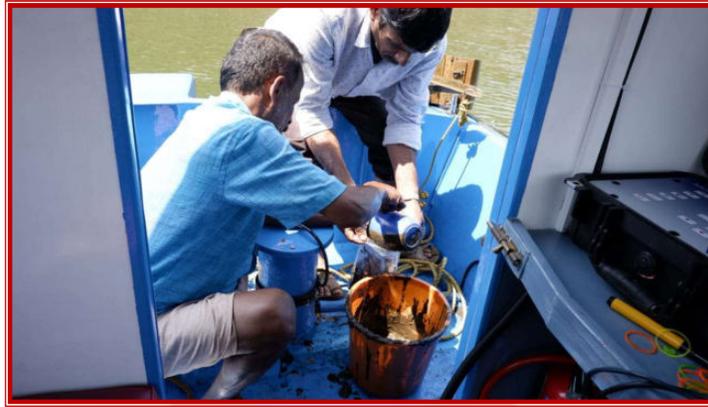
Soil sample collection

Disturbed soil samples were collected using grab type mud sampler (only surface soil) from 4 locations in the reservoir. The sample collection method and sample locations are shown in below Plate and Figure. Undisturbed samples cannot be collected using this type of sampler. These soil samples were analyzed in the lab of Soil Mechanics and Foundation Division, KERI, Peechi.

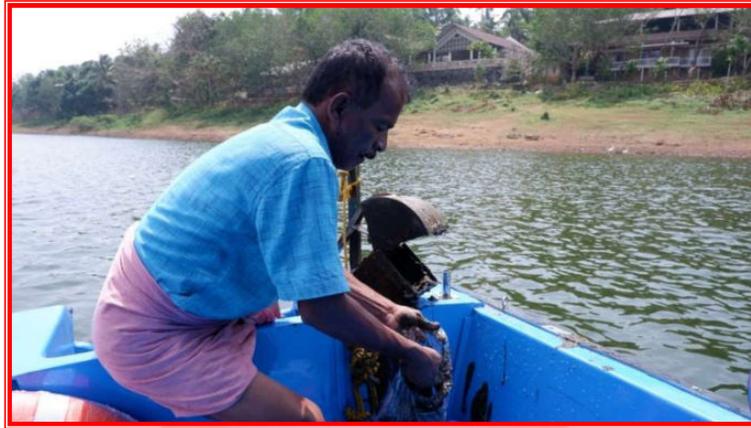
Disturbed soil samples were collected using grab type mud sampler (only surface soil) from 4 locations in the reservoir. The sample collection method and sample locations are shown in Plate and Fig respectively. Undisturbed samples cannot be collected using this type of sampler. These soil samples were analyzed in Soil Mechanics and Foundation Division, KERI, Peechi.

Soil sample collection

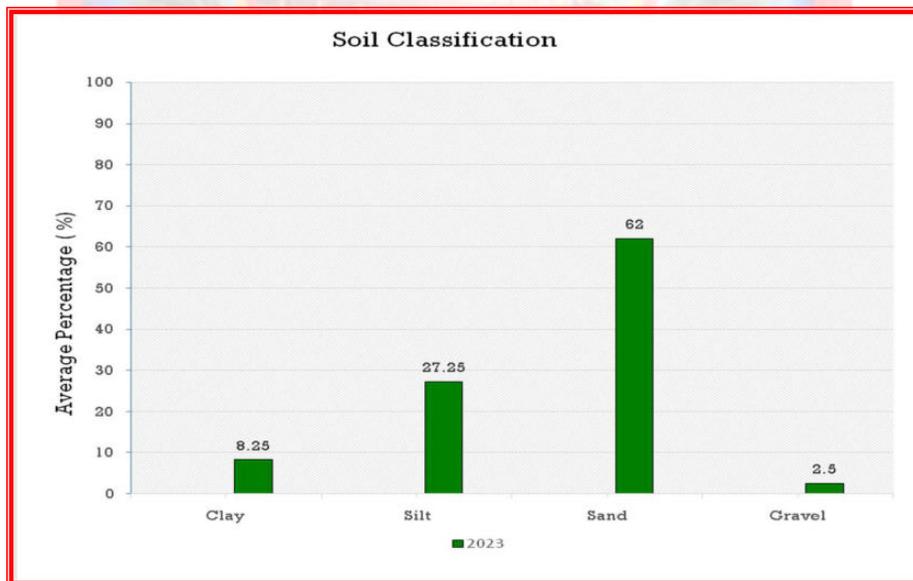
Soil particle distribution

Clay	Silt	Sand	Gravel
1	N- 1173731.662 E- 635834.418	4.45	Disturbed	Silty sand	Mixture of Slate Grey and Light Brown	9	33	56	2
2	N- 1173948.511 E- 635610.268	6.40	Disturbed	Silty sand	Mixture of Slate Grey and Light Brown	9	29	62	0
3	N- 1174096.503 E- 635556.342	7.92	Disturbed	Silty sand	Mixture of Ash Grey and Light Brown	8	26	63	3
4	N-1174169.324 E-635448.993	8.26	Disturbed	Silty sand	Mixture of Ash Grey and Light Brown	7	21	67	5

The percentages of soil particles are only indicative and not accurate. For accurate assessment of contents in the soil, core sample analysis must be done.

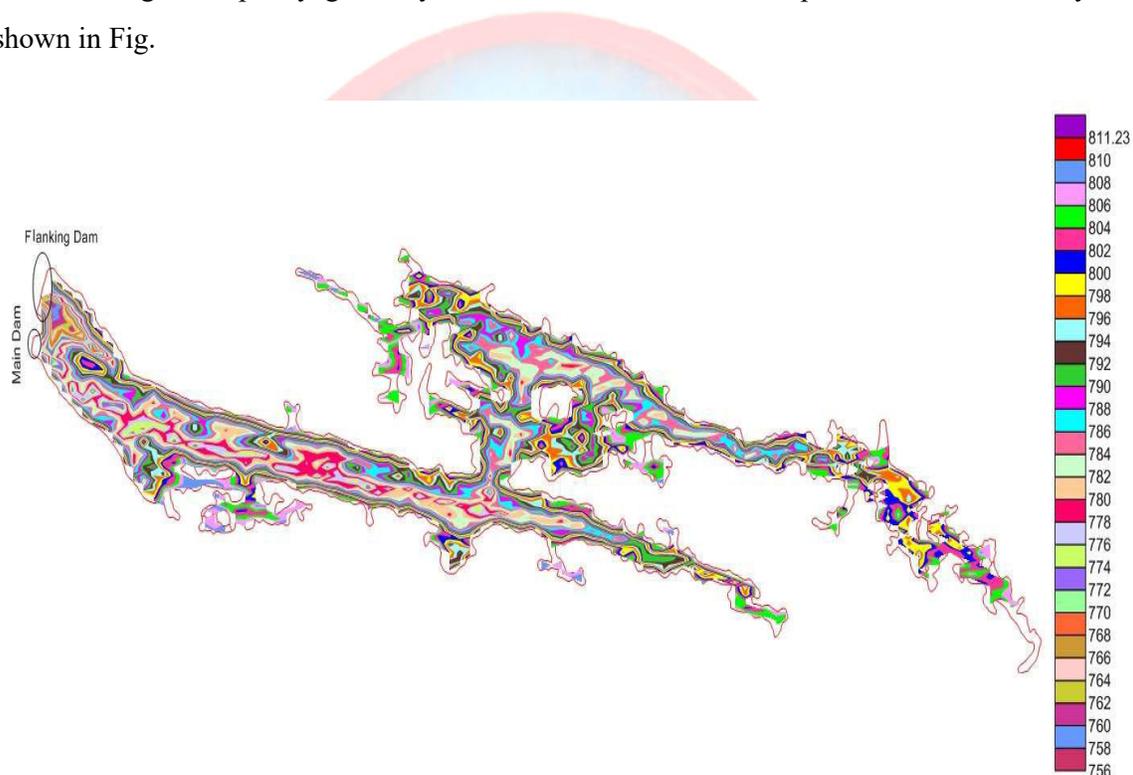
Reservoir volume at different water levels is found out by using Surfer software from the IBS data collected through QINSY software. The present capacity at different level is compared with the original capacity given by KSEB officials. Contour map based on IBS survey is shown in Fig.

Contour Map based on IBS Survey
Reservoir capacity at different water levels

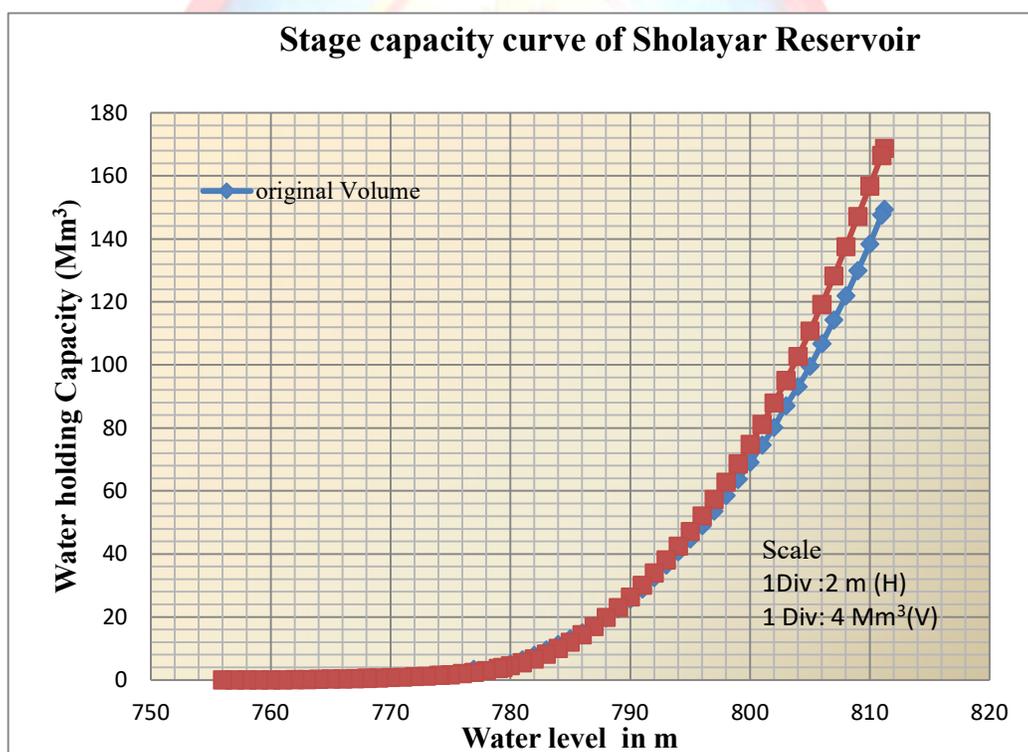
The original storage capacity curve is compared with the same obtained from the IBS survey 2022 as shown in Fig. From the results it was observed that capacity obtained from the present study is more than the original capacity for the top levels (above water level +787.00). For the water level below +787.00 m the capacity of the reservoir obtained from present survey is less than the original capacity.

Stage - Capacity curve

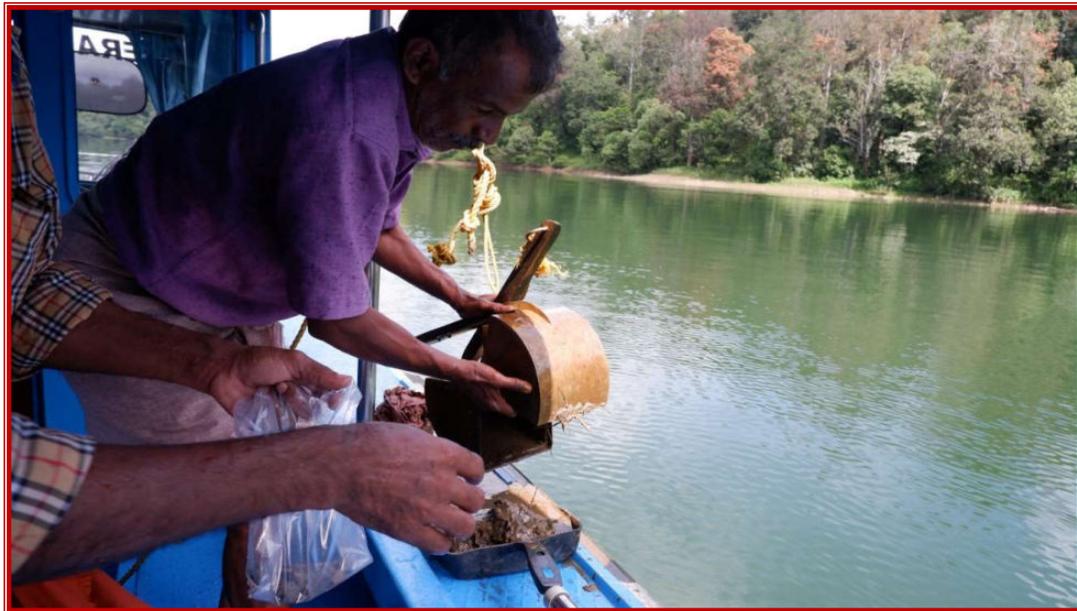
Disturbed soil samples were collected using grab type mud sampler (only surface soil) from 10 locations in the reservoir. The sample collection method and sample locations are shown in below Plate and Figure. Undisturbed samples cannot be collected using this type of sampler. These soil samples were analyzed in Soil Mechanics and Foundation Division, KERI, Peechi.

Soil sample collection

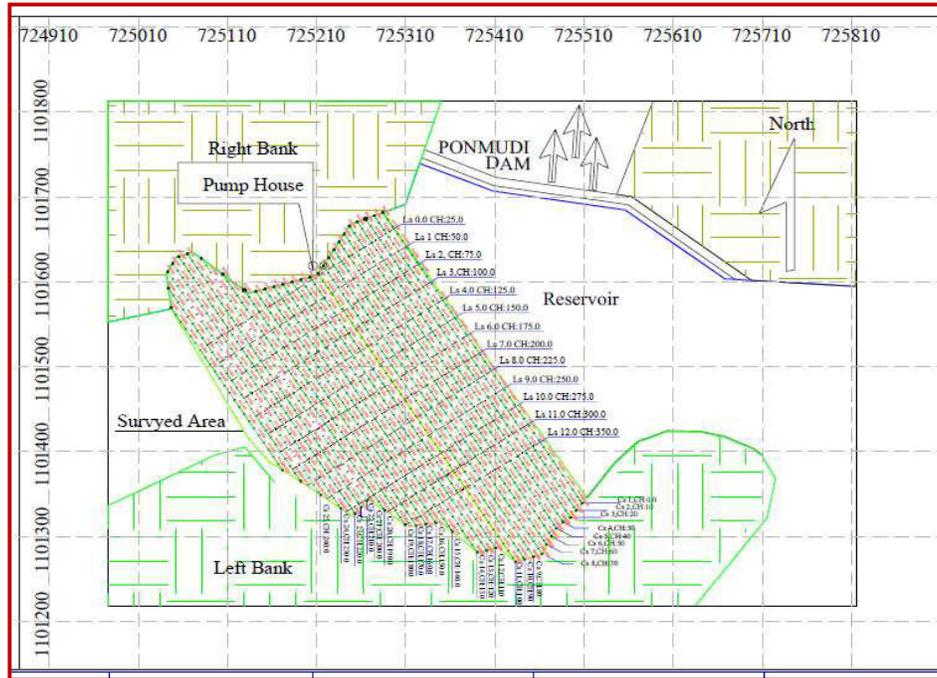
The cross sections of the surveyed area along the width of the river are drawn at 10m interval and the profiles along the direction of flow are drawn at 25m interval. The cross sections, longitudinal sections, contour drawing and the plan showing the cross sections are attached as Annexure. Figure below shows the surveyed area with plotted sections.

Surveyed area with plotted sections

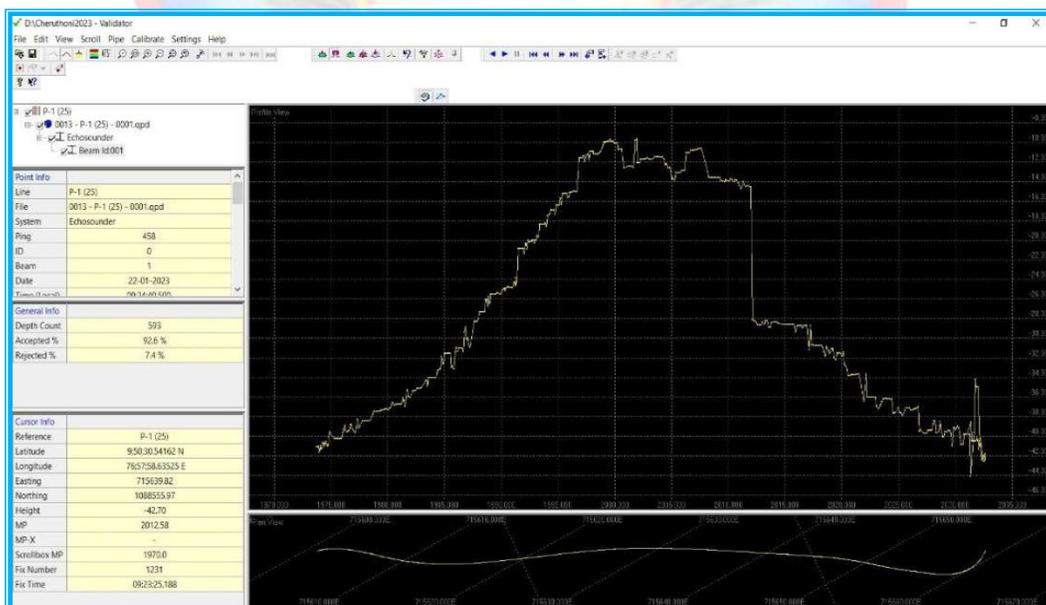
Profile 1-1 in IBS {(E715588.96, N1088452.97),(E715648.46, N1088534.53)}

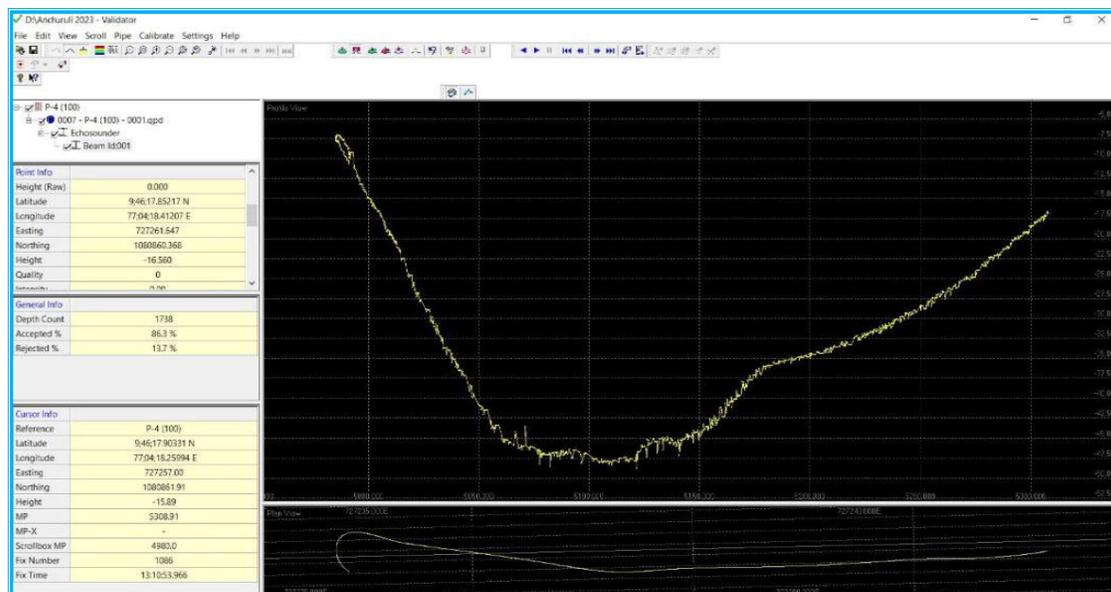
Profile 1-1 in IBS {E727264.06, N1080543.98},(E727261.64, N1080860.36)}

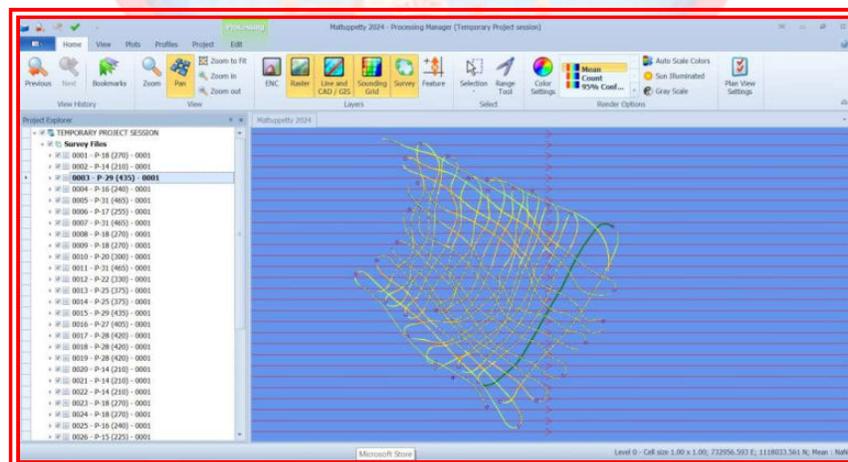
The data is then edited to eliminate spurious readings caused due to violent winds waves using the data processor in QINSY.

Data processing

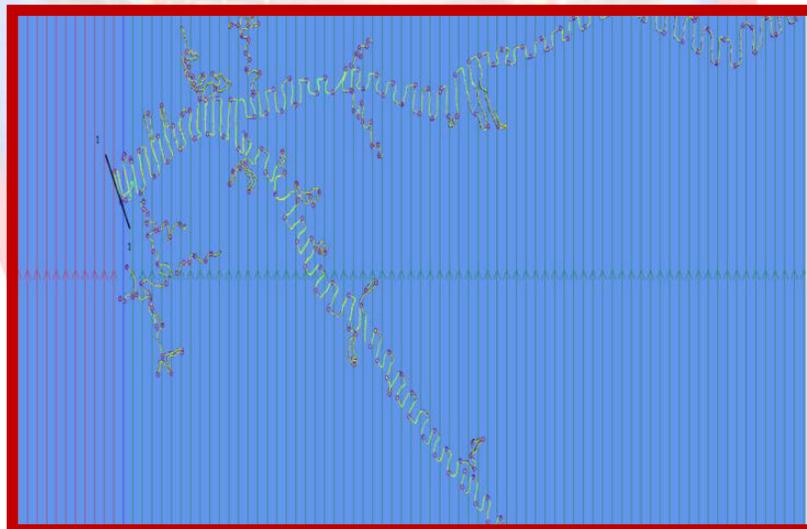
The below figure shows the plan of the survey lines covering the whole area of barrage

Plan of Boothathankettu Barrage showing sections surveyed

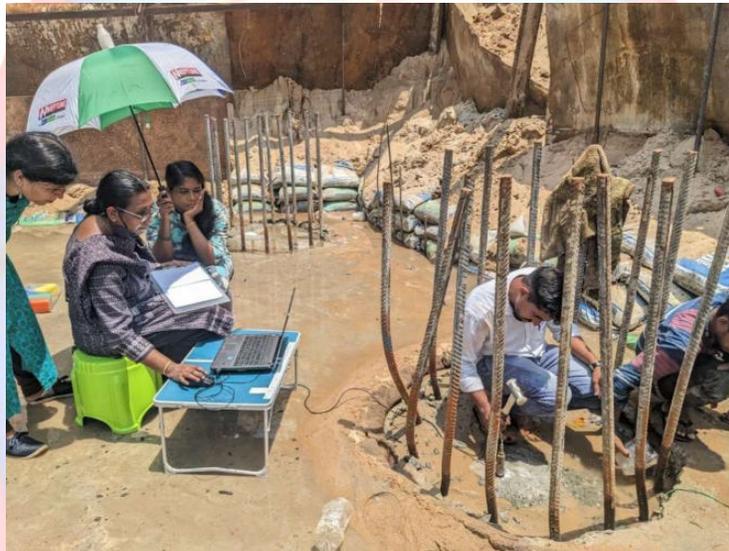
1. Assistant Executive Engineer, Inland Navigation Sub Division, PMG, Thiruvananthapuram, vide letter no D1-248/INSDN/TVM/2020 Vol III dated 02.05.2023 has requested to conduct Pile Echo Test (PET) on 12 numbers of pile (left bank) pertaining to the work “CSIND-Reconstruction of St. Andrews Bridge and approach road across TS canal Ch. 24.30km in Kadinamkulam Panchayath”. Accordingly, the test was performed on 15.05.2023.

Pile Integrity testing is a nondestructive testing conducted on piles as per IS 14893:2021. This is a method usually employed for the evaluation of the physical dimensions such as cross sectional variations, length, discontinuity etc. The test involves striking the top of the pile with a small hammer or an impact device to generate a low-energy wave. This wave travels down the pile and reflects back at the base. The time taken for the wave to return to the surface is recorded. Based on the characteristics of the reflected wave, an analysis is made to assess the condition of the pile. The test is fast to perform and doesn't require heavy

equipment. The pile is not damaged during the testing. The equipment being used by KERI is PET (USB version). Following pile integrity tests were carried out in 2023-24. This test provides only the qualitative information about pile integrity, it doesn't measure load-bearing capacity directly. Proper interpretation of waveforms requires expertise to identify potential defects correctly.

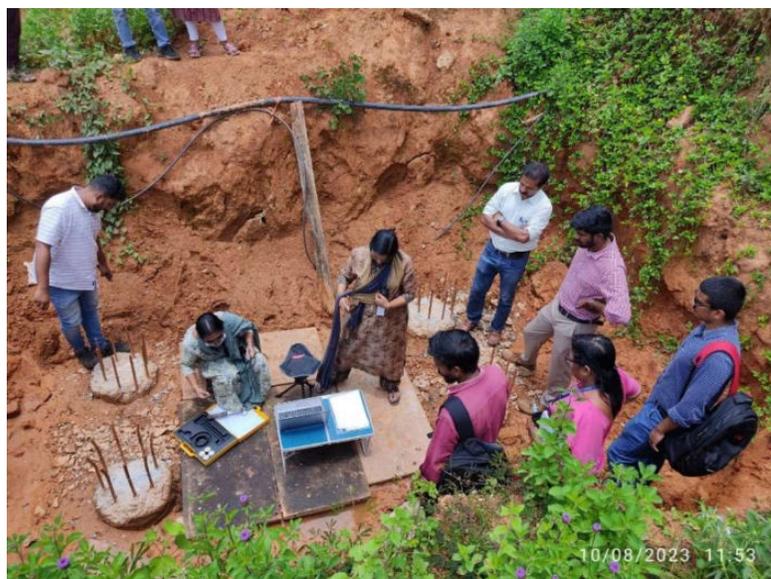
2. Executive Engineer, Karapuzha Project Division, Kalpetta, Wayanad, vide letter no. D1-1271/17(Vol-II) dated 02.06.2023 has requested to conduct Pile Echo Test (PET) on 10 numbers of pile pertaining to the work “Karapuzha Irrigation Project- Construction of Padinjarevedu Branch Canal between Ch.: 710 m to 1410 m including protection walls”. Accordingly, the test was performed on 10.08.2023.

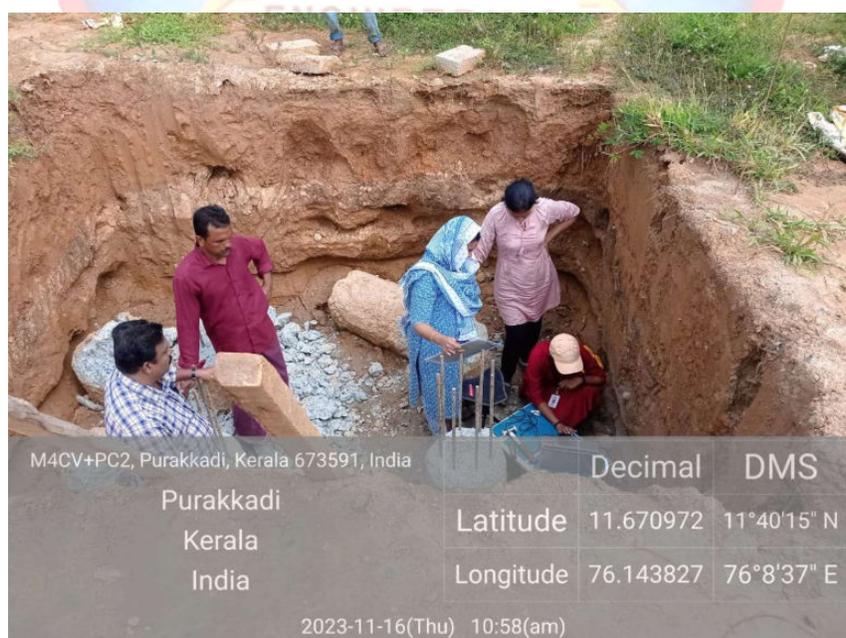
4. Executive Engineer, Karapuzha Project Division, Kalpetta, Wayanad, vide letter no. D4-1573/2020(Vol-II) dated 03.11.2023 has requested to conduct Pile Echo Test (PET) on 10 numbers of pile pertaining to the work “Karapuzha Irrigation Project- Rectification of slided canal embankment at Ch:1800m of Kariambady Branch Canal at Kolampatta”. Accordingly, the test was performed on 16.11.2023.

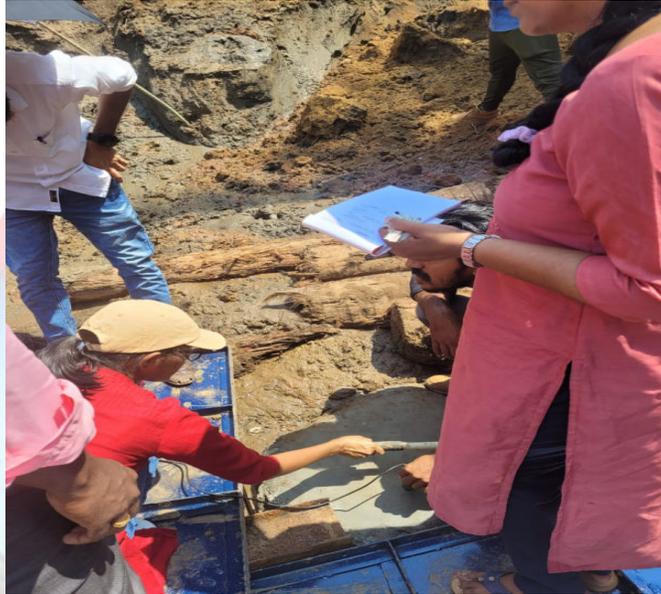
5. Assistant Executive Engineer, Minor Irrigation Sub Division, Kasaragod vide letter no. D3-NABARD-RIDF-XXVIII/4721/2023 dated 12.01.2024 has requested to conduct Pile Integrity Test on 4 piles including a test pile pertaining to the work “Construction of SWE regulator on upstream of old Chithari SWE-RCB across Chithari River in Kasaragod District”. Accordingly, the test was performed on 29.02.2024.

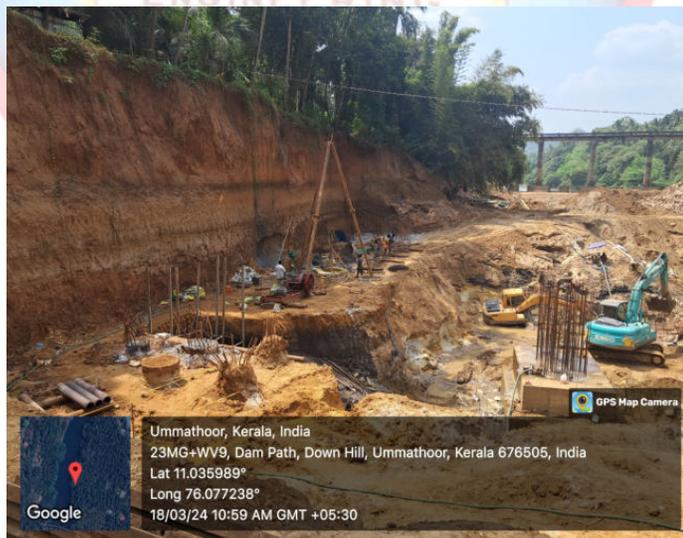
6. Assistant Engineer, Irrigation Section, Malappuram vide letter no. ISMPM/4348/2020 dated 21.02.2024 has requested to conduct Pile Integrity Test on 15 piles pertaining to the work “Construction of regulator across Kadalundi river at Nambranikkadavu in Malappuram Municipality”. Accordingly, the test was performed on 18.03.2024.

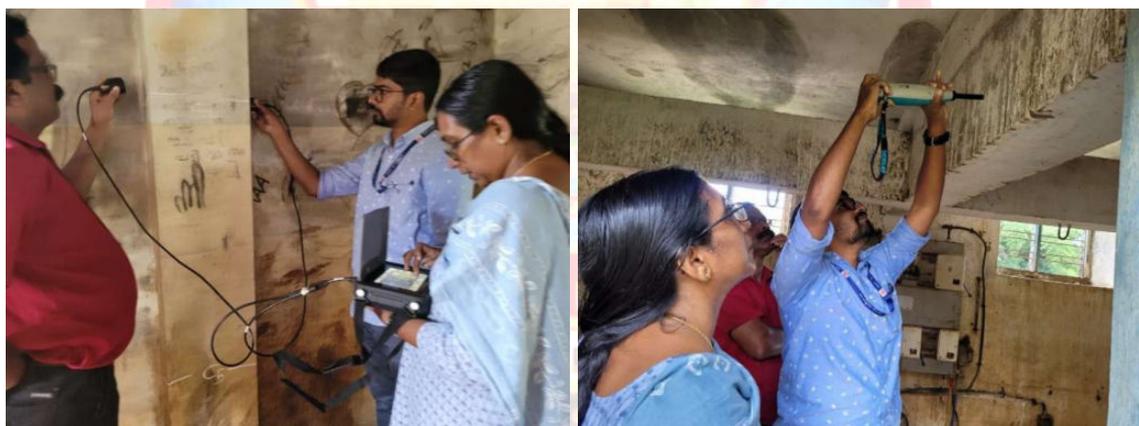
1) Renovation of Malankara Lift Irrigation Scheme in Panamaram Panchayath, Wayanad District- NDT Test on old pump house

Executive Engineer, Minor Irrigation Division, Sulthan Bathery vide Lt. no. D4-1140/2018 dated 21.08.2023 had requested to assess stability of old pump house of Malankara Lift Irrigation Scheme in Panamaram Panchayath, Wayanad District. A site visit was organised from KERI on 19-09-2023 to conduct Ultrasonic Pulse Velocity Tests and Rebound Hammer Tests on the structural elements of the existing pump house.

Ultrasonic Pulse Velocity Test and Rebound Hammer Tests are performed on concrete to assess the quality of concrete as per IS 516 (Part 5/Sec I): 2018 and IS 516 (Part 5/Sec 4): 2020 respectively. Proceq Pundit PL 200 with 54KHz transducers are used for UPV tests and Proceq Silver Schmidt N type hammer is used for Rebound Hammer test. Following works were carried out in 2022-23.

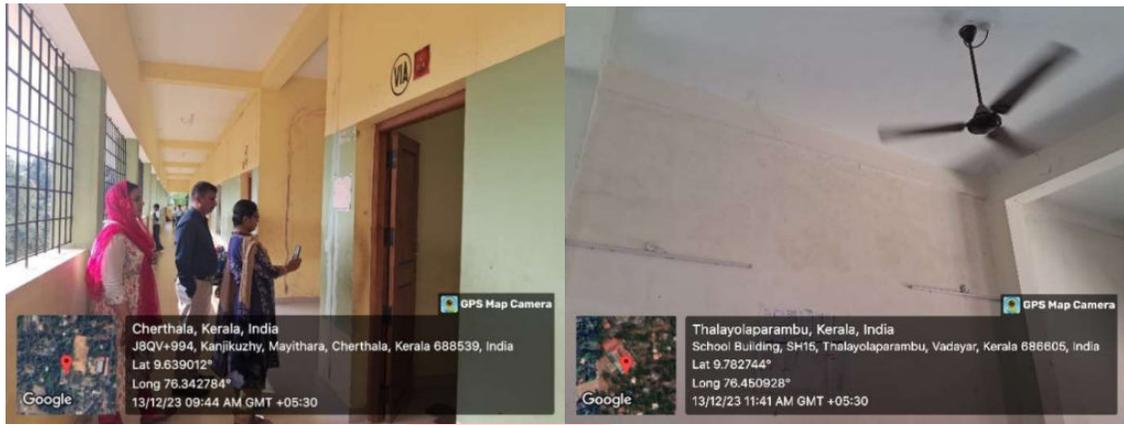
2) Structural Stability of GDVHSS Charamangalam and AJJM GHSS Thalayolaparambu

Sri. Sibi.K.Jose, Kannampuzha (H), Parathodu P.O, Kambilikandom, Idukki had requested the Director, Kerala Engineering Research Institute, Peechi to check the structural stability of two school buildings – GDVHSS Charamangalam, Kanjikuzhi, Mayithara, Cherthala and AJJM GHSS, Thalayolaparambu Kottayam. Accordingly a joint tem headed by Joint Director CM & FE conducted the site inspection on 13.12.2023 and inspected both the school buildings.

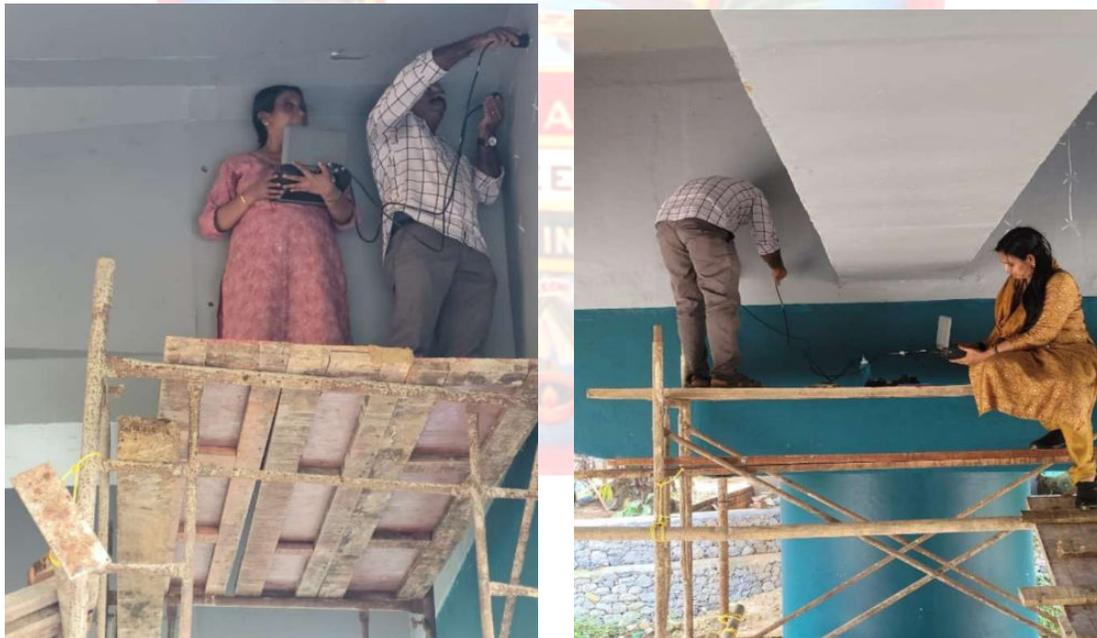
3) NDT Test : Parakadavath Bridge across Cherupuzha, Perambra LAC in Kozhikkode District

Assistant Engineer, PWD Bridges Section, Vadakara vide Lt. no. PWD/BS/VDA/PRK dated 04.01.2024 had requested to carry out Ultra Sonic Pulse Velocity Test and Rebound Hammer Test to assess the quality of concrete of P1 and P2 diaphragm walls of Parakadavath Bridge across Cherupuzha, Perambra LAC in Kozhikkode District. Accordingly a team headed by Joint Director, CM & FE including Deputy Director and Assistant Director of Construction Materials Division, KERI, Peechi visited the site and conducted the requested NDT tests on 15.01.2024 in the presence of Assistant Engineer, PWD Bridges Section, Vadakara.

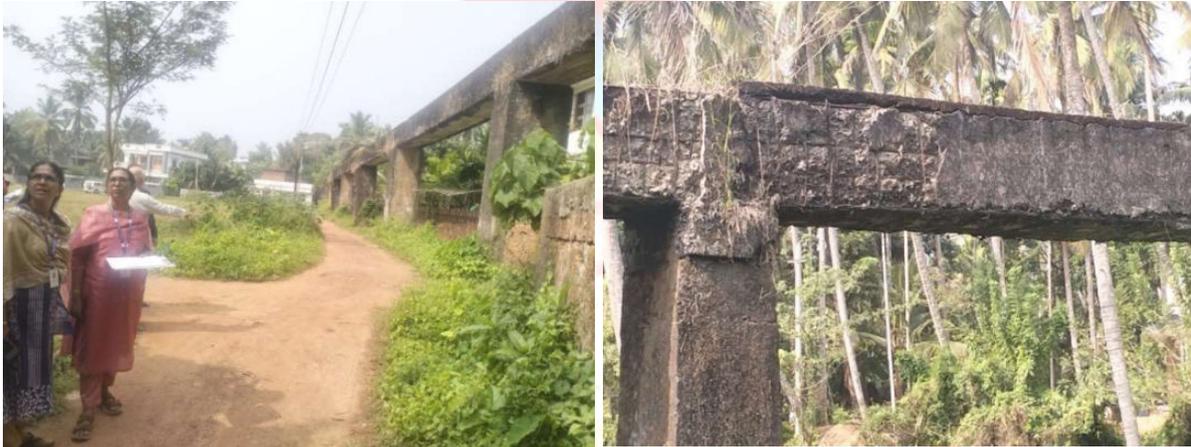
5) Inspection Report – Damaged Aqueducts of Azheekkal Branch Canal & Edakkad Branch Canal of Pazhassi Irrigation Project, Kannur.

Superintending Engineer, Project Circle, Kannur vide Lt. no. D2-4452/2021 dated 07.12.2023 informed that as part of renovation works of Pazhassi Irrigation Project , it is proposed to revive Edakkad branch canal & distributaries as well as Azheekkal branch canal & distributaries. It was also requested to conduct necessary tests for the damaged piers of the aqueducts enlisted below. Accordingly a team headed by the Joint Director, CM& FE, KERI, Peechi including Deputy Director and Assistant Director of CM Division, KERI, Peechi visited the sites along with project authorities on 16.01.2024.

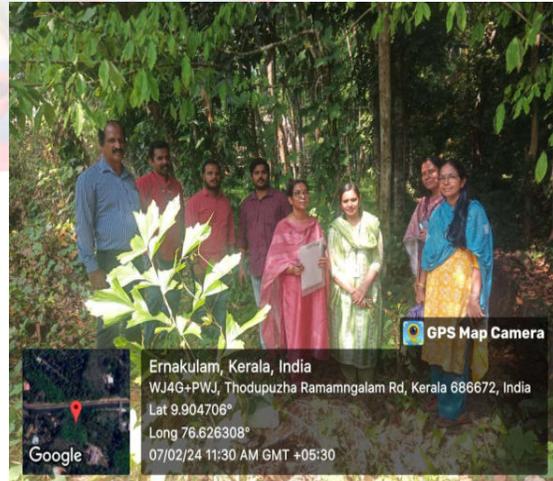
6) Site Inspection: MVIP Rectification works to damaged lining portion of LBMC between Ch. 17010 to 17300 m

A team headed by Director, KERI including Joint Director, CM & FE, Deputy Director and Assistant Director of Construction Materials Division along with the project authorities visited the site on 07.02.2024 and suggested methods to quantify the seepage through the lined canal.
