KERALA ENGINEERING RESEARCH INSTITUTE

ANNUAL REPORT 2023-24

Publication No. 86

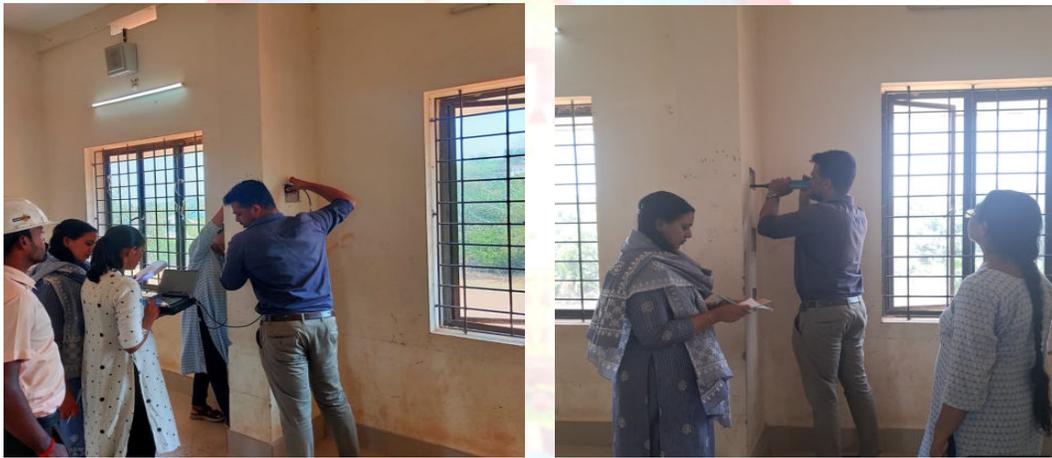
7) Inspection Report - Structural Stability of GHSS Pezhakkappilly

M/s.CMK Projects Private Limited, Bangalore vide Lt. no. Nil dated 07.03.2024 had requested to carryout Ultrasonic Pulse Velocity Test, Rebound Hammer test and Profometer studies on reinforced concrete members at random in the second floor of GHSS Pezhakkappilly to assess the quality of in-situ concrete, compressive strength of concrete, concrete cover & location of reinforcement respectively. Accordingly a team headed by the Deputy Director, Construction Materials Division, KERI, Peechi including Assistant Directors and Research Assistant of Construction Materials Division, KERI, Peechi visited the site along with the project authorities on 27.03.2024

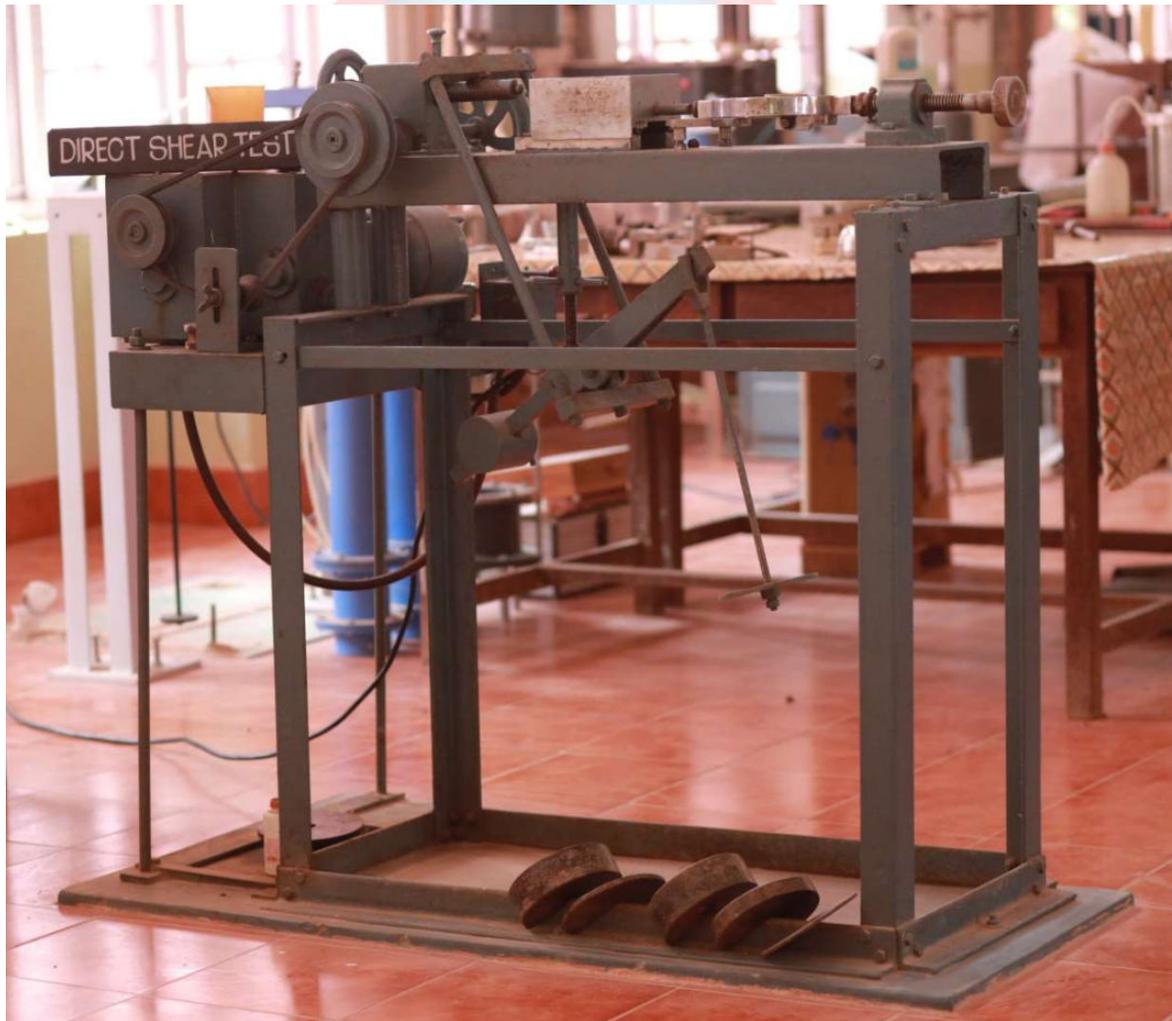
Fig. Direct Shear Apparatus

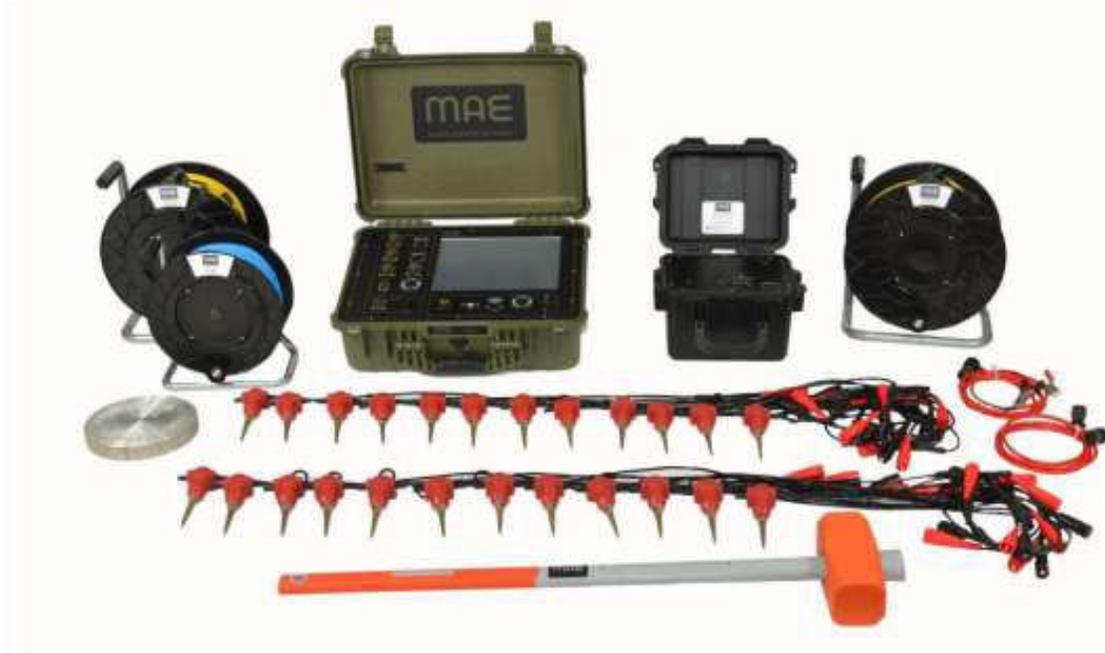
Fig. Apparatus used for Seismic Refraction Survey

Modernizing the lab will come true with the addition of modern Instruments. This lab is equipped with Engineering Seismograph and is used for subsurface characterization by seismic refraction method. Additionally, this division is equipped with instruments for Seismic Tomography Surveys to detect and study deteriorated zones within the dam body.

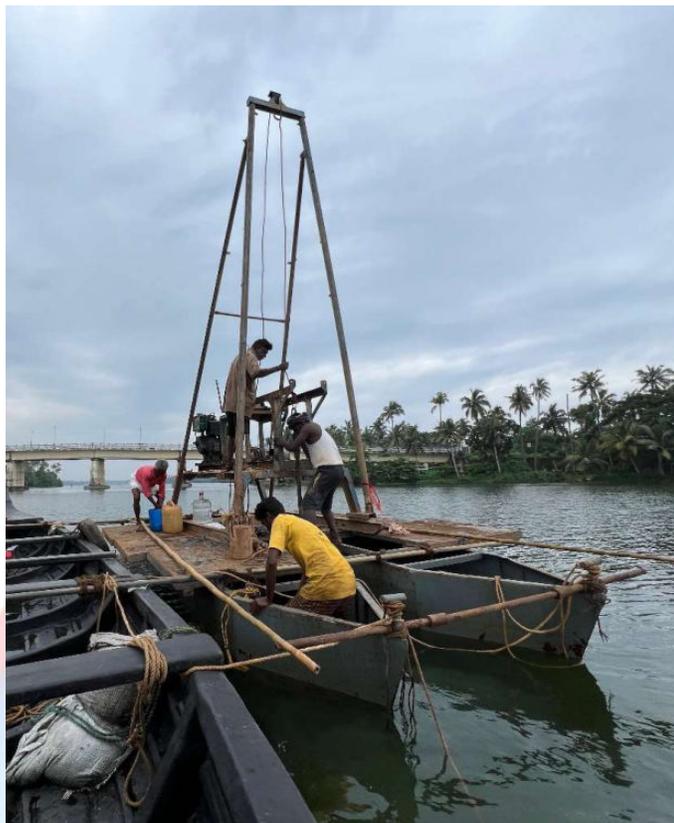
Fig a. Rotary Calyx drilling machine mounted on Pontoon.

- Equipment for hand augering.
- In situ Vane shear test apparatus
- Rotary Calyx drilling machines - 2 Nos.

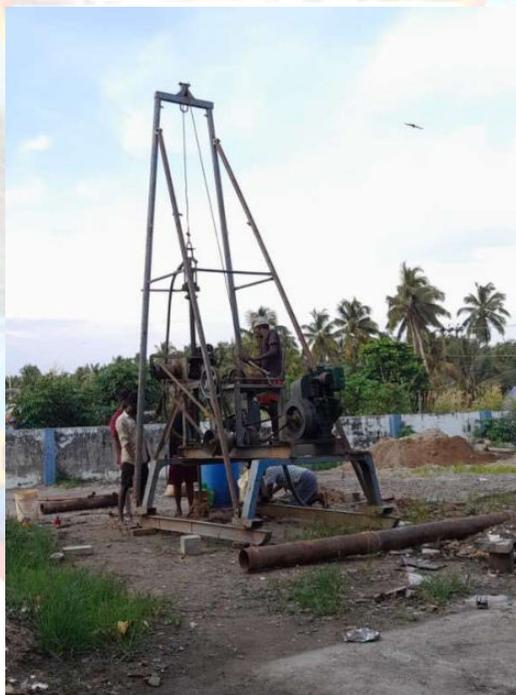
Fig.1- Investigation for Chettuva Fishing Harbour.

The field investigation work at this site was carried out from 21th November 2023 to 27th November 2023. In order to conduct soil investigation for the extension of existing harbour, one borehole was decided to drill in the space provided between existing harbour and compound wall. Boring works was carried using Rotary calyx-type drilling machine. Boring was conducted up to a depth of 30m as per the requirement of preliminary study as required by the project authority. The estimated cost for the project is 1,00,531/-, and the total expenditure incurred for the work was Rs: 1,00,427/-

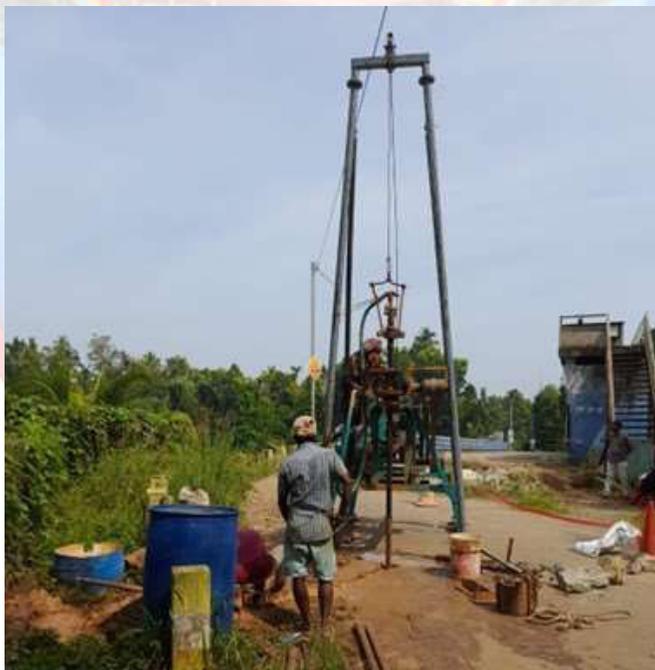
Fig.2-Soil investigation for Attappilly RCB across Kurumali River.

The location of the boreholes were already decided from IDR, so that as per IDR drawing, five boreholes were set out in the approach road. The investigation included activities such as boring, collection, and testing of soil samples. For soil exploration, five boreholes were drilled between 7th December 2023 and December 18th, 2023. Rotary calyx-type drilling machine was used for the boring process, with the drilling conducted until reaching the hard rock level. The estimated cost for the work is 2,00,000/-, and the total expenditure incurred for the execution of the work was Rs: 99,585/-.

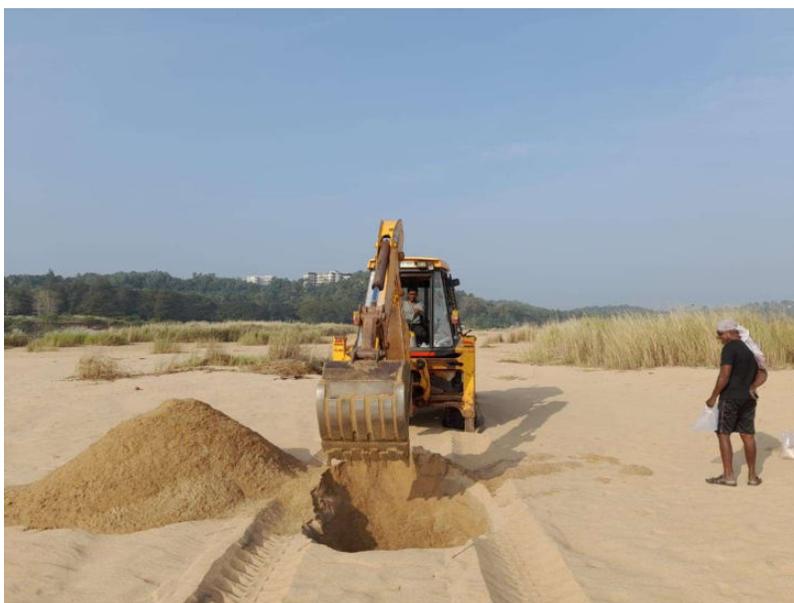
Fig.3- Soil investigation work for desiltation of construction of RCB across Bharathapuzha at Kankakkadavu

It was decided to excavate boreholes using hydraulic excavator up to a depth of around 3m. The boreholes were dug at intervals of 1m depth, reaching a maximum depth of around 3m from the current bed level. The field investigation work at this site was carried out from January 12th, 2024 to January 13th, 2024, by the Instrumentation division of the Kerala Engineering Research Institute, Peechi. Twenty boreholes were excavated using a hydraulic excavator. Samples were collected from the bed level and at depths of 1m, 2m, and up to around 3m. A total of 78 representative samples were collected from the aforementioned 20 boreholes and from different depths. The estimated amount for the work was Rs:1,68,500/- and the total expenditure incurred for the execution of work was Rs:1,48,496/-.

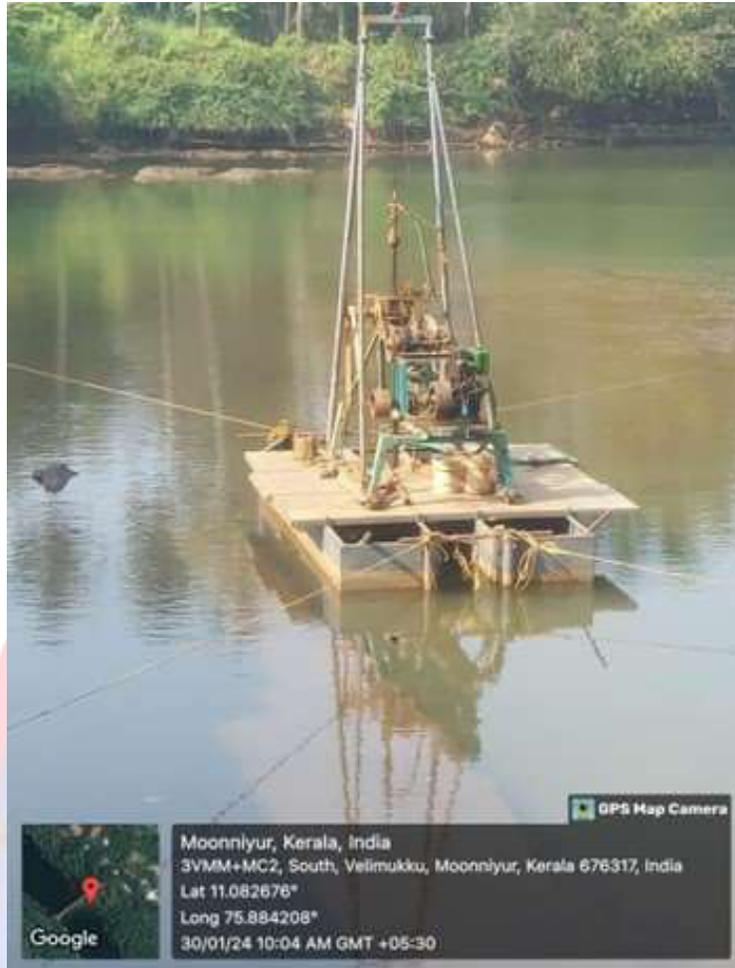
Fig.4-Soil investigation Works To The Reconstruction Of Mannatampara Weir Across Kadalundi River.

The field investigation work at this site was carried out from 27th November 2023 to 28th February 2024. Boring plant . The estimated amount for the work was Rs:9,30,000/- and the total expenditure incurred for the execution of work was Rs:7,52,752/-.

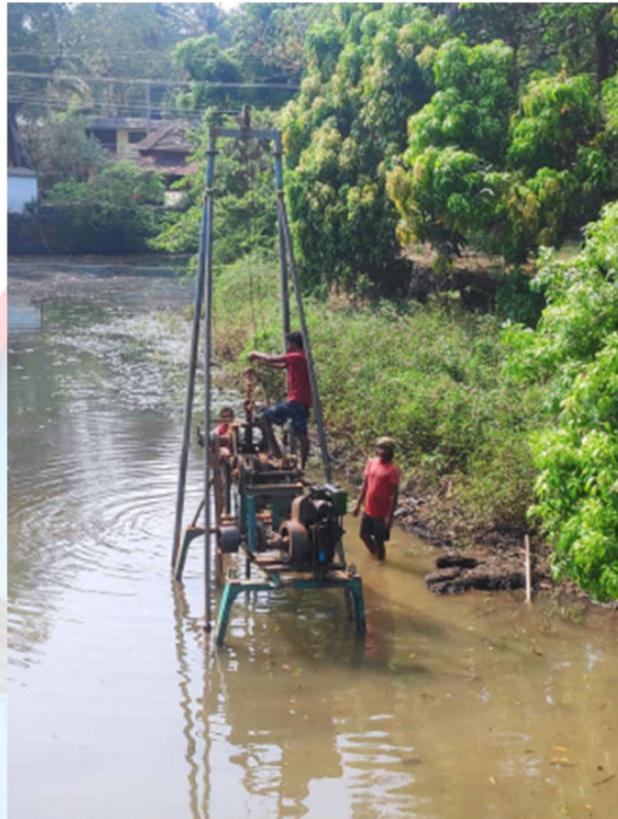
Fig.5-Soil Investigation work for the reconstruction of Tholur Chira.

In order to conduct soil investigation for the reconstruction of Tholur Chira in the Wadakkanchery River in Thrissur District, Ten borehole was decided to be drilled.. The field investigation work at this site was carried out from 29th February 2024 to 18th March 2024. The total expenditure incurred for the execution of work was Rs:2,07,754/-.

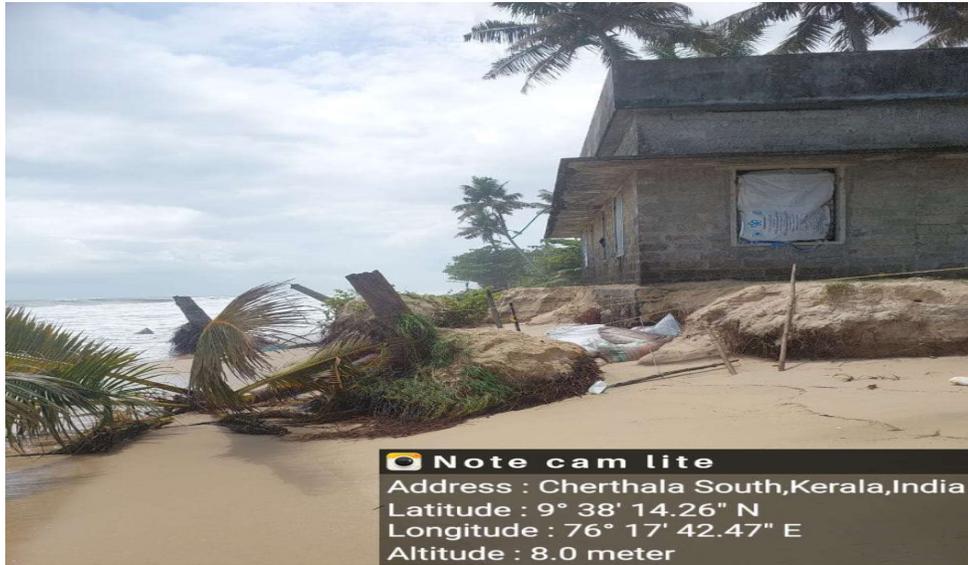
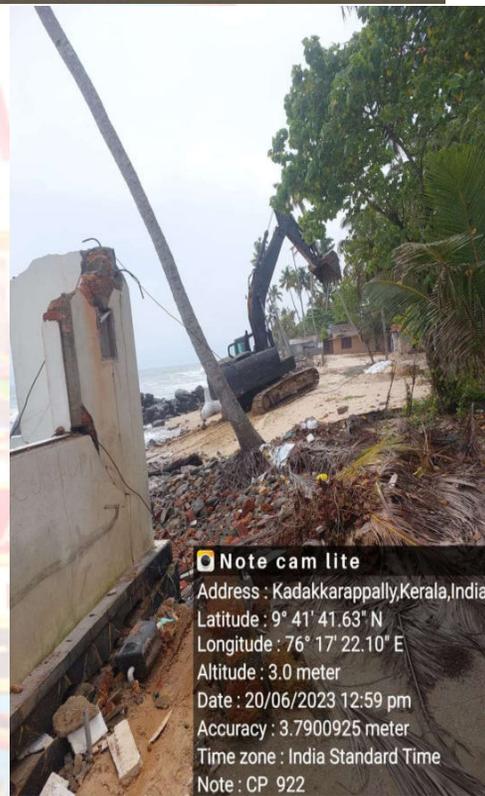
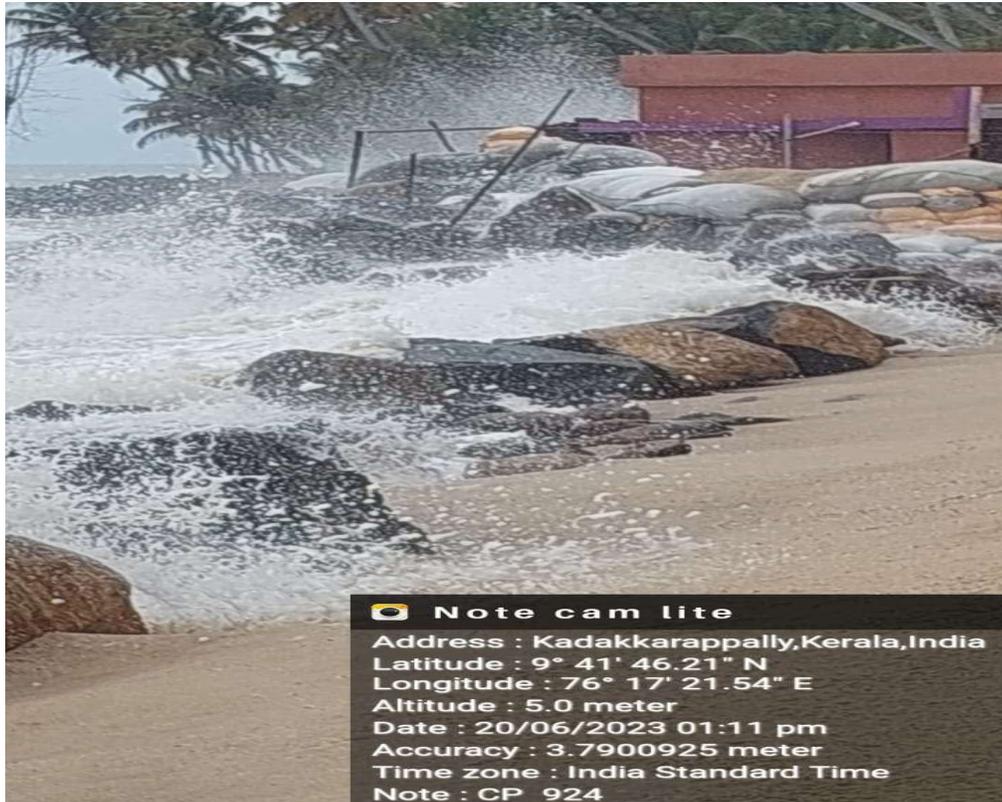
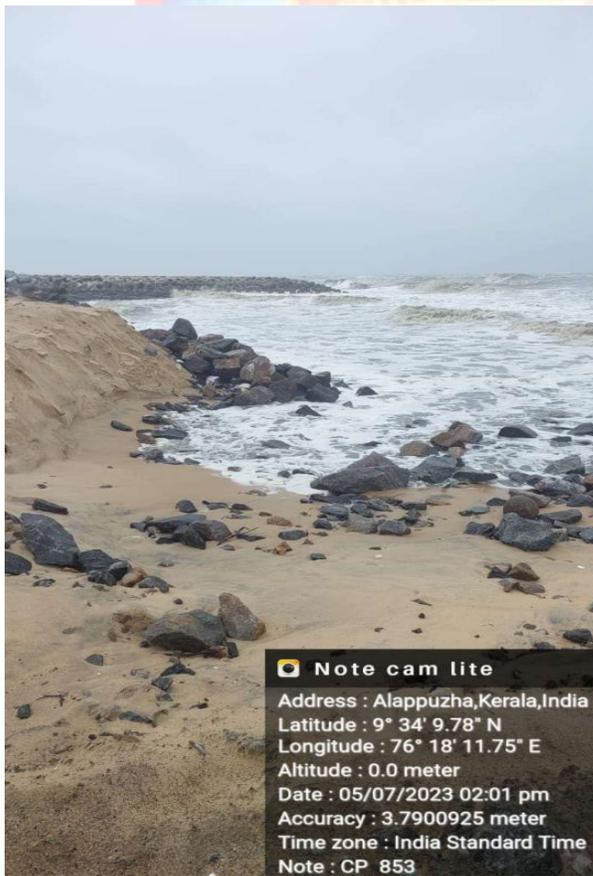
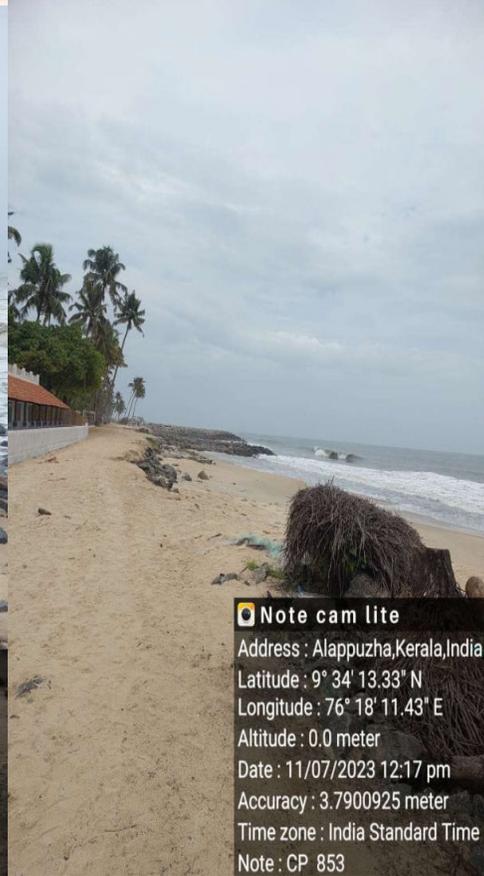
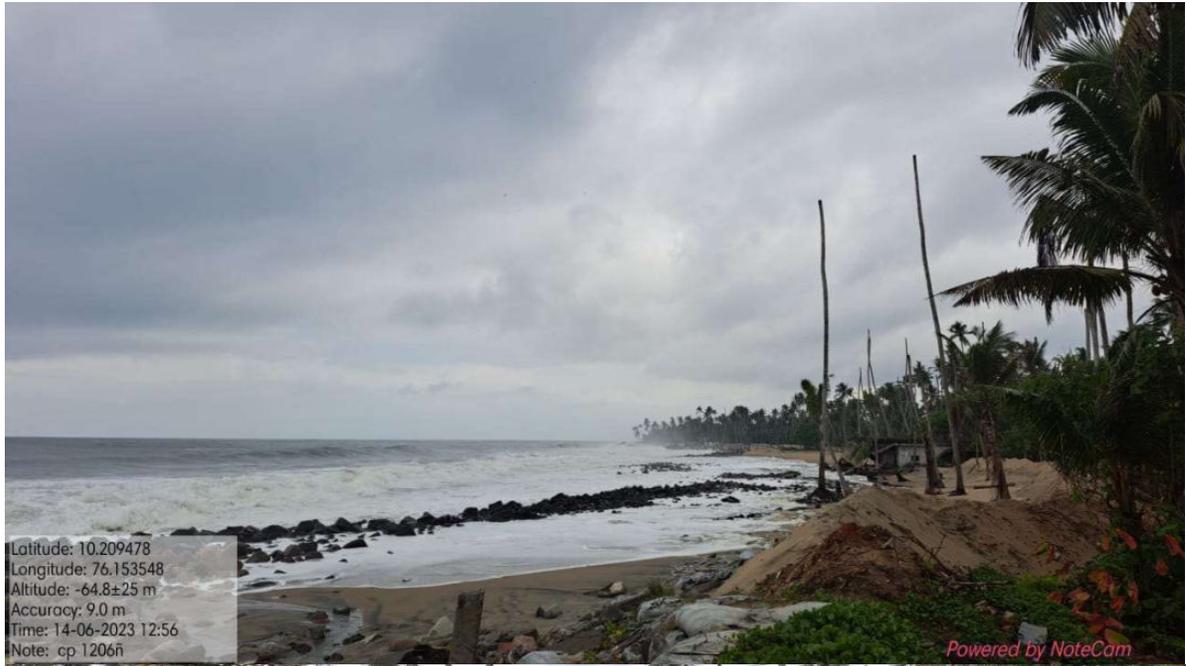
VII Photos of Coastal Damages

Coastal Damages occurred within the jurisdiction, were closely monitored and were reported every week during the monsoon. Details of coastal damages are reported once every month during off-monsoon months. During this year moderate coastal damages and heavy coastal erosion were reported from Chennaveli (CP 890-895) and Thanky(Ottamassery) (921-929). At Chennaveli between CP890 & CP89, one residential building underwent severe foundation soil erosion, rendering the house unfit for dwelling and more than four coconut trees overturned and fell down. At Ottamassery from CP 921 to CP 929, houses situated near the sea shore underwent serious foundation soil erosion due to overtopping waves and more than five houses partially damaged. More than 7 coconut trees overturned and fell down. Due to heavy wave attack, beaches eroded for a width of about 10 to 15m at Kattoor, Chennaveli

and Ottamassery. At Kattoor, coastal damages considerably reduced during the year. Between CP854 and CP 859 severe coastal erosion and beach loss occurred during the monsoon season. As groynes with tetrapod protection work has progressed from CP839 to CP853, beach erosion is comparatively reduced. At Chennaveli, moderate to severe coastal erosion and beach loss occurred.

At Azhikode(CP 1188-1195) beach eroded to about 15m width throughout the entire stretch and a Scarp height of approximately 0.6m formed. At Kara (1213-1224) area, Water advanced about 15m into the nearby houses and 3 houses are partially damaged. Shore is severely damaged, hence trees have fallen down. One commercial building partially damaged between CP1397 & CP1398-Achangadi. At Vadanappally (N)1354-1356 seven nos. of coconut trees fell down and seawall road completely breached at this stretch. At Eriyad (1205-1220) seawall fully damaged, Heavy overtopping above damaged seawall. Reach II(Chettuva North to Ponnani) Backshore eroding to about 3 to 4 m. At Veliyancode(1500-15012) houses are partially damaged and one old building damaged.

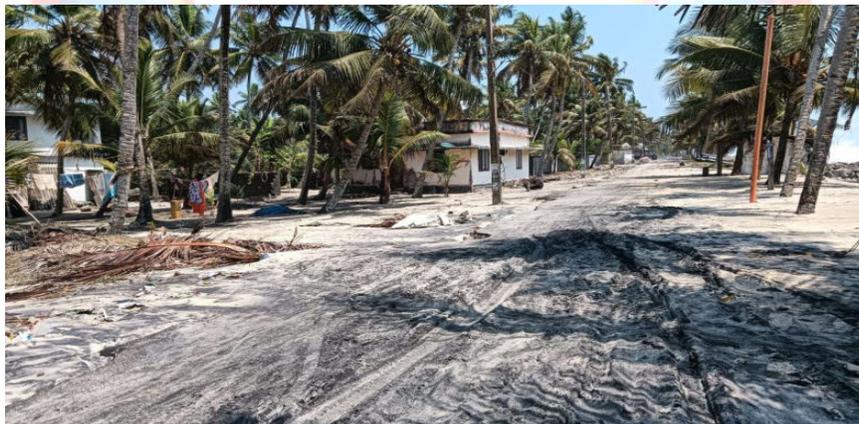
Fig.: Transportation blocked at CP stone 576

Photographs were taken of the coastal damages during high waves along the sea coast and have been presented in the form of a report. Due to the unexpected cyclone and surge waves phenomenon (April and may 2024) damages occurred in between Valiazheekkal and Alappuzha pier, 2 no. of houses were damaged. 1 sawmill of woodwork was damaged. Roads are filled with sand and the transportation were blocked. 10 numbers of casuarina trees fell down near CP 679 and CP 680 at Punnapra.

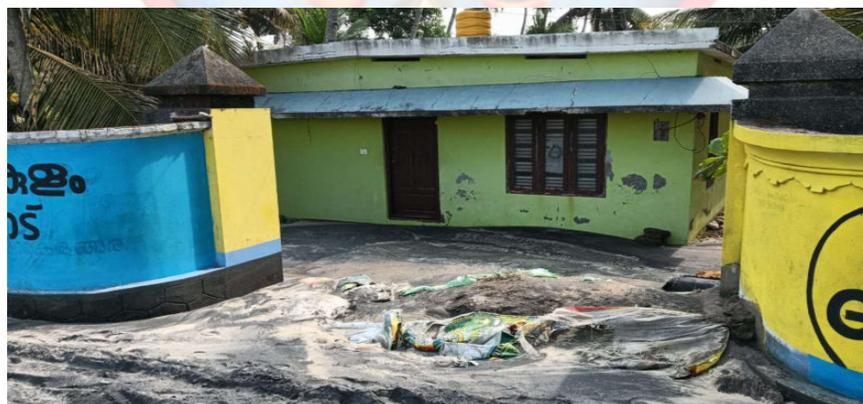
Fig. House get damaged at CP stone 507

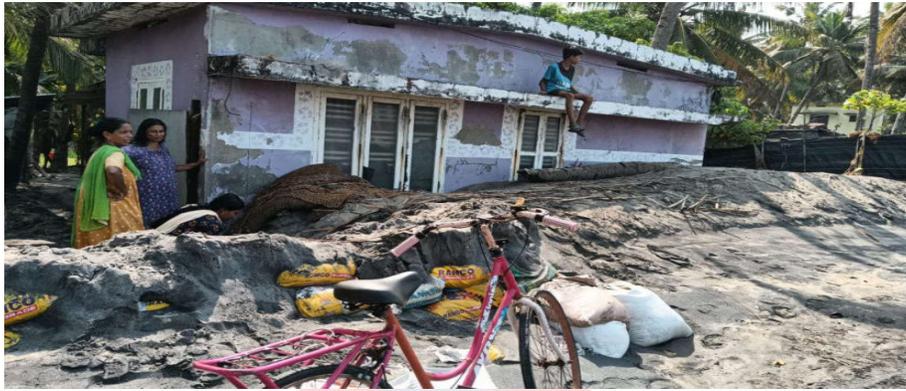
Fig. House get damaged at CP stone 506

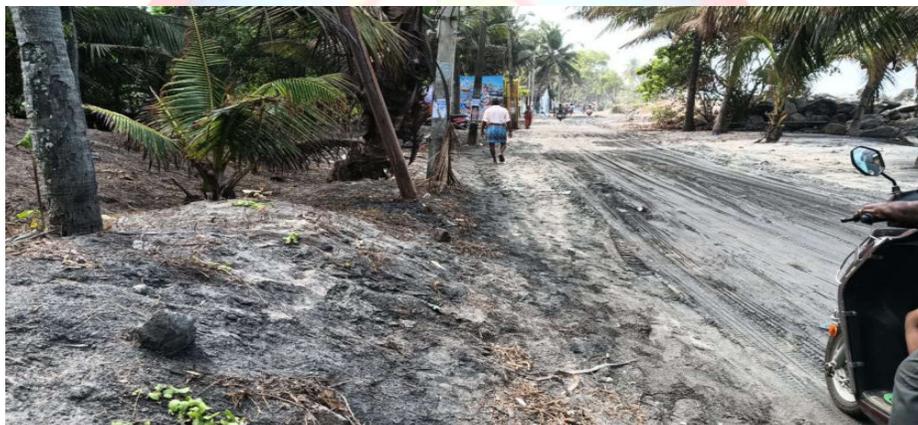
Fig. Road get blocked at CP stone 511

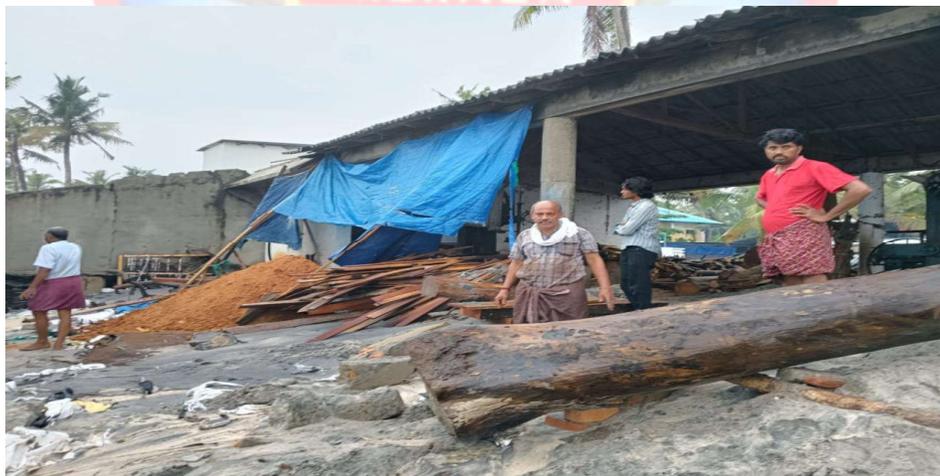
Fig. wood saw mill is get effected near Aratupuzha

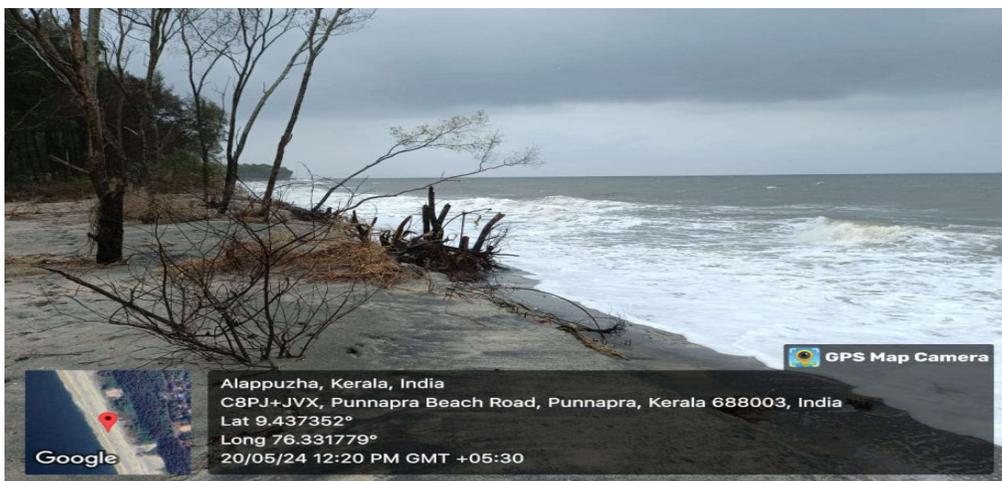
Fig. casuarina trees fell down near CP 679 and CP 680 at Punnpra

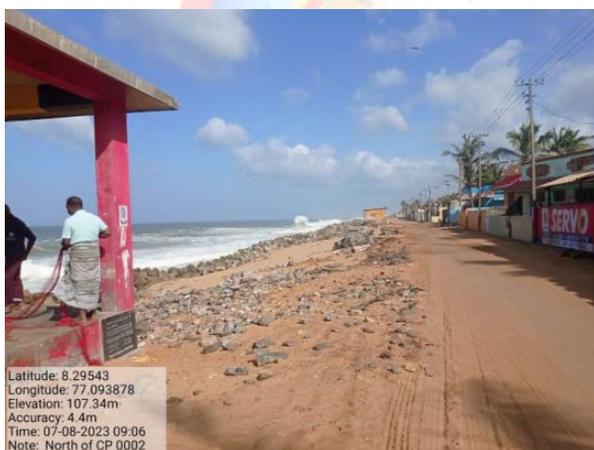
Fig 14 1: Damaged Sea wall at Kollamkode

Kollamkode at CP No. 0000 is the starting point. The area between CP NO.0000 to CP NO. 0008 was protected by the sea wall. The above area is thickly populated and is situated very near to the sea wall. Many numbers of Groyne are now under construction of Tamil Nadu Government from last week of November 2019 near the South of CP 0000 at Kollamkode. The construction of Groyne is seriously affected the north side of this Groyne, that is CP 0000 to CP 0008.

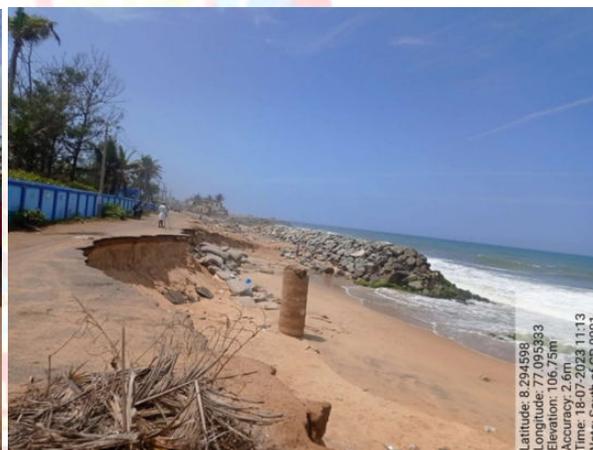
Fig 14 2: Damaged Road at Kollamkode

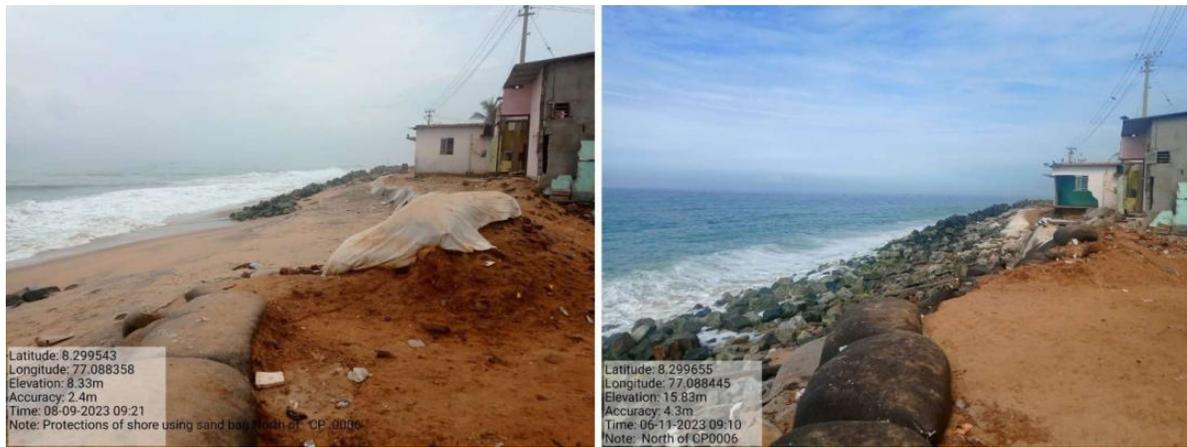
Fig 14 3,4: House before and after Damage at Kollamkode, North of CP 0006.

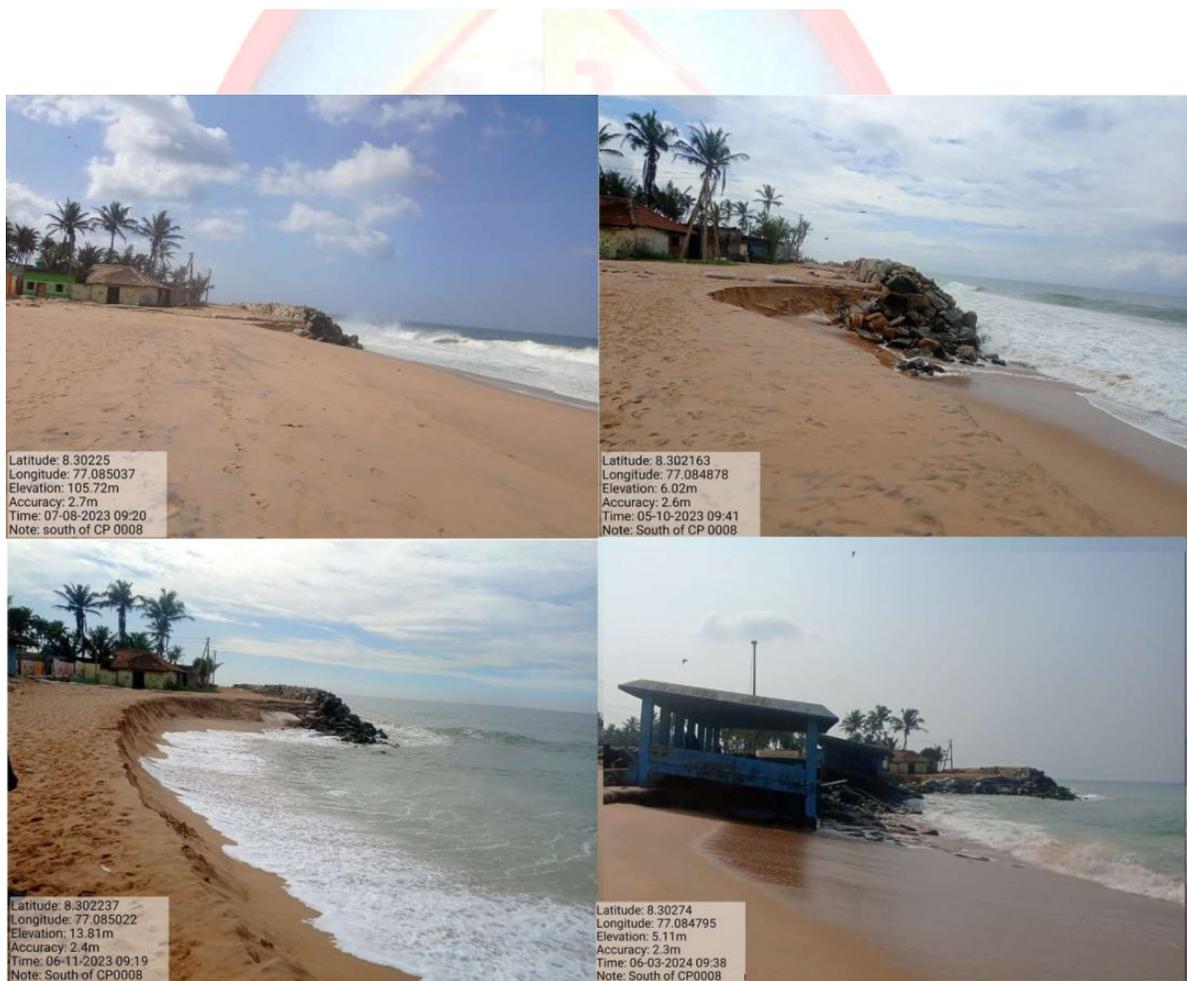
Fig 15: Shoreline Changes over Few months- South of CP 0008

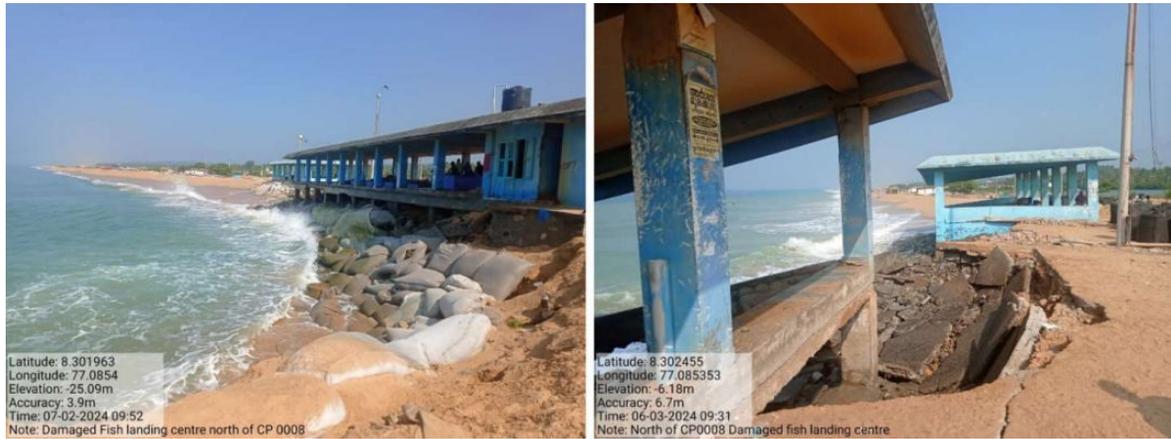
Fig 16: Damaged net winding Centre, North of CP 0008

Continuous sea attacks occurred in this region due to the after effect of this Groynes construction. Much damage takes place such as about 1 nos of Houses are damaged and Two net winding Centre is damaged during the previous year. Moreover, the existing sea wall between CP 0000 to CP 0008 is fully damaged, sinked and collapsed condition. Due to the continuous sea attack without season, this coastal region is now changed as one of the vulnerable reaches.

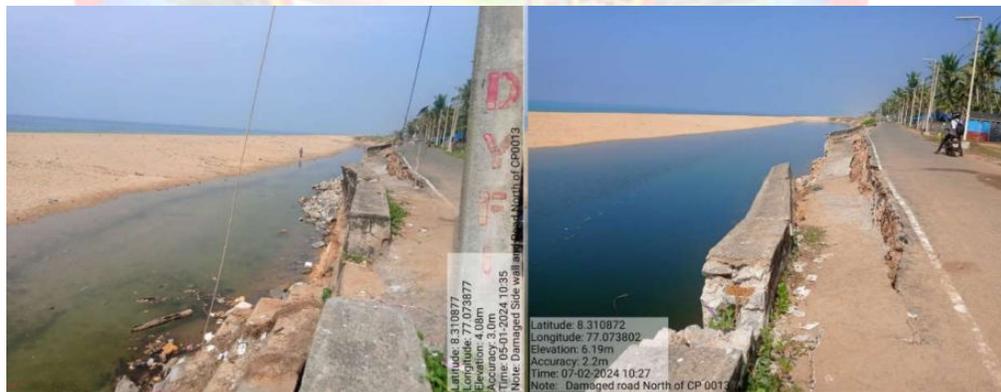
Fig 18: Sea wall at Panathura

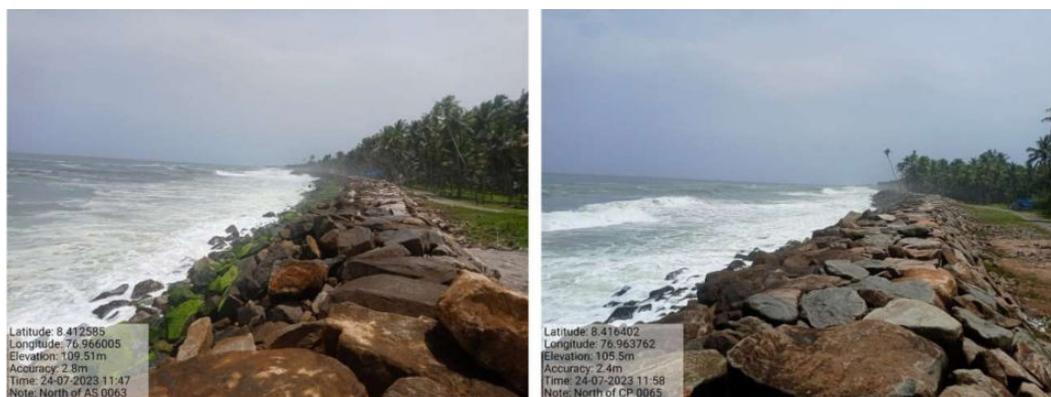
Fig 17: Damaged road and Side wall at Poovar between CP 0013 and CP 0015

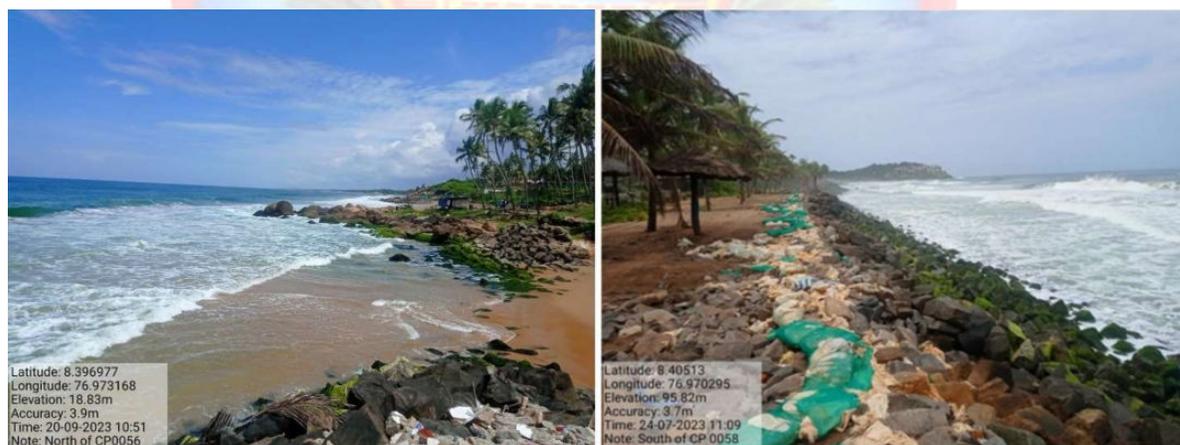
The sea wall at CP 0057 to 0060 (Samudra beach) has been dilapidated and spreaded due to severe sea attack and overtopping and the remaining portion of sea wall maintained in good condition. Two numbers of groins situated between CP 0069 and CP 0070.

Fig 19 1,2: Damaged Sea wall at Kovalam

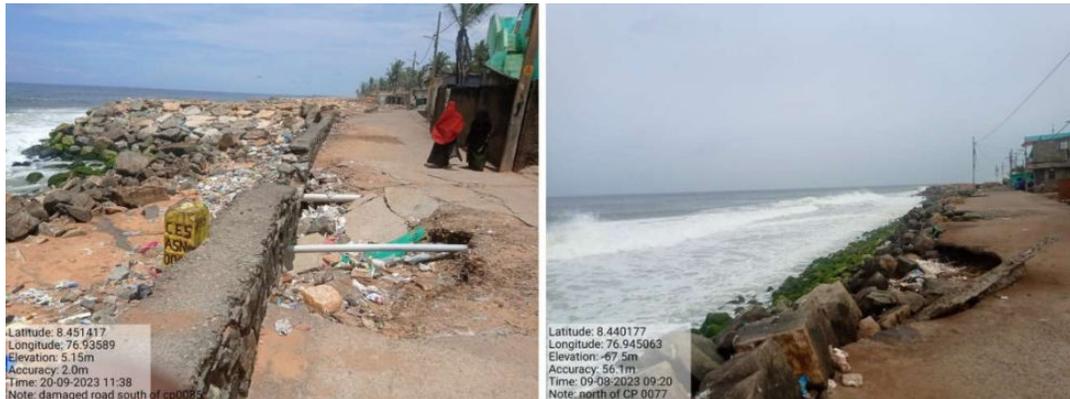
Fig 20 1,2: Damaged Sea wall at Ponthura

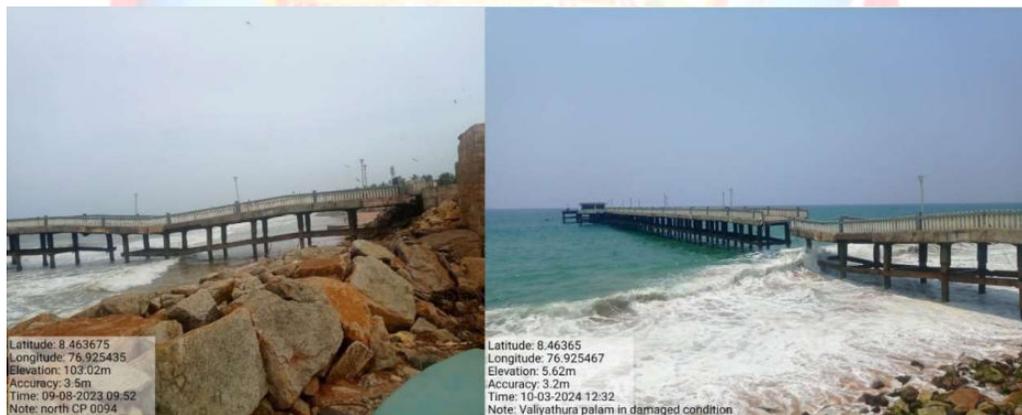
Fig 21 1,2: Valiyathura bridge before and after damage

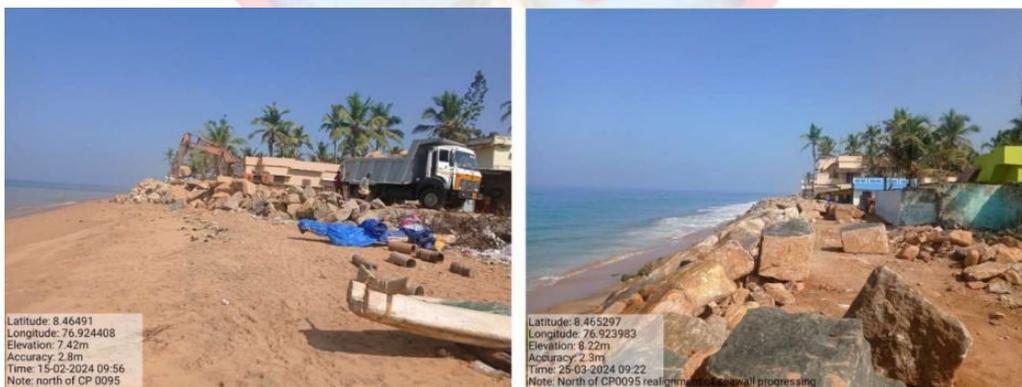
Fig 22 1,2: Realigning of sea wall progressing at Valiyathura, North of CP 0095.

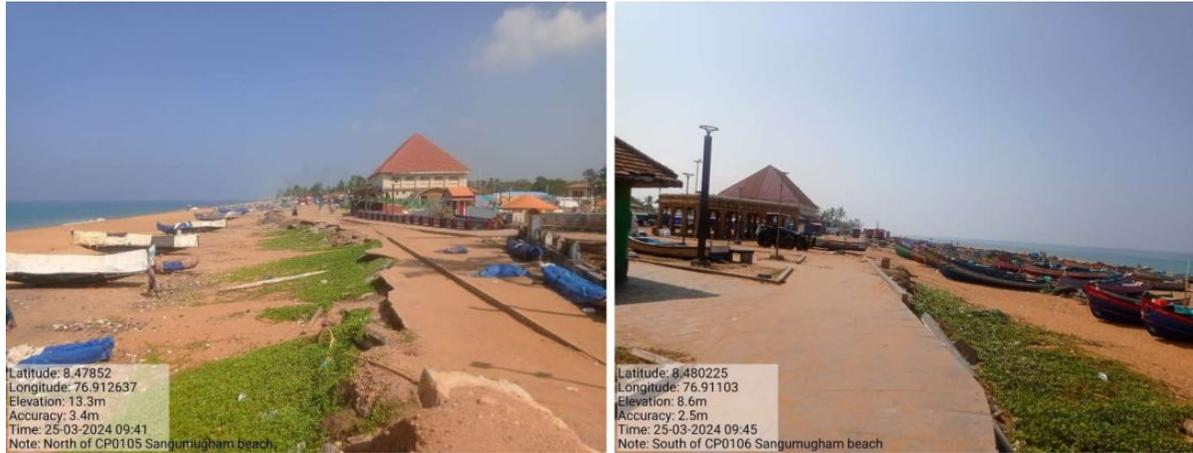
Fig 23 1,2: Sangumugam Beach

15 nos of groynes have constructed at Beemapally area (Between CP 0085 and 0092). The famous Sangumugam beach was fully washed due to the sea attack during the previous years, including the approach road and the beach footpath. During this year the road has re-constructed and now the traffic maintained properly. The Diaphragm wall construction has been completed between CP 0103 and 0107 for the protection of road from the sea attack.

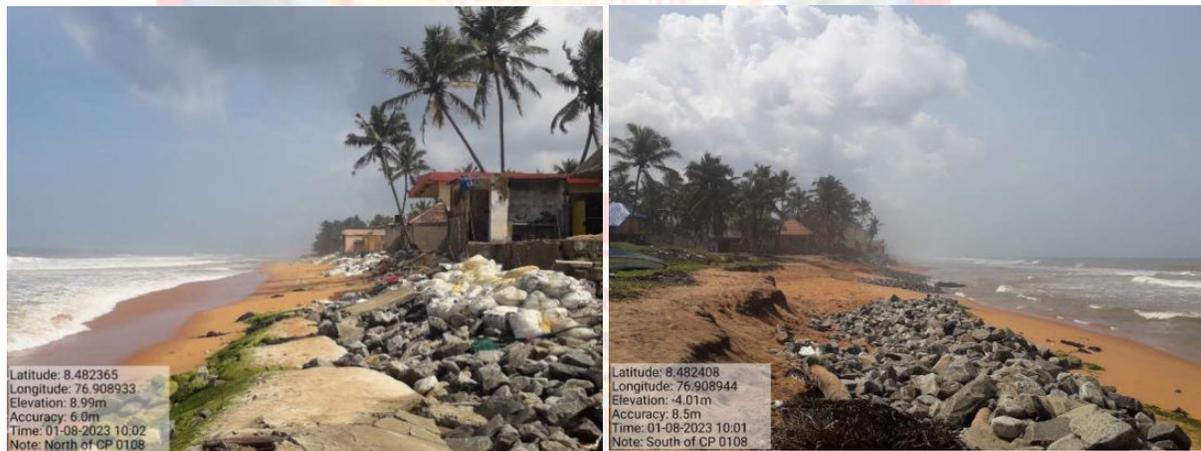
Fig 24 1,2: Damaged Sea wall at Sangumugam

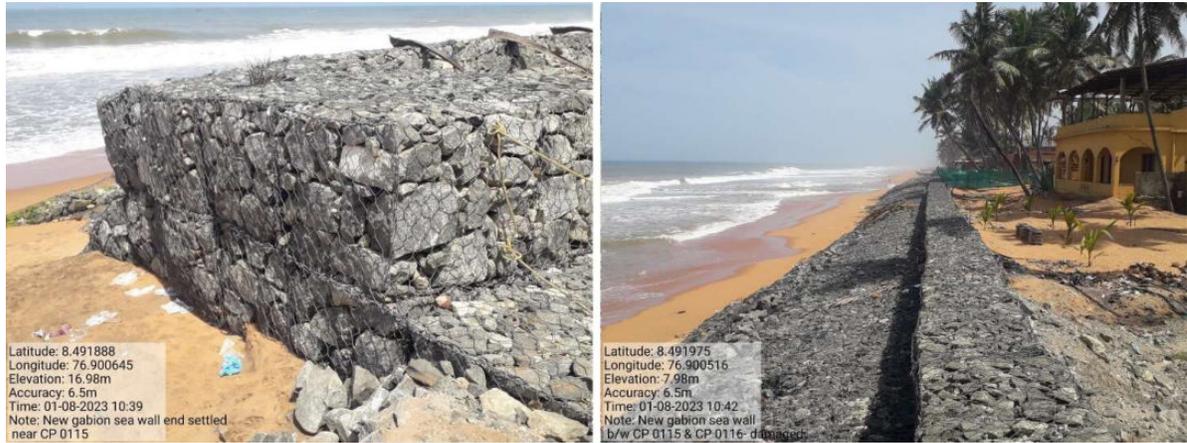
Fig 25 1,3: Settled Gabion Sea wall between CP 0115 and CP 0116

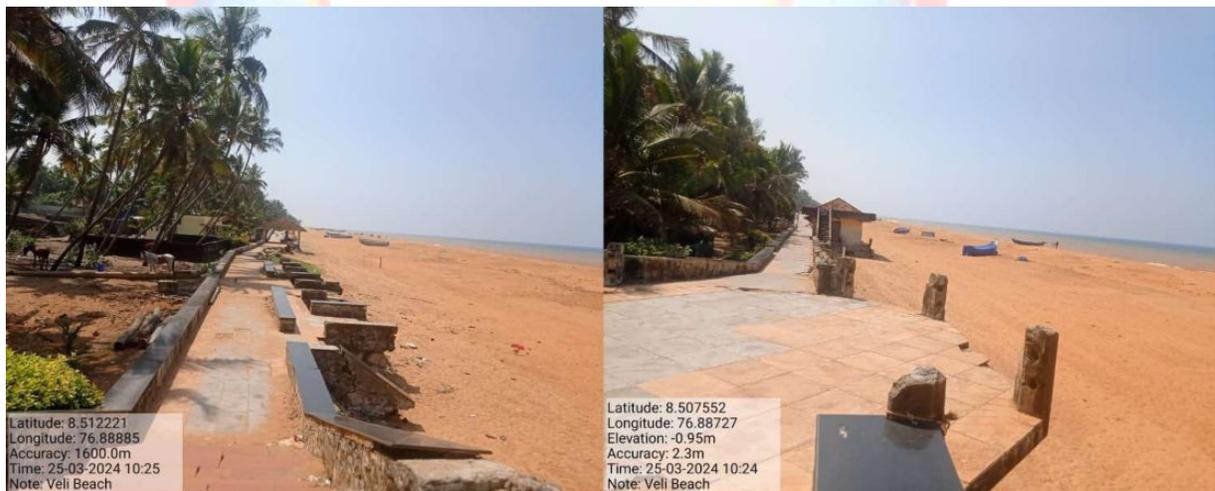
Fig 26: Veli Beach

CP No.0112 ,0114 and 0116 are simultaneous observation points of this office. The Veli pozhi is situated in between CP No.0127 and 0128. CP No.0128 to 0135 is protected by the Seawall.

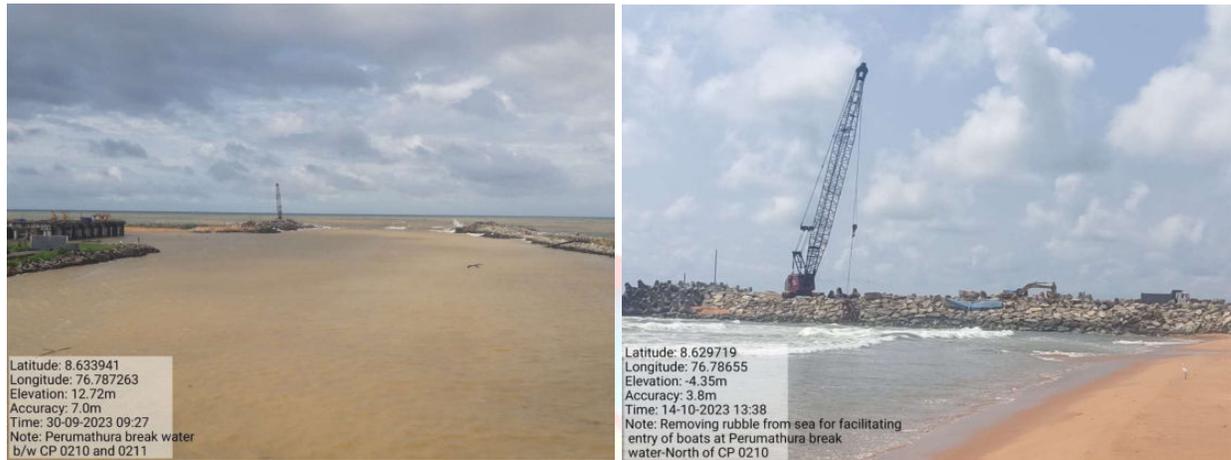
Fig 27: Perumathura Breakwater Between CP 0210-0211

Since the distance of CP between 137 to 150 (about 2.6 km) is under the control of ISRO and has been declared as Restricted area, the details of coast of this area is unknown. The area under this reach is very calm and maintains good beach in all the seasons. Between CP No 0210 and 0211, the harbor engineering department has constructed the breakwater at Perumathura. Hence, very large shore was created between CP No 0195 to 0211.

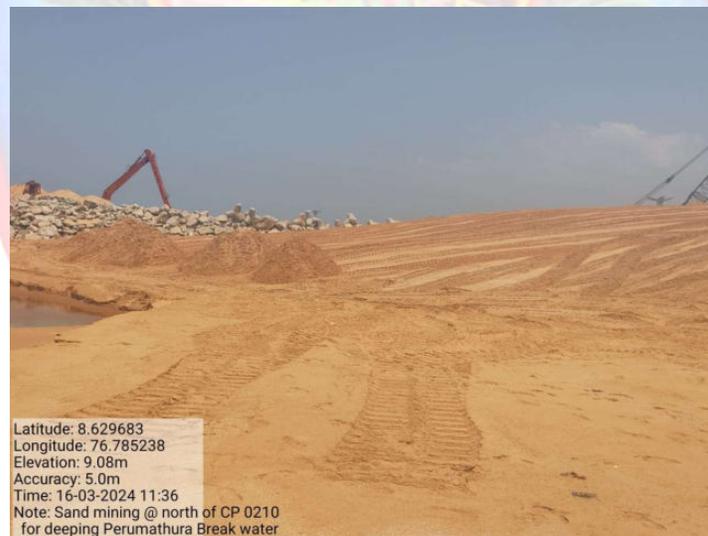
Fig 28: Sand mining at North of CP0210 for deeping Perumathura Breakwater
