KERALA ENGINEERING RESEARCH INSTITUTE

ANNUAL REPORT 2023-24

Publication No. 86

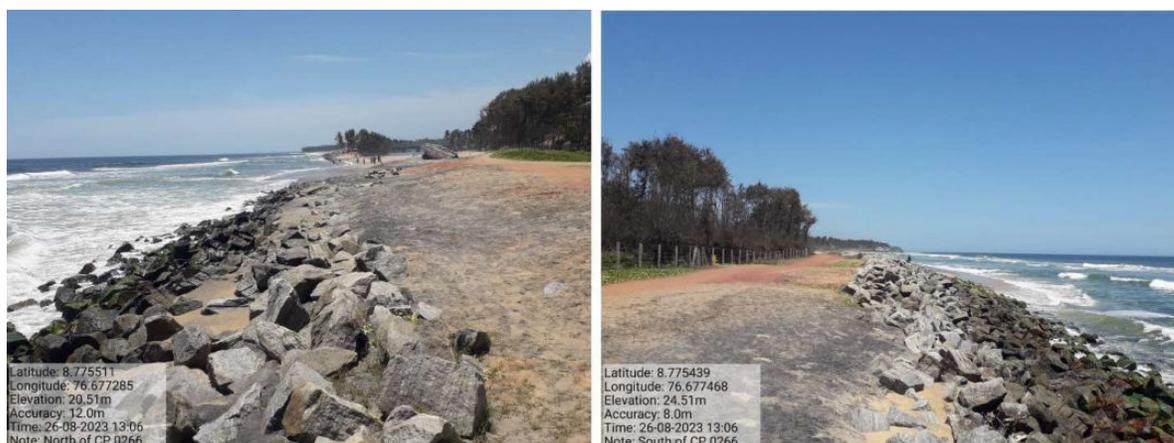
Fig 29: Damaged sea wall at Kappil

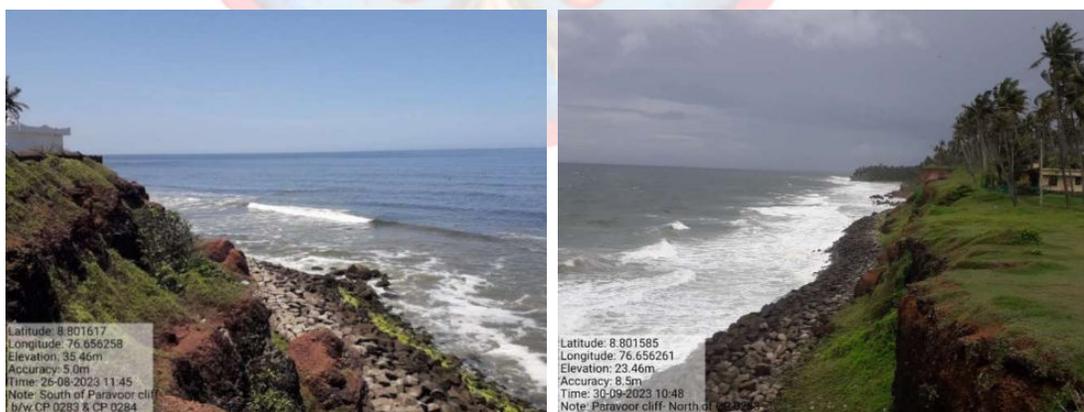
Fig 30: Paravur Cliff

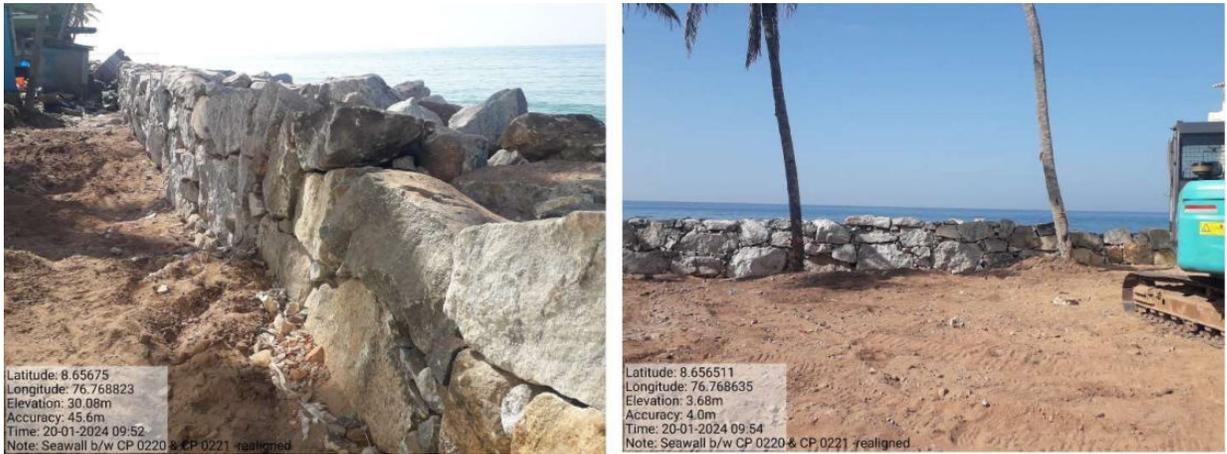
Fig 31: Sea wall between CP 0220 and CP 0221 before and after realigned.

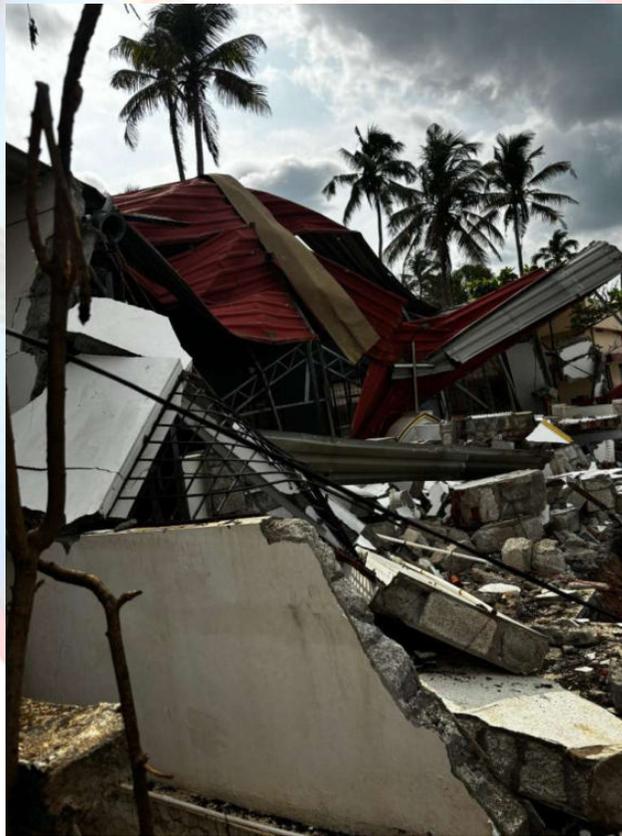
St Gorge Chappel @ CP 327, Vedikkunnu fully collapsed due to wave attack

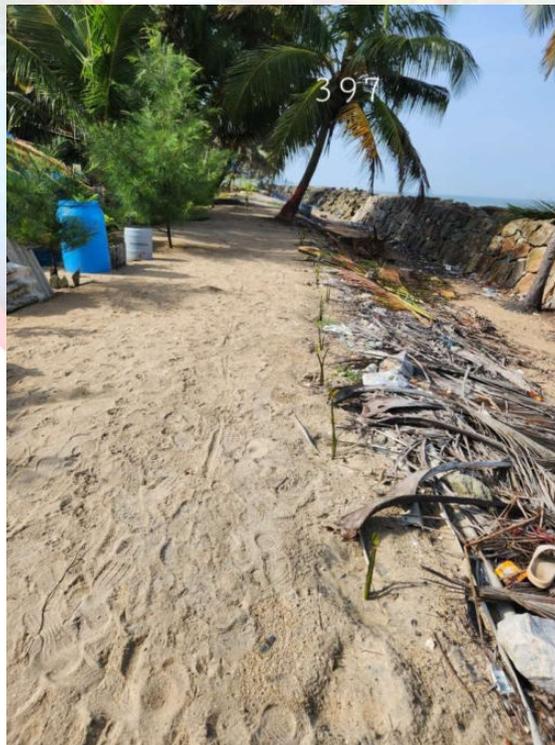
Mangroves planted @ CP 397 by the local bodies

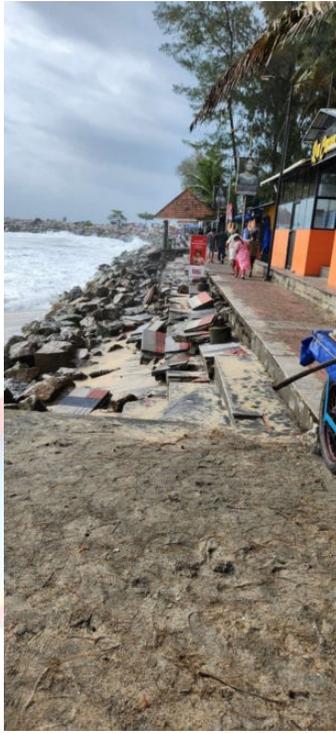
Sea attack at Azheekkal Beach CP 499

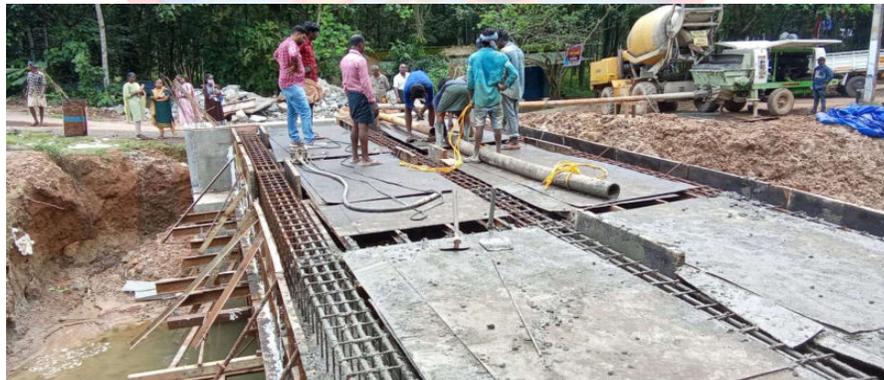
Concreting the long and short beam of the bridge with RCC 1:1.5:3 near Ch 5000m of RBMC

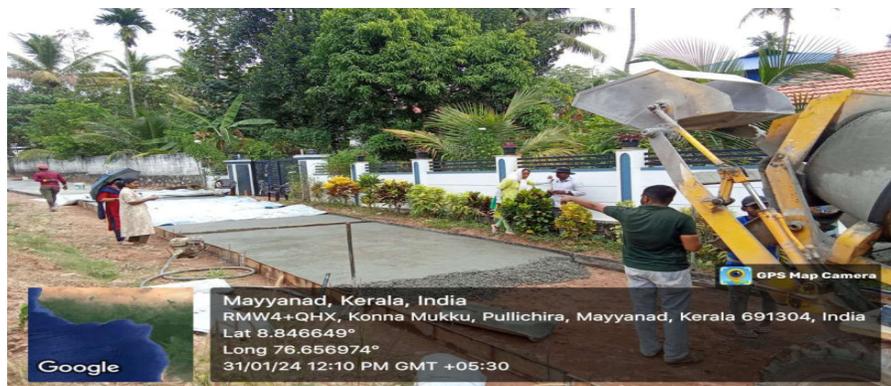
Canal bund road concreting with CC 1:2:4 using 20mm metal near Ch.5200m

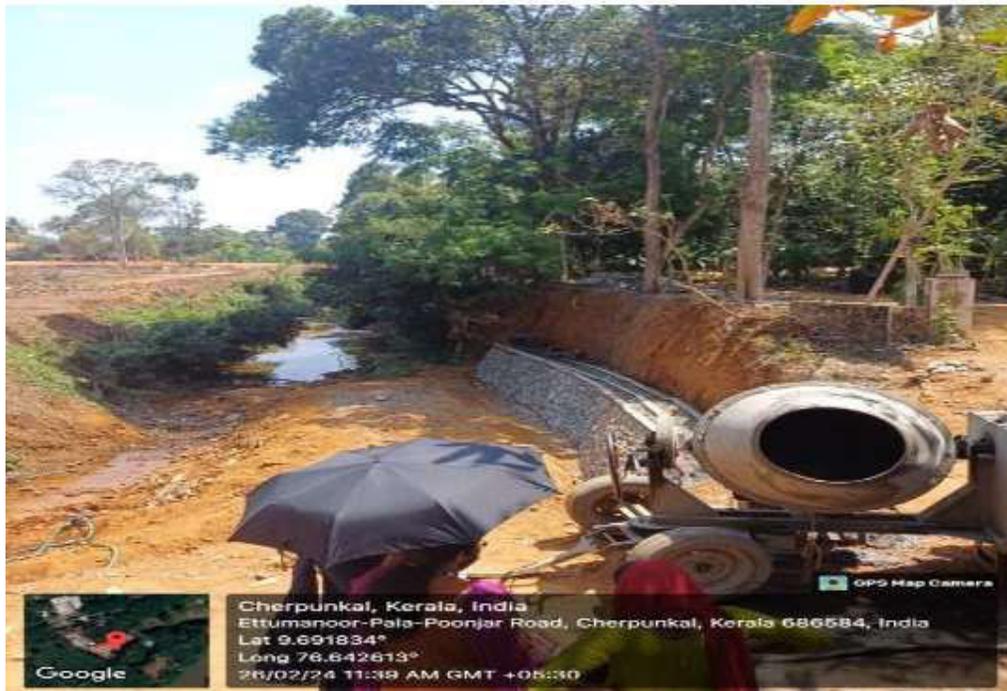
Renovation of AnthiMahakalanKavu temple pond in ward no.6 of Neendoorpanchayath

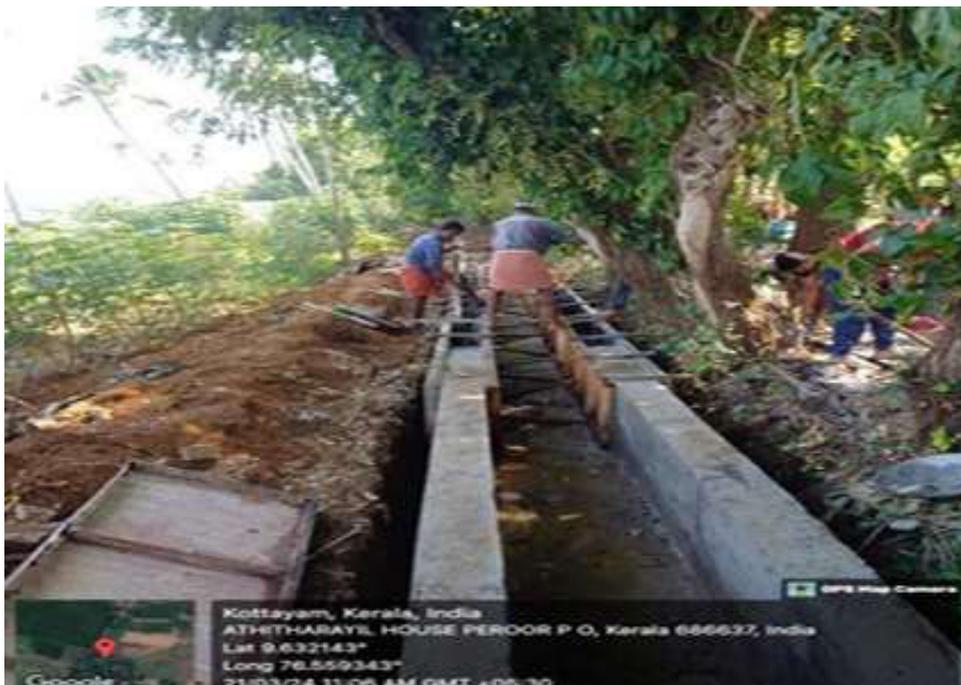
Protecting the right bank of Chakinithodu- near Samaritin Resource centre ,Cherpunkal in KidangoorPanchayath
