# KERALA ENGINEERING RESEARCH INSTITUTE

## ANNUAL REPORT 2022-23

***Kerala Engineering Research  
Institute, Peechi***

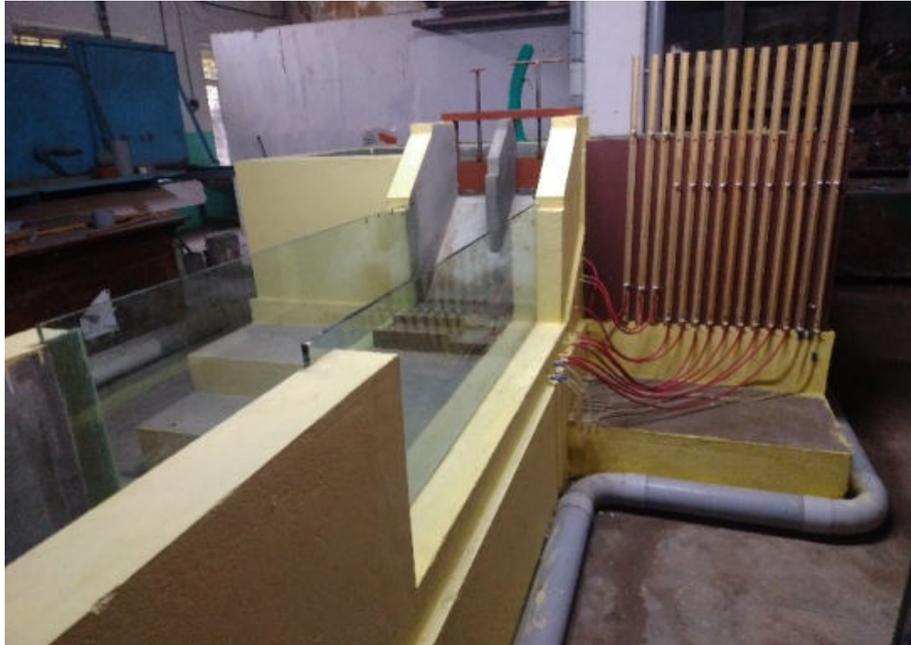
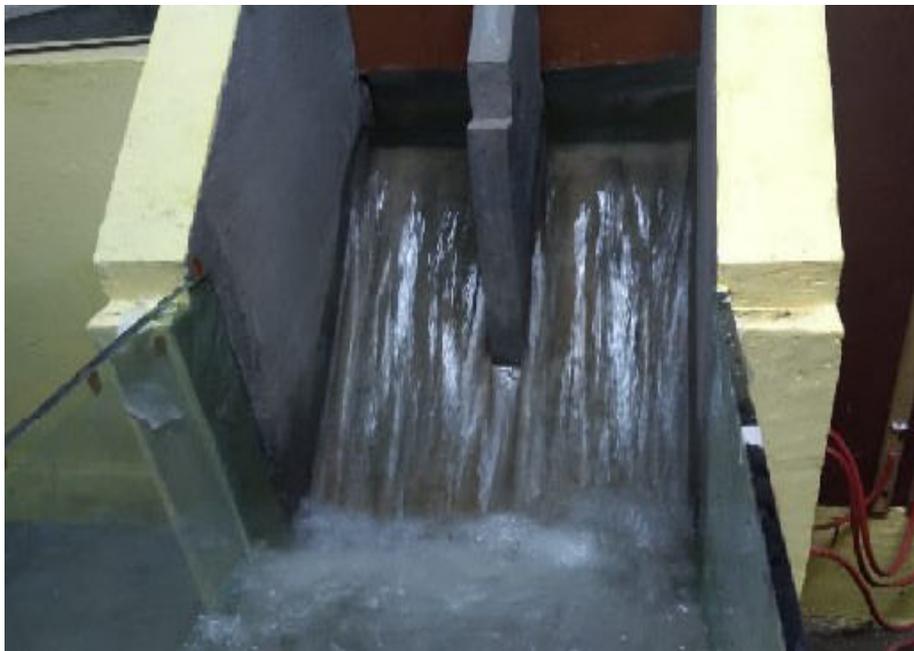
The model of the prototype spillway of the Kuttiyadi dam was constructed to a scale of 1: 60 in the Hydraulics laboratory of Hydraulics Division, KERI. Out of four bays, an undistorted model of two bays was constructed at two different downstream bed levels (having downstream bed level at +15.0 m and +16.5 m) as in prototype. Among the two bays, the centre bay is at +15.00 m and end bay is +16.50 m as in Fig. 1, following the Froude's model law, for scaling the parameters in order to achieve dynamic similarity between the model and prototype. An Ogee type of spillway model with stilling basin and energy dissipater corresponding to the prototype was constructed according to the scaled dimensions in model following the scale ratio. The spillway was also provided with shutters so as to control the flow of water from the reservoir to the downstream. The reservoir with head maintaining facility, facility for discharge measurement, pressure head measurement, flow profile plotting along the spillway flow path also exist in the model. The discharge measurement was done using a calibrated V - notch. The model set up along with elevation of the spillway is shown in Fig. 1, with the piezometer tapings (Sp1 to Sp15) provided to measure the pressure head when the flow occurs over the spillway. The design discharge adopted for the model building of spillway as supplied by IDRB is 1584 m<sup>3</sup>/s. Based on the details supplied by the Irrigation Design and Research Board (IDRB) on the modified design of the spillway, the physical model of the prototype spillway was simulated in the hydraulics laboratory of KERI considering Froude's similitude, and the performance of the model was analysed. The details pertaining to the spillway model building, model observations, analysis are discussed.

The flow simulation through the Ogee spillway was carried out for different discharges between the minimum to the maximum corresponding to the maximum water level in the prototype. Several trials were done and flow characteristics were observed. The details of the pressure head values were recorded in the piezometer tapings. The actual discharge corresponding to different head water over the spillway crest was measured using the calibrated V notch. For the spillway having effective length 'Le' and the head over the crest 'H', the discharge co-efficient 'C' in the discharge equation for the spillway  $Q = C Le H^{3/2}$  were estimated for different discharges. Based on the theoretical and the actual discharge values corresponding to different water levels, the co-efficient of discharge of the spillway is estimated. The initial depth of flow and the sequent depth for the hydraulic jump were

By simulating site conditions, a physical observation of the jump in the stilling basin was done to see the flow pattern and energy dissipation.

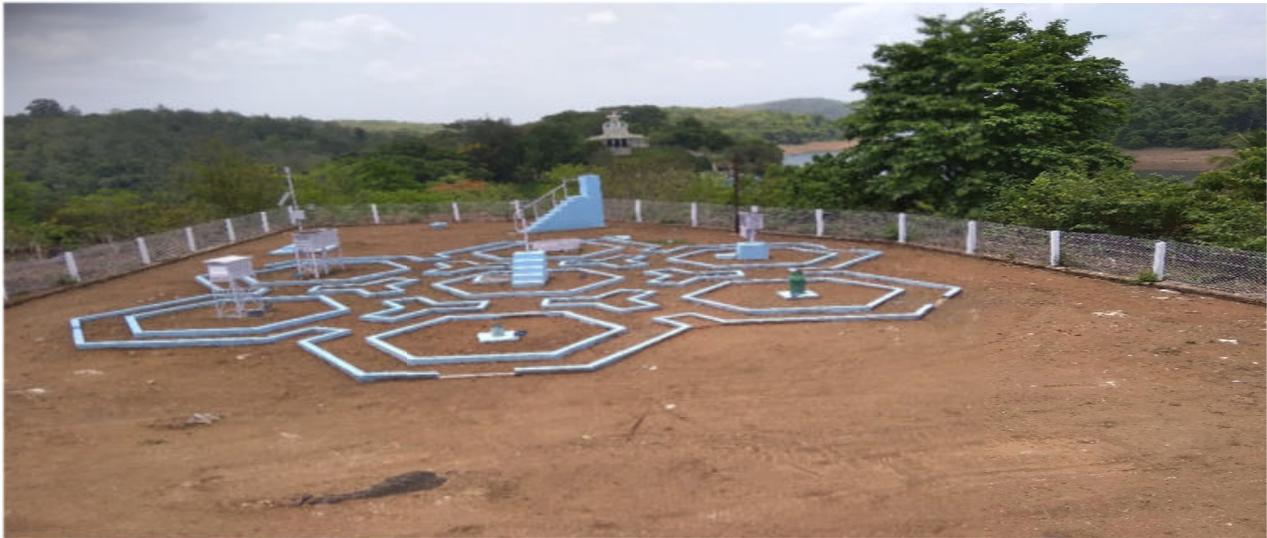
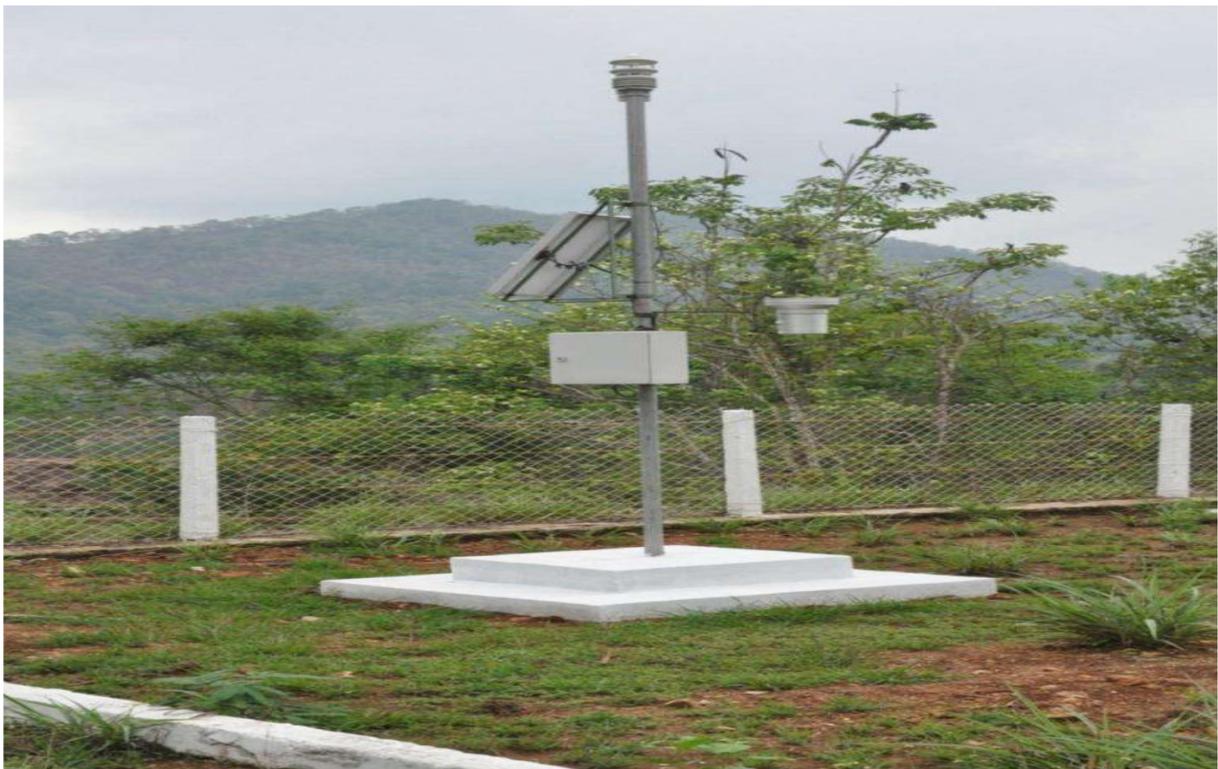
As part of modernization, an automatic weather station was installed in June 2014. Time series observations are vital to improve the understanding of weather dynamics and its variability. The automatic weather station (AWS) plays an important role in providing short term and long-term time series weather observations. Automatic weather station is functioning with a solar panel for uninterrupted power supply.

The Automatic Weather station collects data related to air temperature, air humidity, barometric pressure, ultrasonic wind speed, ultrasonic wind direction, global radiation and precipitation using different sensors. These data can be accessed using a software HYDRAS.

1. Ultrasonic Wind speed and Direction sensor & Compass
2. Global Radiation Sensor
3. Temperature, Humidity, Barometric Pressure Sensors
4. Rain Gauge
5. Data Logger

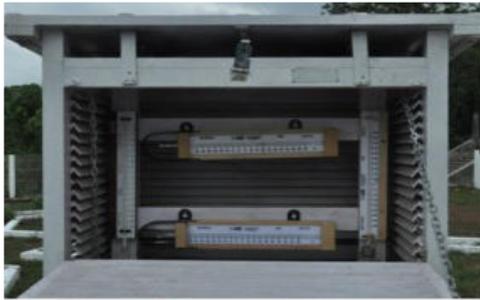
**PSYCHROMETER**

- Temperature – Max & Min Thermometers & Bimetallic Thermograph
- Relative Humidity – Psychrometer (Dry & Wet bulb) & Hair Hygrometer
- Rainfall – Standard Rain Gauge, Self Recording Rain gauge
- Evaporation – Land Pan Evaporimeter
- Wind Direction – Wind Vane
- Wind Speed – Cup Anemometer
- Bright Sunshine – Sunshine Recorder

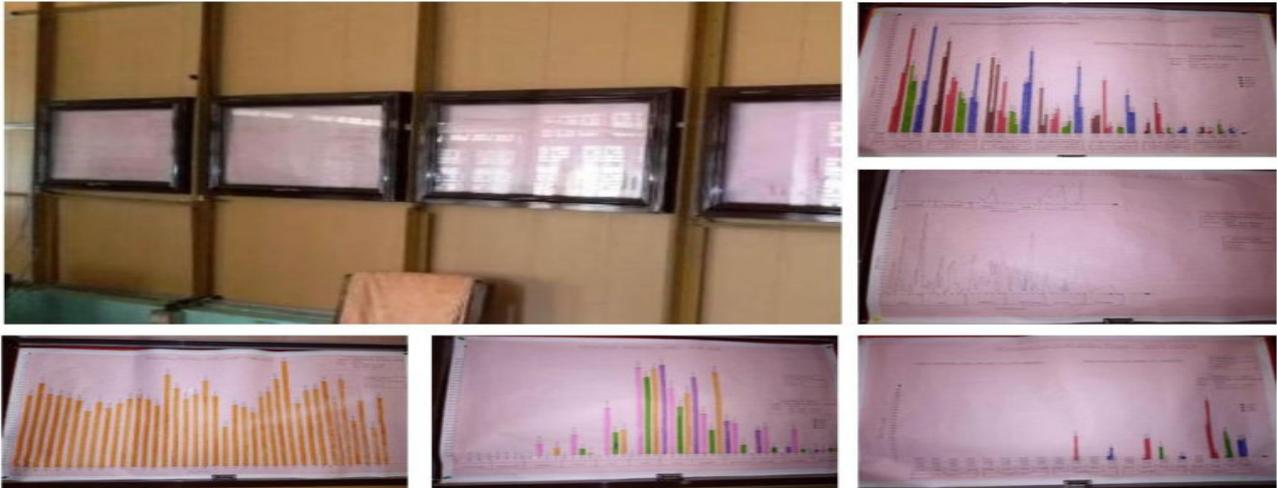
**Graph for temperature, annual rainfall, 10 days chart for rainfall, monthly chart for rainfall etc.**

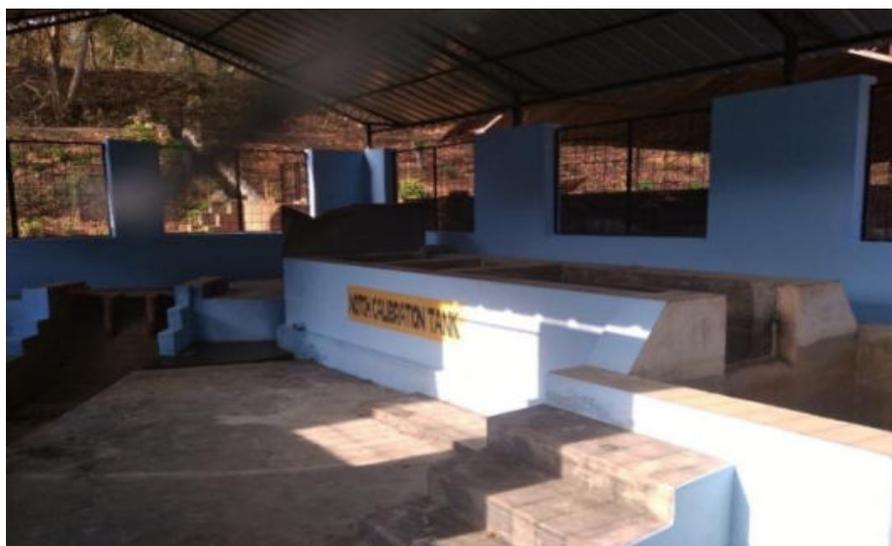
**Notch Calibration Facility**

Notches are used for measurement of discharge through open channels by placing or constructing them across the stream or channel. The discharge over notch is measured by measuring the head acting over the notch. The actual discharge and theoretical discharge will be equated using a suitable coefficient of discharge and a factor for the head of flow. The process of assessing these constants is called calibration. Once the equation relating discharge and head of flow over the notch is established by calibration experiment, the discharge at any point in a channel can be estimated by fixing the notch across the channel and measuring the head of flow.

The notch calibration tank situated at outdoor Model Area I is generally used for the calibration of notches received from various irrigation projects of Kerala. In this year we have not received any new notches for calibration.

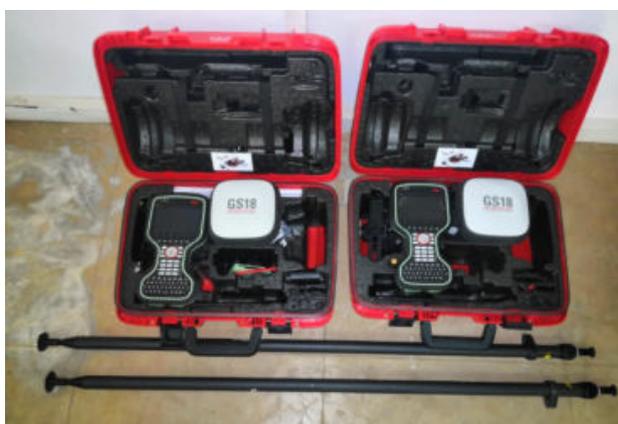
Leica GS 18T is GNSS RTK rover and is a part of the Leica Geosystems self-learning GNSS series with advanced signal tracking technologies. With more constellation and L band, GS18T will have more satellites in canopy area. GS18T is fitted with Inertial Measurement Unit (IMU) based tilt sensor, so that no magnetic field can affect the positioning. This can work close to bigger concrete structures with larger reinforcement, Electrical installations etc. Due to the tilt compensating function, it is not required to hold the survey pole in vertical position, that is there is no need to level the bubble for measuring and staking of points. In this the sensor accurately and reliably measures the pole tilt and together with RTK or Smart Link, provides an accurate tilt compensated position. There is savings up to 20 per cent over conventional surveying practices due to the fact that no time is wasted by levelling the bubble. The IMU-based tilt-compensating RTK is applicable at large tilt angles of more than 30 degrees, where a 3D positioning accuracy of 2 cm is still achievable.

Leica GS 18T is integrated with a new Cinterion cellular modem that supports LTE (4G) as well as all existing networks. In Leica GS 18T a self-learning GNSS sensor is being used, hence the best satellite signals and the best available correction data is chosen automatically thus achieving best possible position accuracy and quality. By incorporating sensor heading into 3D visualization of the surroundings, the user can easily orientate himself in the surveying environment, which improves productivity and user experience. The measurement engine in GS 18T is ME7 (measurement engine generation 7). This gives an ultimate performance in GNSS positioning.

Leica GS18 T GNSS RTK rover with CS20 Field  
controller

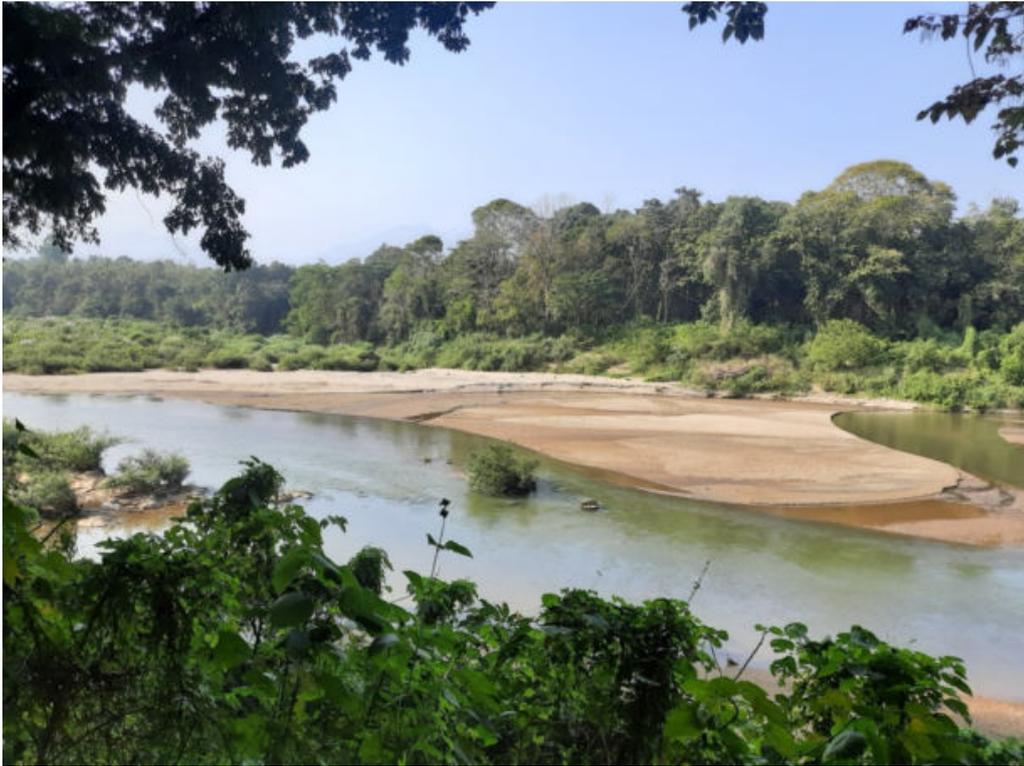
**Sediment deposition in Chaliyar river**

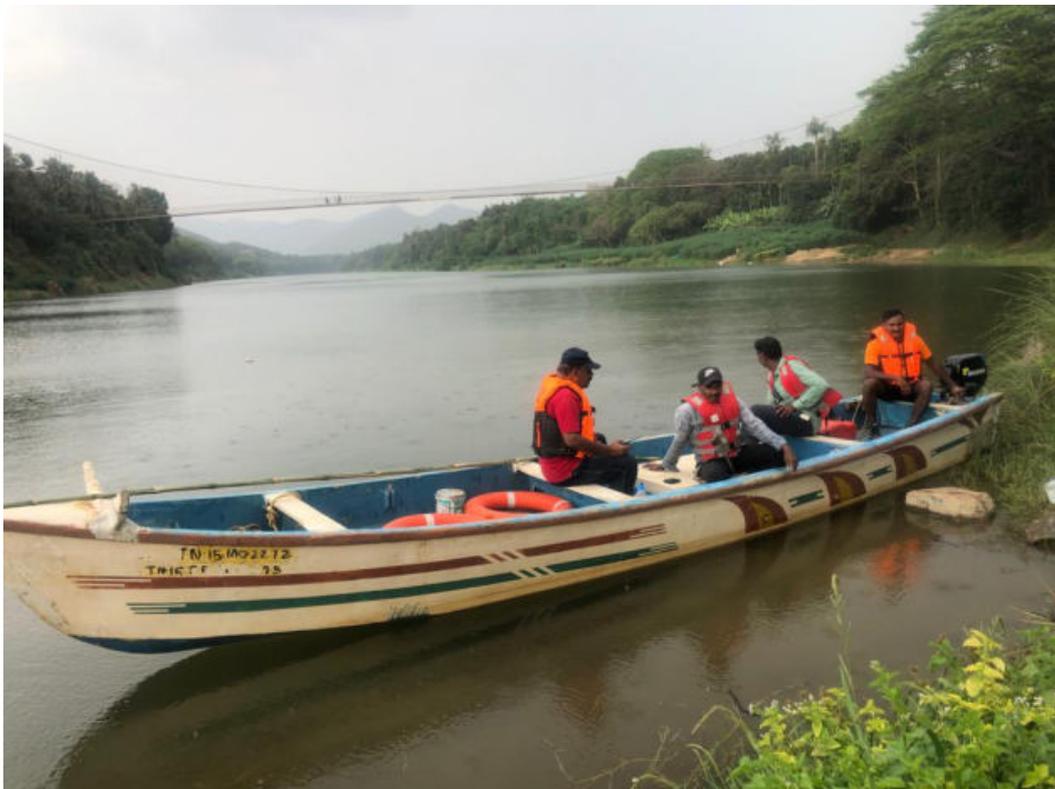
**Topographic surveying of river cross-sections**

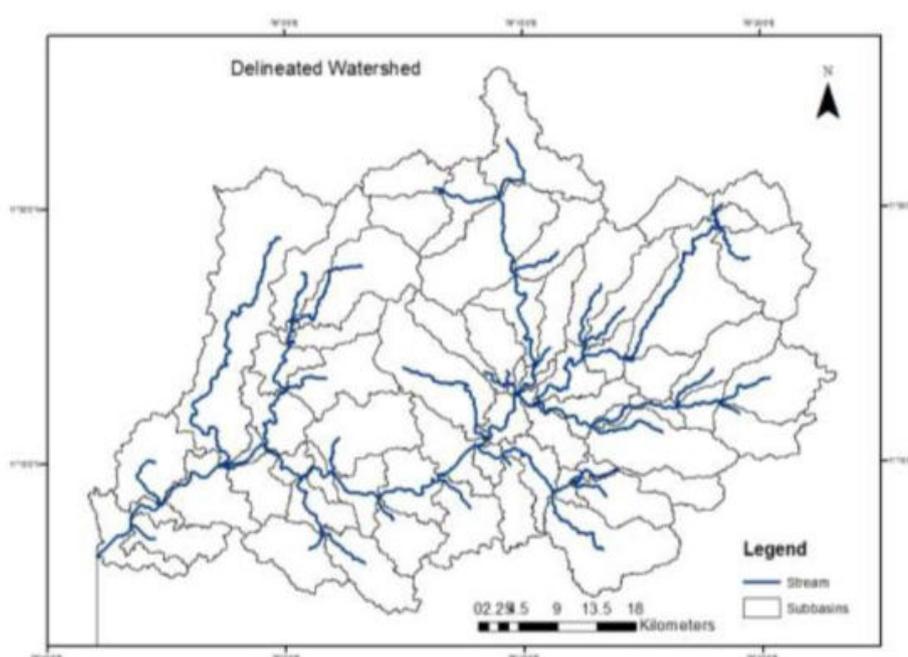
The river basin was delineated from SRTM DEM using the HEC-GeoHMS toolbar and watershed area was found to be 2953 Km<sup>2</sup>.

## Watershed delineated in HecGeo-HMS tool

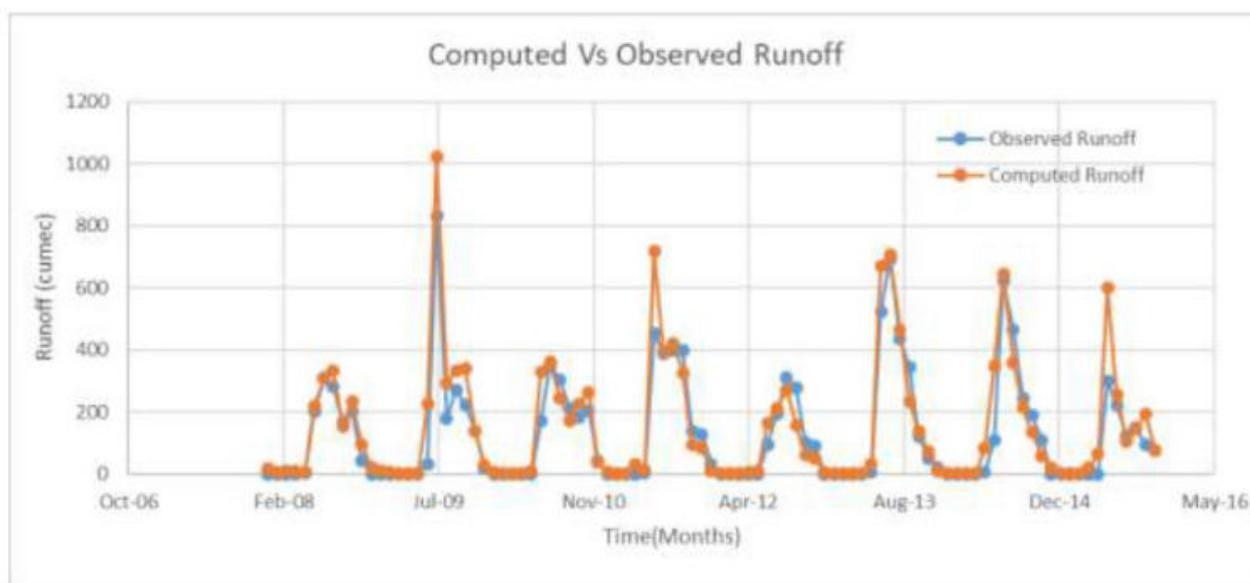
subbasins were determined using HEC-HMS software. The discharge values obtained at Kuniyil station from simulations were compared with the corresponding values measured from the field for the above-mentioned period. The parameters of sub-models were varied manually as well as using optimization algorithm based on Simplex method until good matching is obtained between observed and simulated flows. The matching between observed and simulated flows was assessed using the conditions such as NSE and PBIAS. After the calibration process, good matching between observed and simulated discharges at Kuniyil station was obtained and the corresponding NSE was 0.83.

#### **Comparison of observed and simulated discharge at Kuniyil station during calibration period**

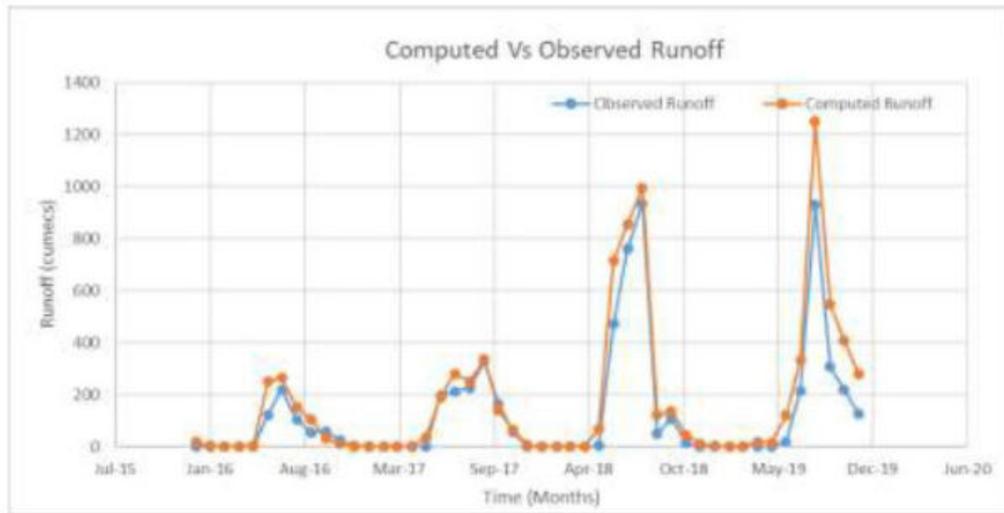
After the calibration, the performance of the model was validated by comparing the observed and simulated flows in the Kuniyil station from the year 2016 to 2019. Reasonably close agreement was obtained between the observed and simulated flows although some isolated over predictions of discharge can be seen during high flow season. The NSE obtained during the validation process is 0.85.

### Comparison of observed and simulated discharge at Kuniyil station during validation period

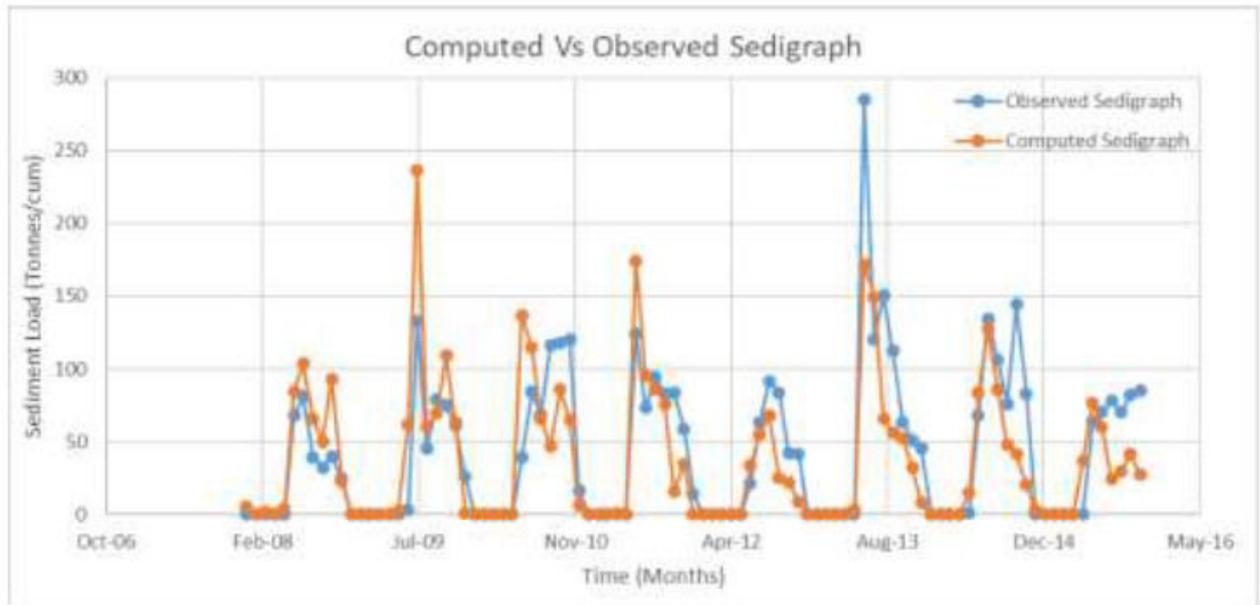
After successfully developing the rainfall-runoff model, it is necessary to accurately simulate the erosion behaviour of the catchment area during various rainfall events. This was accomplished using Modified USLE method available in HEC-HMS. The parameters required for this process such as topographic factor, cover factor, erodability factor, practice factor and enrichment ratio were determined based on catchment and soil characteristics and varied during the calibration phase until good matching between the observed and simulated sediment load (sedigraph) was obtained. The daily sediment loads were converted to monthly values during the calibration process. The observed and simulated sediment loads at Kuniyil station were compared during the calibration period by successively varying the above mentioned parameters. Finally, a reasonably good matching is obtained between observed and simulated sediment loads at Kuniyil station with a NSE of 0.45.

### Observed and simulated sediment load at Kuniyil station during calibration period

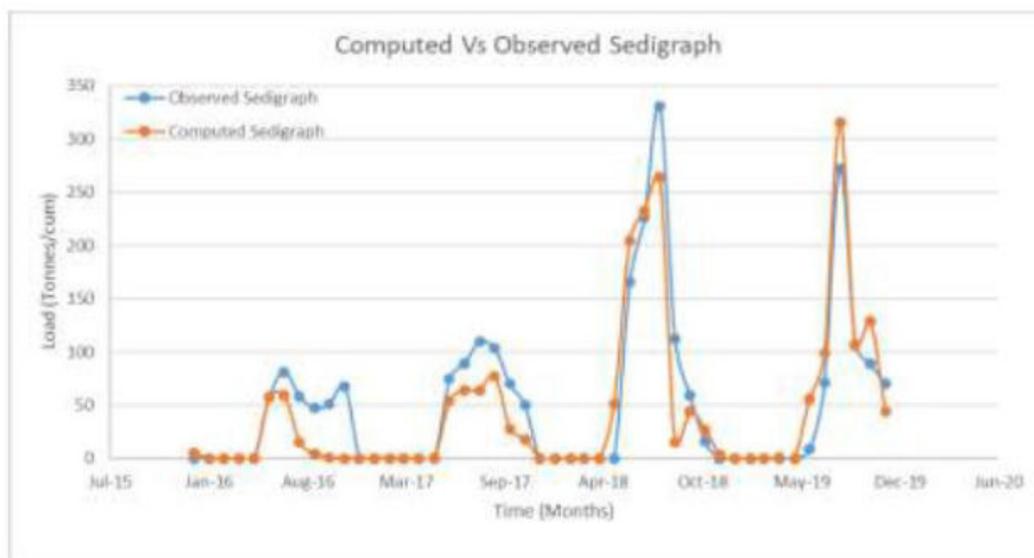
Satisfactory matching between observed and simulated sediment loads at Kuniyil station was obtained during the validation period (2016-2019). The value of NSE obtained during the validation period was 0.74.

### Observed and simulated sediment load at Kuniyil station during validation period

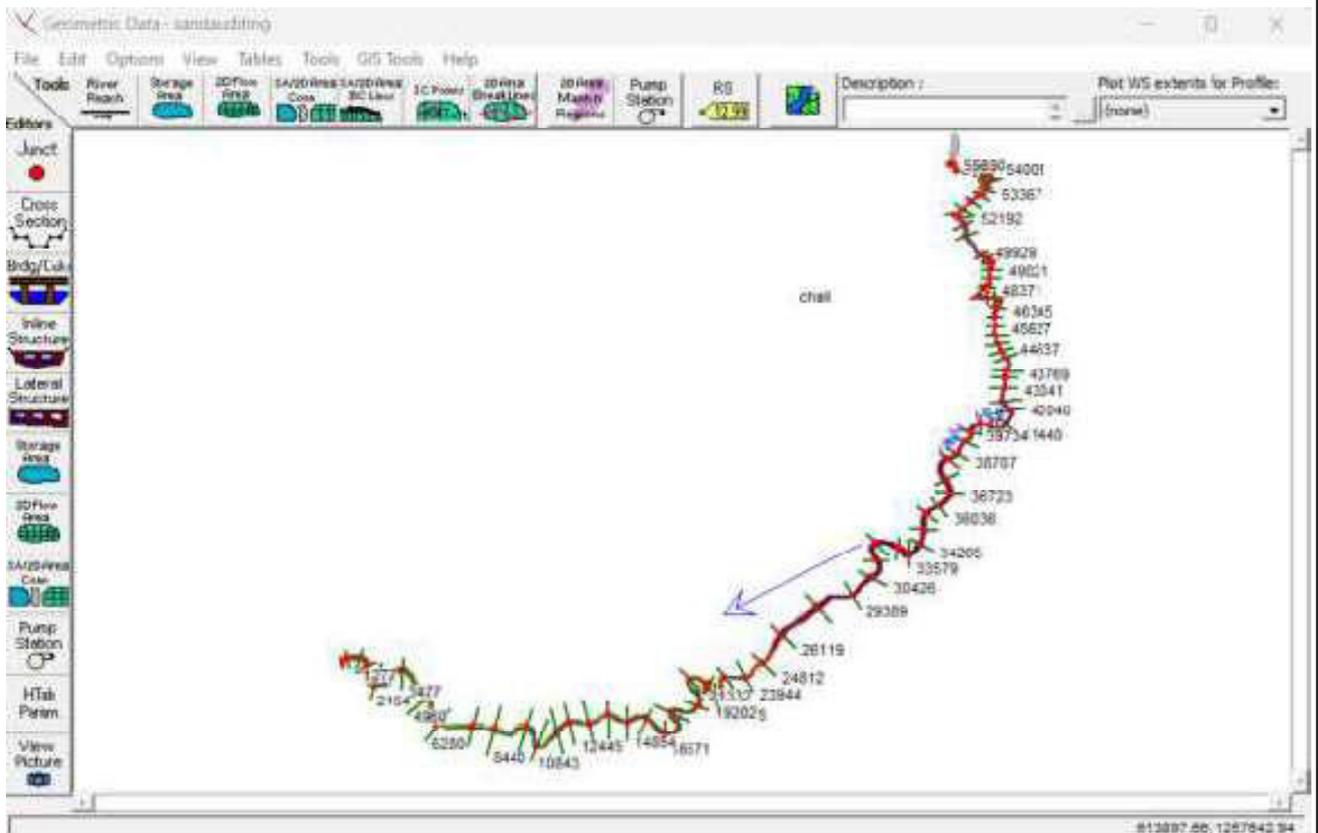
HEC-RAS software as river geometry. The bank extents of cross-sections were corrected using DEM. Unsteady flow analysis was carried out in HEC-RAS software. After defining the geometry of river channel, next step is to provide boundary conditions for the geometry thus formulated. The upstream boundary condition is the flow hydrograph at upstream of Ambittanpotty bridge and downstream boundary condition is the rating curve at Kuniyil station which was obtained from the stage-discharge curve at the respective station. The lateral inflows at the junctions where tributaries join with main river were provided as flow hydrographs at the respective locations in the main river.

HEC-RAS model setup

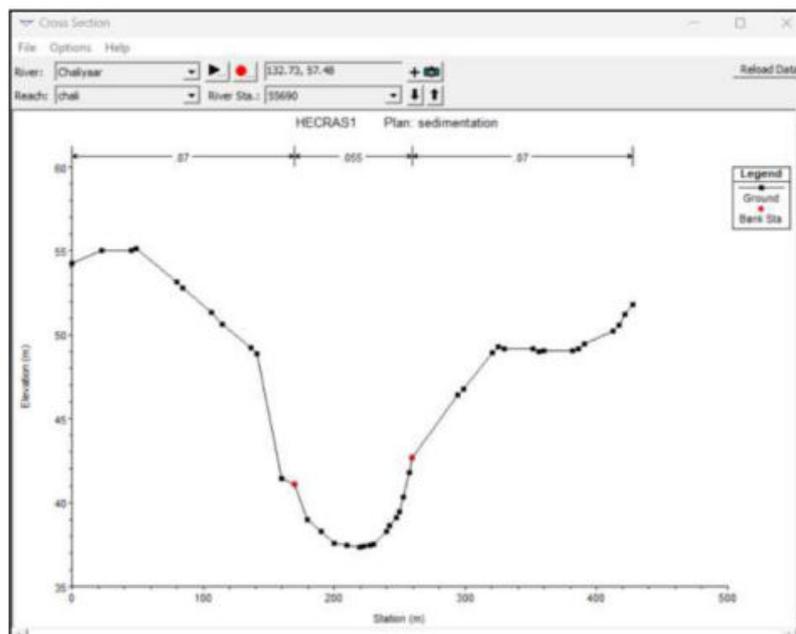
**Cross-section of river at chainage 55690m**

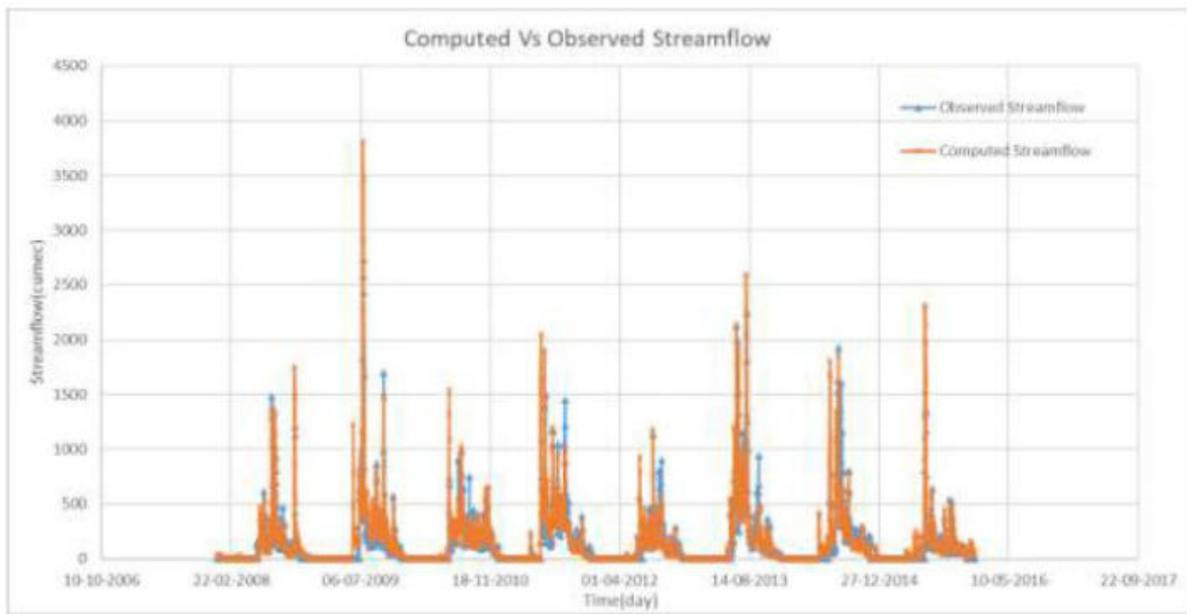
The unsteady HEC-RAS model was calibrated during the period from 2008-2015 by comparing the discharge values at the Kuniyil river gauging station. The Manning’s constant (N) was varied until good matching is obtained between the observed and simulated values of discharge at Kuniyil gauging station. The simulated stream flows at Kuniyil gauging station was compared with observed stream flows and satisfactory matching is obtained between both of these values. Slight under estimation of peak and quantity of stream flow was obtained

during the calibration period. In general, satisfactory matching was obtained between observed and simulated stream flows with a NSE of 0.52.

**Observed and simulated stream flows at Kuniyil gauging station during calibration period**

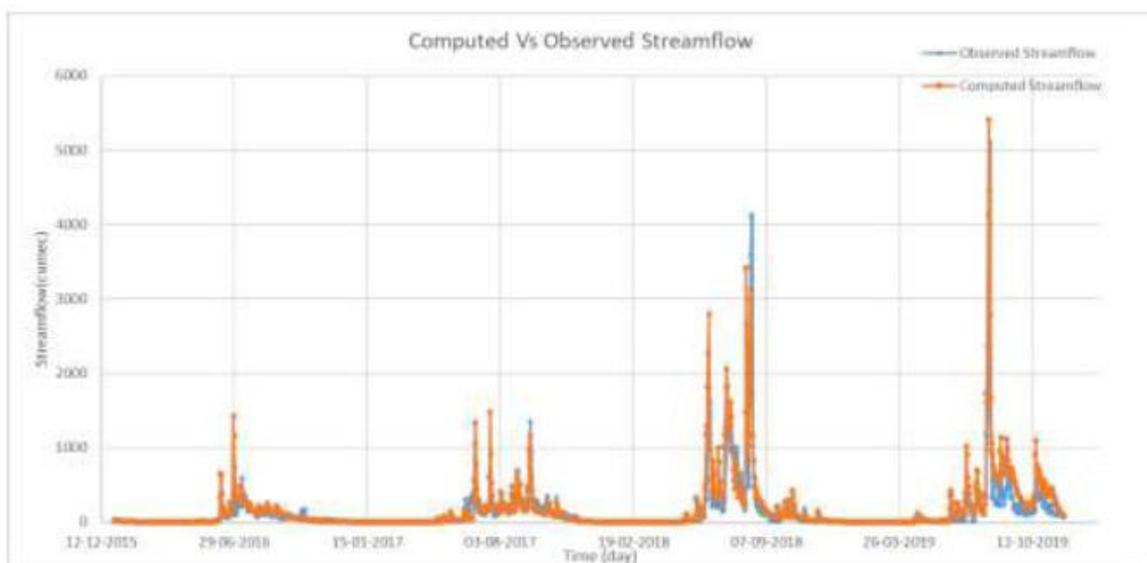
The hydraulic model is validated during the period from 2016-2019 by keeping the same value of Manning’s coefficient as that obtained from calibration process. Satisfactory matching between observed and simulated stream flows was obtained at Kuniyil gauging station with a NSE of 0.57. Slight under estimations of peak flows and discharge volumes were experienced during the validation phase also.

**Observed and simulated stream flows at Kuniyil gauging station during validation period**

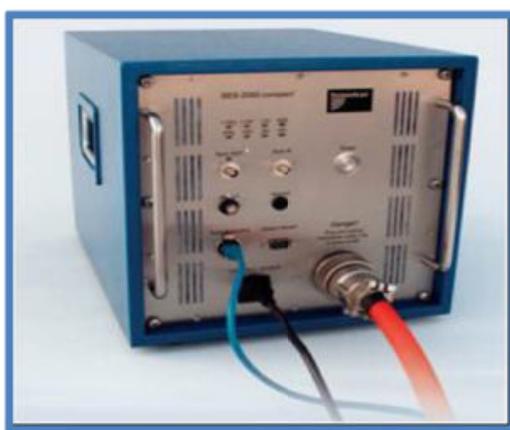
**Top- side Unit**

The system SES-2000 sub-bottom profiler, which is a mobile parametric sediment sounder, was used for bathymetric and sub-bottom profiling survey. The SES- 2000 hardware component and transducers are shown in Figures below. High frequency signal (HF -100 kHz) and the secondary low frequency signal (LF -6 to 12kHz) are used. The spatial distribution of sediment in each cross section can be analyzed.

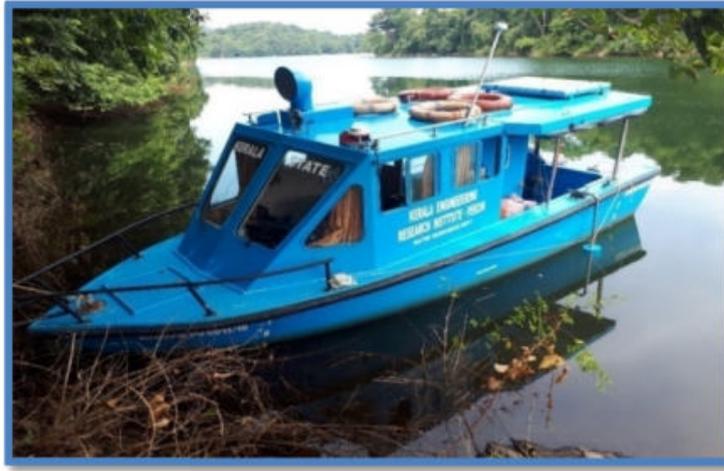
**FRP Boat**

Fiber reinforced Plastic (FRP) boathaving two 60 HP petrol out board engines, dimension of 7.5m X 2.66m X 1.20m and 8persons capacity with the equipment is used for the survey.For the power supply, two solar panels of 80Watt each are mounted on the roof of the boat.

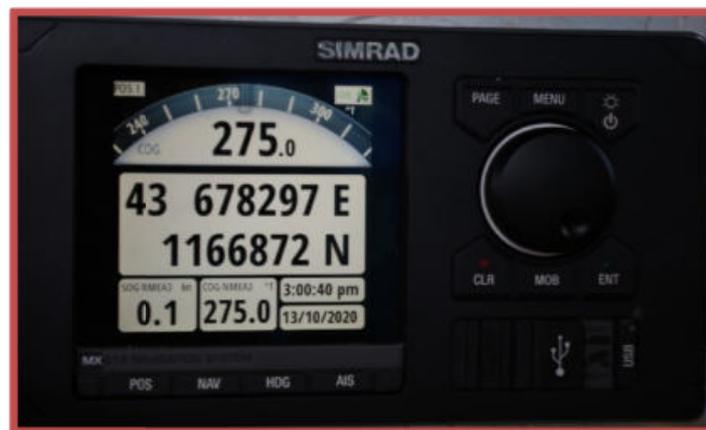
**MX610 Navigation System**

DGPS SIMRAD MX- 610 is highly reliable and it receives correction from a permanent reference station, which is approved by Govt. of India, Dept. of Light house and Light ship. It can also track up to 12 satellites to achieve maximum positional accuracy. The received position is transferred to Echo Sounder and Sub Bottom Profiler data collection laptop.

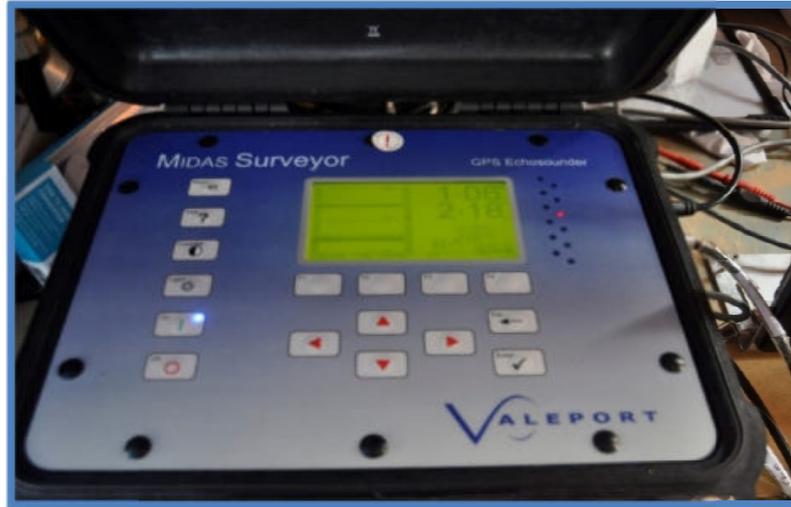
The MIDAS Surveyor is a revolution of small boat survey work with an integral GPS receiver. It logs and displays DGPS position data in WGS 84 or Local Grid. This Echo-sounder is designed to measure under water depth up to 1200m. Accuracy of instrument is 1centimeter. The dual frequency echo-sounder is specified to distinguish between fluff top depth and the consolidated bottom. The high frequency (200 KHz) is used to detect the top of the mud/sediment. Under favorable conditions the low frequency signal (33 KHz) can penetrate into the bottom and reveal information about the bottom structure.

**MIDAS Surveyor Echo Sounder**

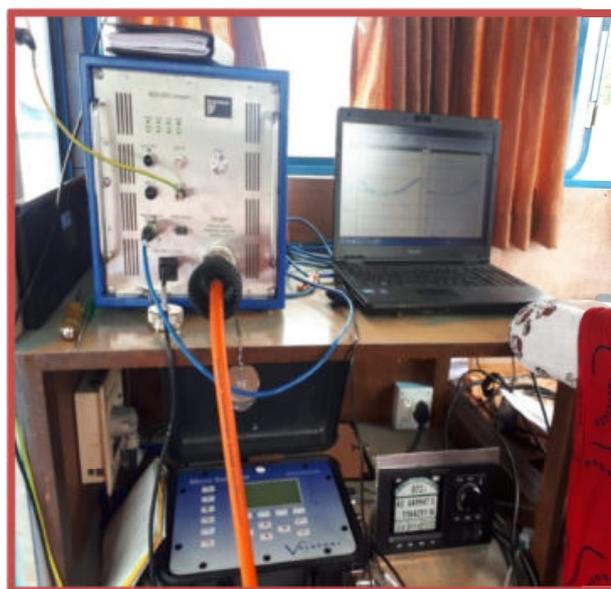
**Equipment Set up inside the Boat**

Mobile station set up for data collection is shown below.

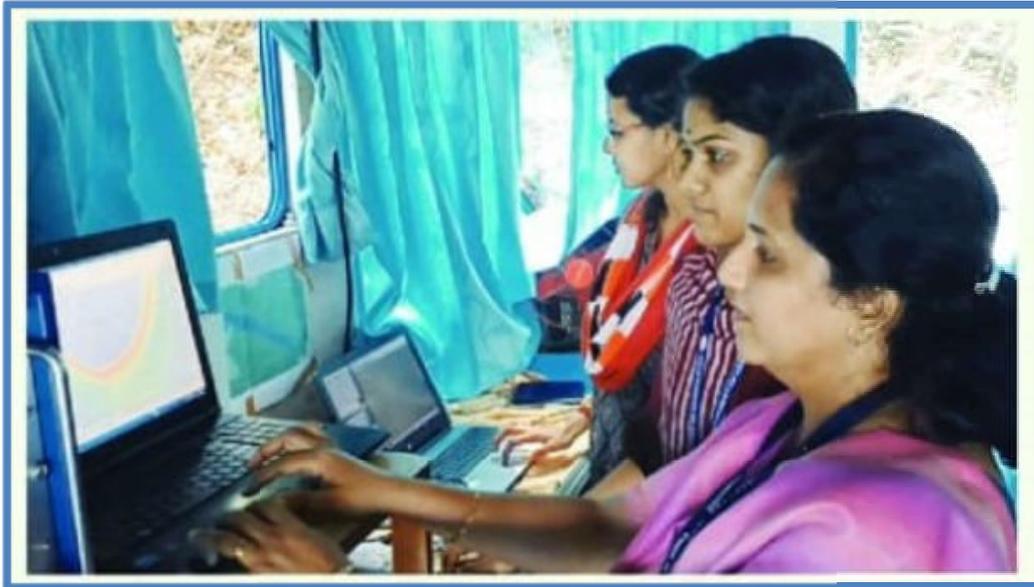
The mobile station consists of the DGPS and its antenna, Echo sounder, Sub Bottom Profiler and the transducers etc which are mounted on the FRP boat. The transducer of Sub Bottom Profiler is permanently fixed at the center of the boat. The transducer of Echo sounder is connected to the left side of the boat and is detachable. Proper connections are made between these equipment and the laptops for the data collection. By using the **Planning and presentation** menu in **Qinsysoftware**, chart is prepared by taking UTM co-ordinate at two known points. With these co-ordinates of two points reference lines are drawn. Segment lines are drawn parallel to this reference line at a particular interval such that the entire reservoir area can be covered. The boat is sailed along the planned track with a speed of 3 to 4 knots. The data from the Echo sounder and Sub Bottom Profiler is collected simultaneously through two laptops. For IBS Survey, the laptop loaded with QINSY survey software is used. For Sub Bottom Profiler, the data is collected using laptop installed with Seswin software. There are three modules in the QINSY Software. Data Acquisition, Data Processing and Data export/import.

### Data Collection set up inside the Boat

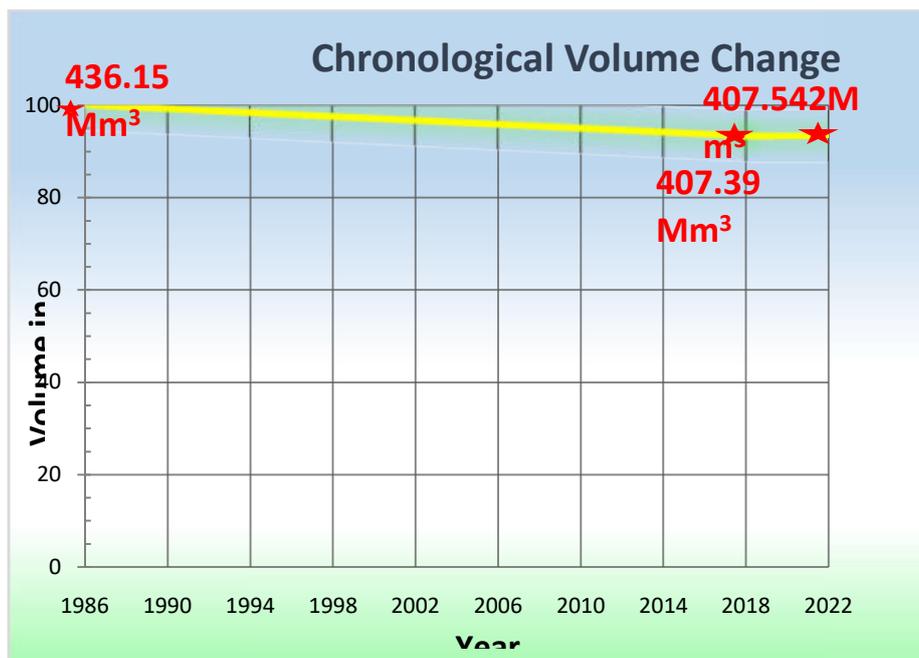
The graphical representation of chronological volume change is shown in Figure below.

Chronological Volume Change

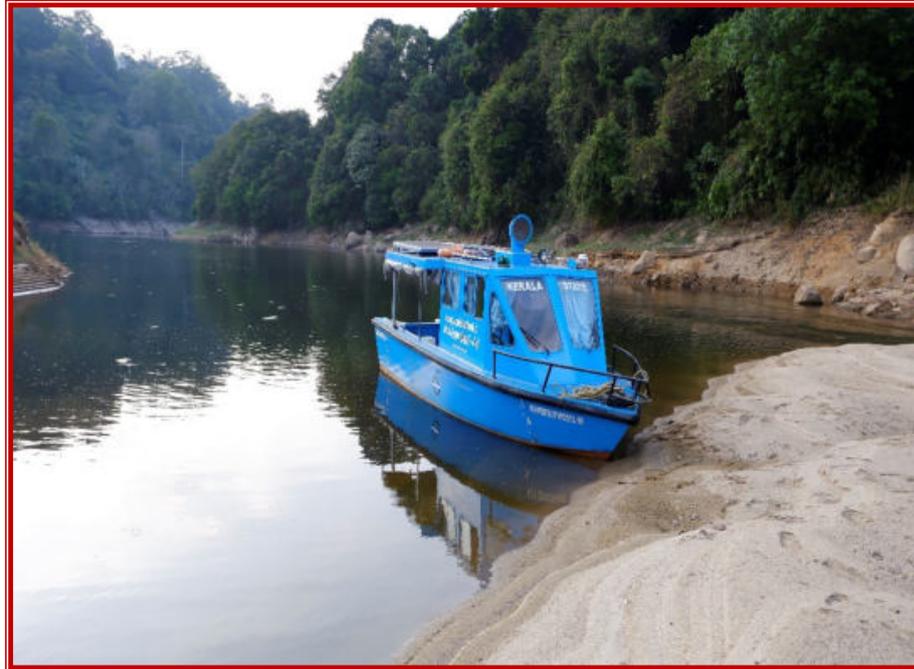
**Huge sand deposit at Umayar River mouth**

Scouring action of the heavy waves generated by the wind and effect of heavy flood occurred in 2018 and 2019 caused erosion in top level of reservoir. This is the reason for increase in water spread area and thus the capacity at the water level 112.85m with respect to the previous study. Water spread area shows an increase up to a level of 89.0m in the present study compared with previous study results. But the capacity shows a slight increase at the topmost level only, due to the increase in water spread area. At the bottom layers even though the water spread area shows a slight increase, the capacity decreases due to the deposition of the scoured material from the top layers. At the bottom level of 71.0m onwards the capacity loss is 100% ie; entire area below this level is filled with scoured materials from top layers and sediment load carried by the stream. From the salient features of the reservoir, it is known that the dead storage level is 70.25m. ie the reservoir area above the dead storage level also almost completely filled with sediments. The gross reduction in capacity at water level 112.85m is only 6.56%. Actual reservoir capacity of  $407.542\text{Mm}^3$  at this level is reduced by  $28.608\text{Mm}^3$  in 36 years. From this reduced capacity around 69.91% ( $20\text{Mm}^3$ ) capacity loss is caused by the deposition at bottom area below the water level of 71.0 m.

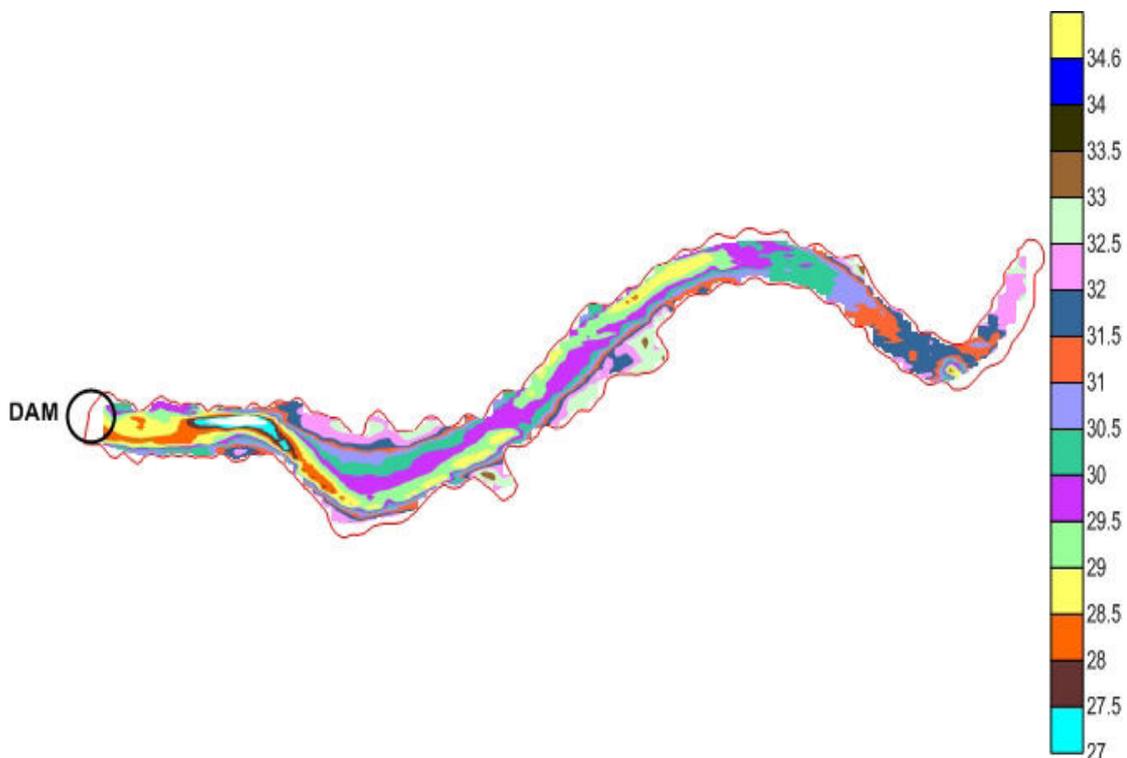
The survey is carried out at the water level of 34.6 m. As per the current IBS study the volume at this water level is estimated as 0.982 Mm<sup>3</sup> and the corresponding water spread area is 0.201 Sq.km. Reservoir volume at different water levels can be found out from the IBS data collected through QINSY software by using Surfer software. Table shows reservoir capacity at different water levels and Figure shows contour map based on IBS survey.

Contour Map based on IBS Survey

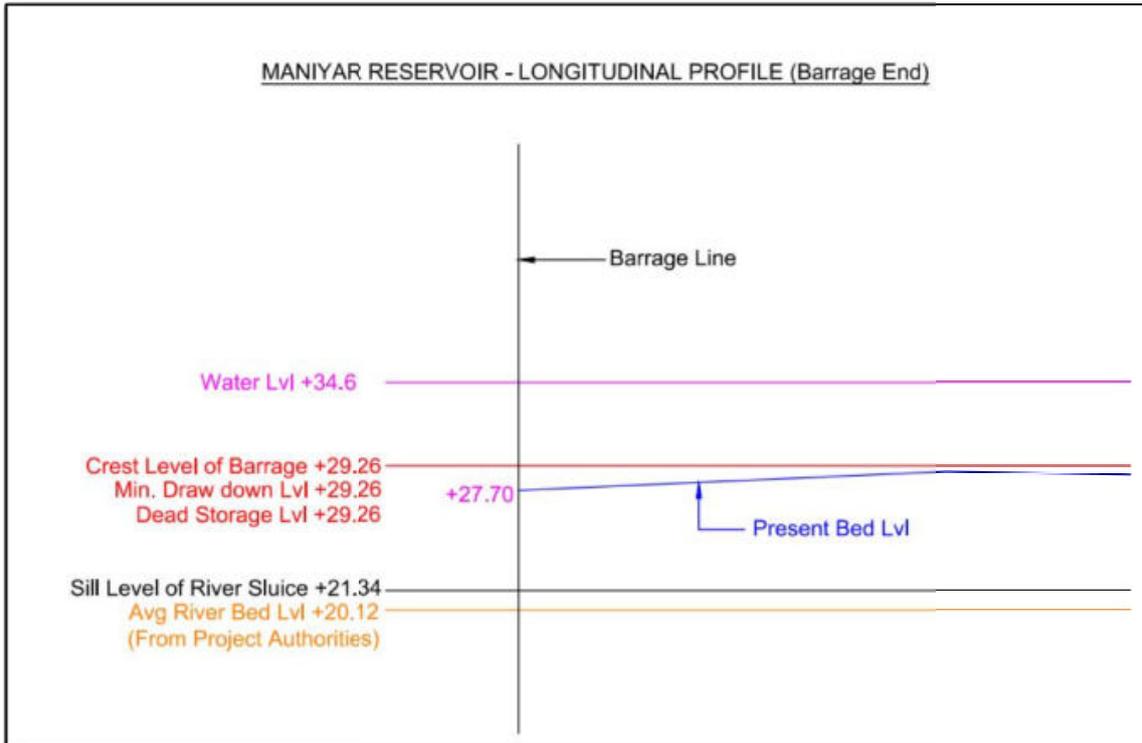
Figures shows the various levels such as crest level, river sluice level, the present bed level etc. at the face of barrage and at the end point of survey near Karikkayam Hydroelectric project respectively. The project authorities requested that the sediment should be removed up to the level below the river sluice near the barrage. Hence the quantity of sediments to be removed from the reservoir bed was calculated by keeping the proposed bed level near the barrage structure as +21.00m (Just below river sluice level) and near Karikkayam Hydroelectric Project (Survey end point) as present existing bed level (+32.59 m).

**Various levels at the face of barrage (Starting point of Survey)**
