# KERALA ENGINEERING RESEARCH INSTITUTE

## ANNUAL REPORT 2022-23

***Kerala Engineering Research  
Institute, Peechi***

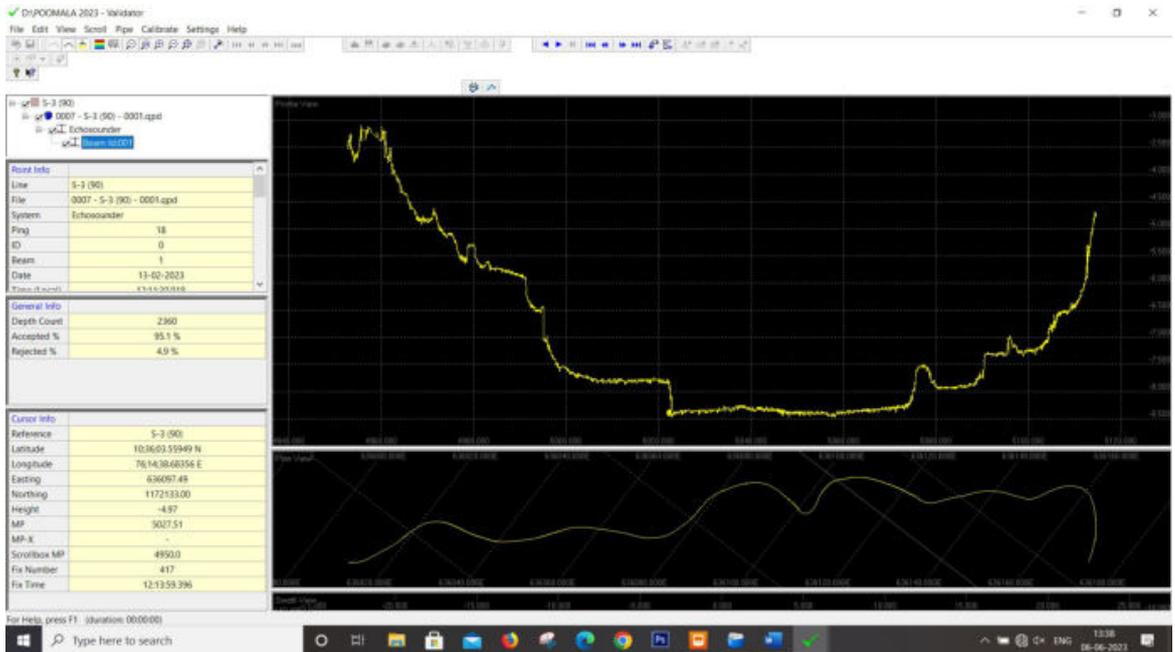
Fig Poomala\_ A Profile in IBS

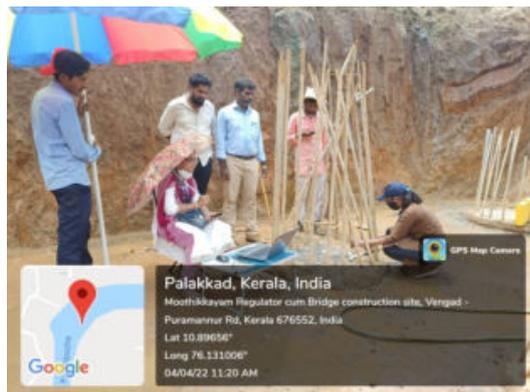
1) The Project Engineer-9, Kerala Irrigation Infrastructure Development Corporation Ltd, Thiruvananthapuram vide letter no PE9/MKM/KIIDC dated 29.03.2022 has requested to conduct Pile Echo Test (PET) on the pile group pertaining to the work “KIIFB Project Construction of Regulator Cum Bridge across Thoothapuzha at Keezhmurikkadavu, Moothikkayam in Moorkkanad Panchayath”. Accordingly, the test was performed on 04.04.2022.

**8 no. of piles as per request of the Project Engineer-9, KIIDC Ltd, Thiruvananthapuram vide letter no PE9/MKM/KIIDC were tested.**

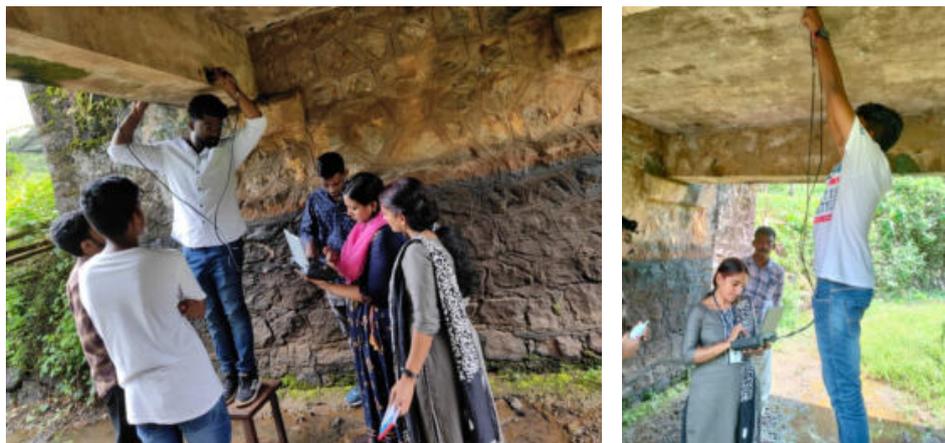
The Chief Engineer (IDRB), Thiruvananthapuram vide Lt. no. DM-AD5/2/2015/IDRB dated 29.08.2022 had instructed KERI to carry out studies to assess the condition of Poovanchira Canal Bridge in Pananchery GP constructed across right bank main canal of Peechi Irrigation Project between ch. 11/800km and 11/850km.

The tests were performed on the concrete beams and concrete deck slab of the bridge. The beams and slab are divided into three grids at downstream and upstream side. The test equipments can only be used where smooth concrete surfaces are available. The test readings are affected at every tested surface due to distresses like spalling, cracks and voids present in the concrete. The available readings are taken for evaluation. The quality of distressed parts is taken into account by visual observation.

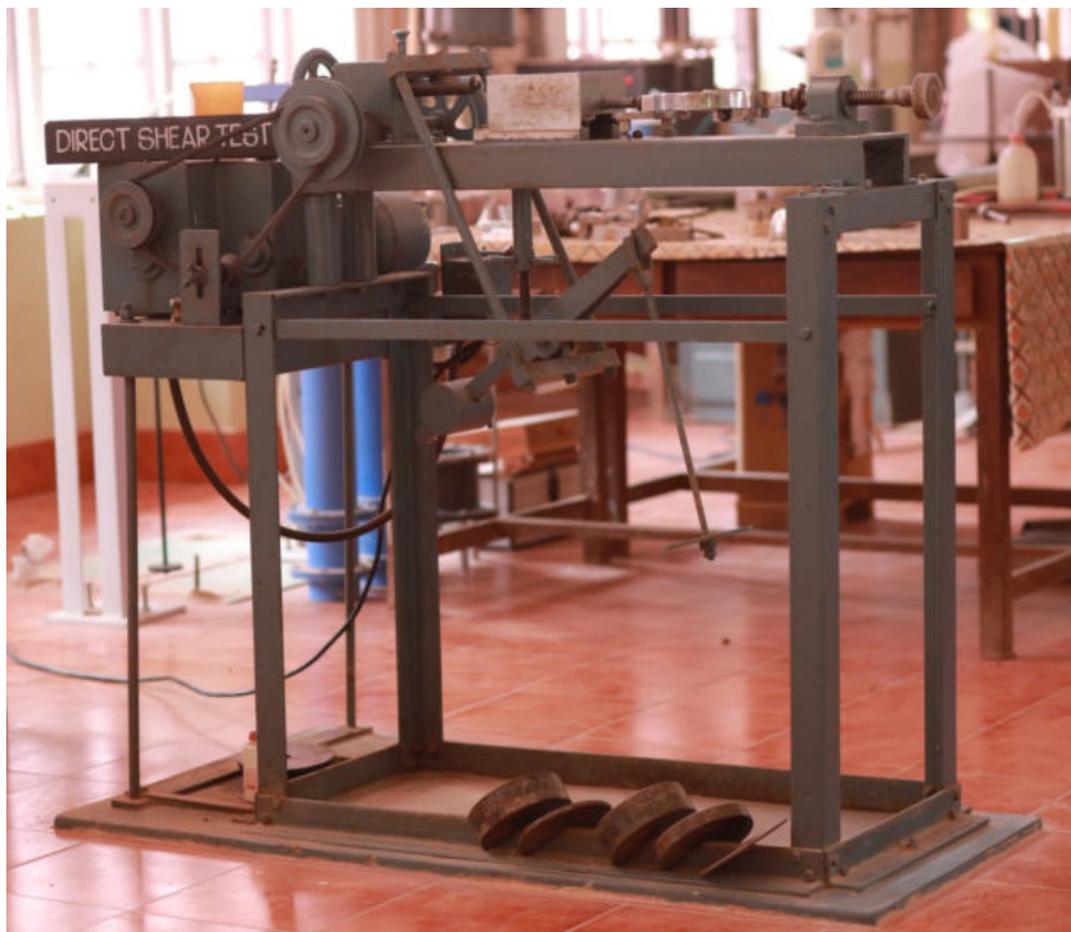
**Fig. Direct Shear Apparatus**

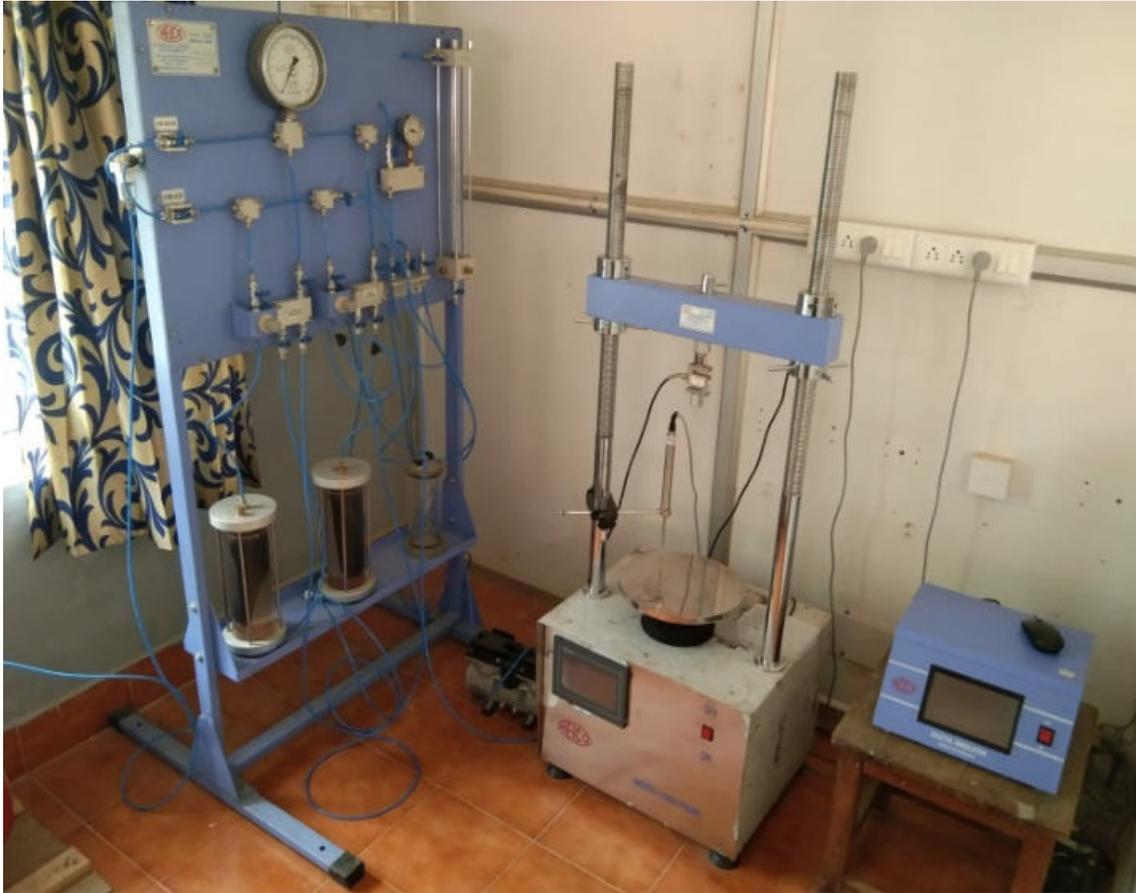
**Fig. Static Triaxial Testing Apparatus**

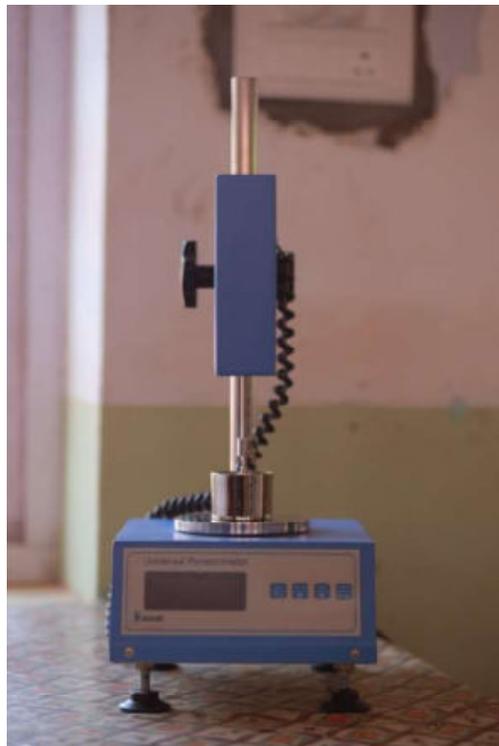
**Fig. Digital Soil Cone Penetrometer**

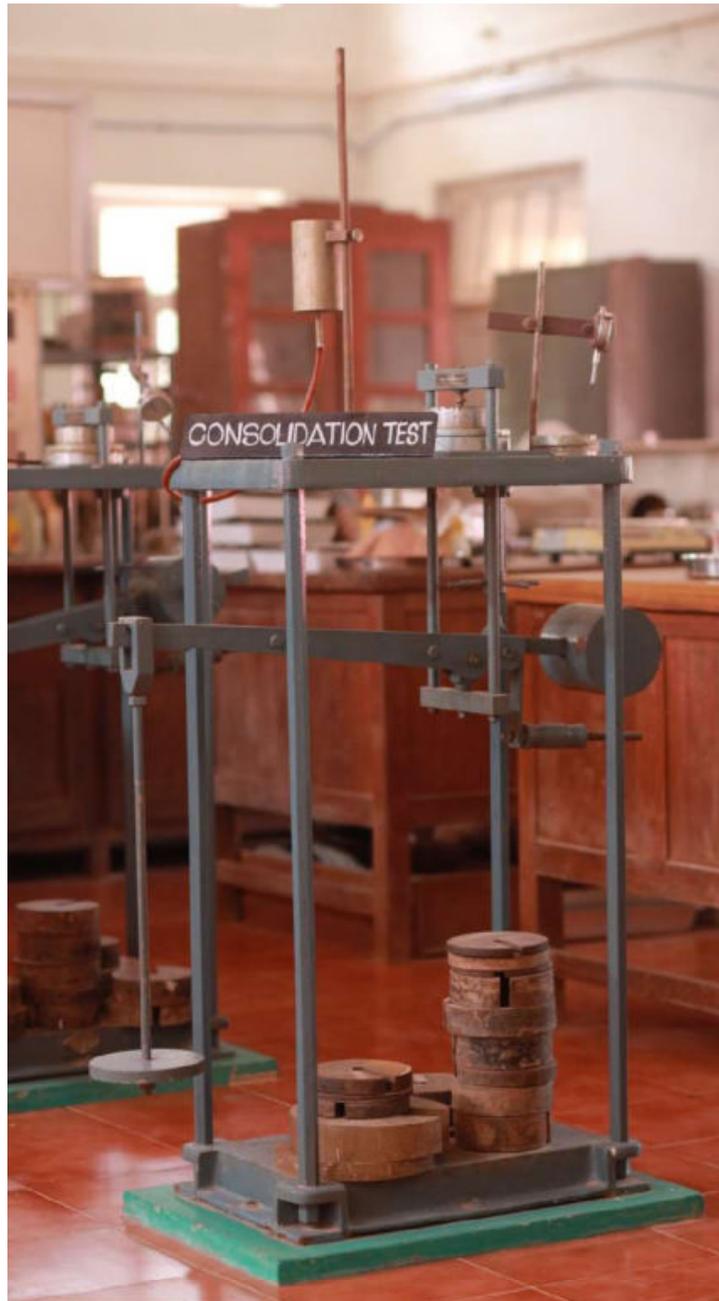
**Fig. Consolidation Test Apparatus**

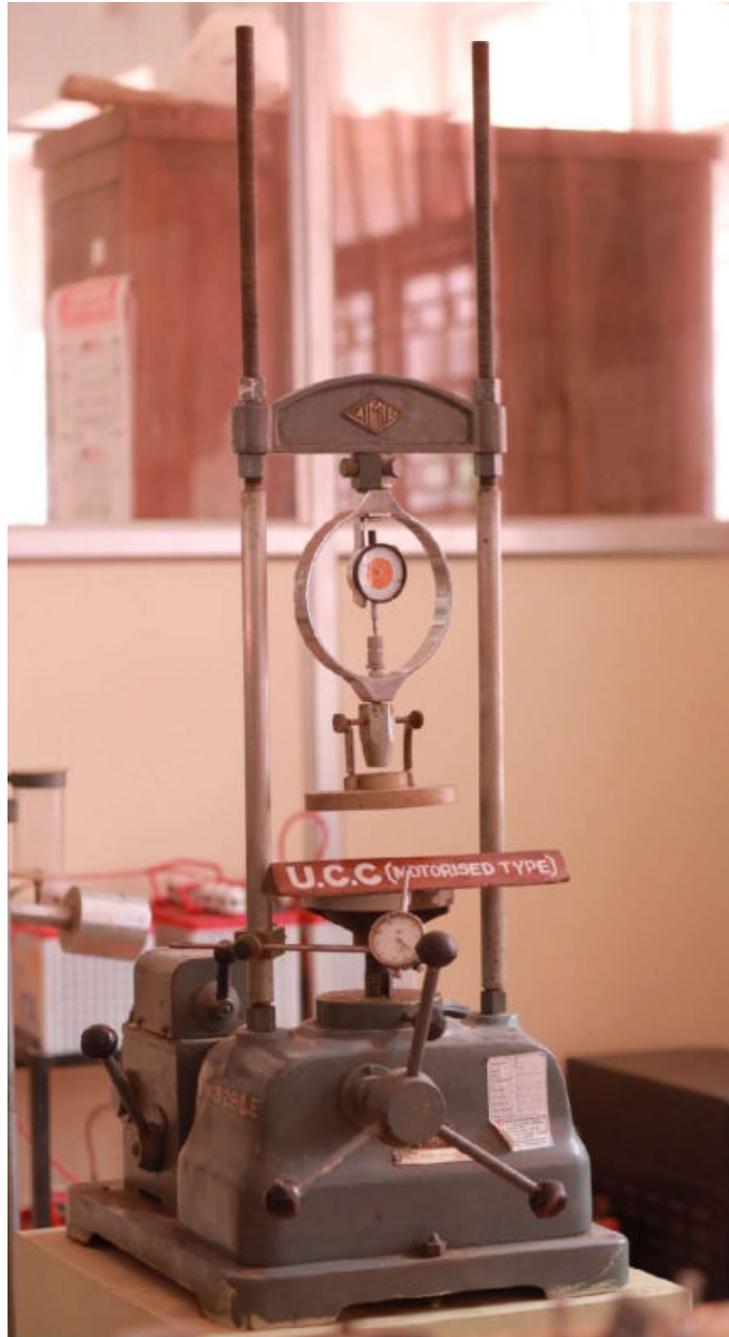
**Fig. Unconfined Compression Test Apparatus**

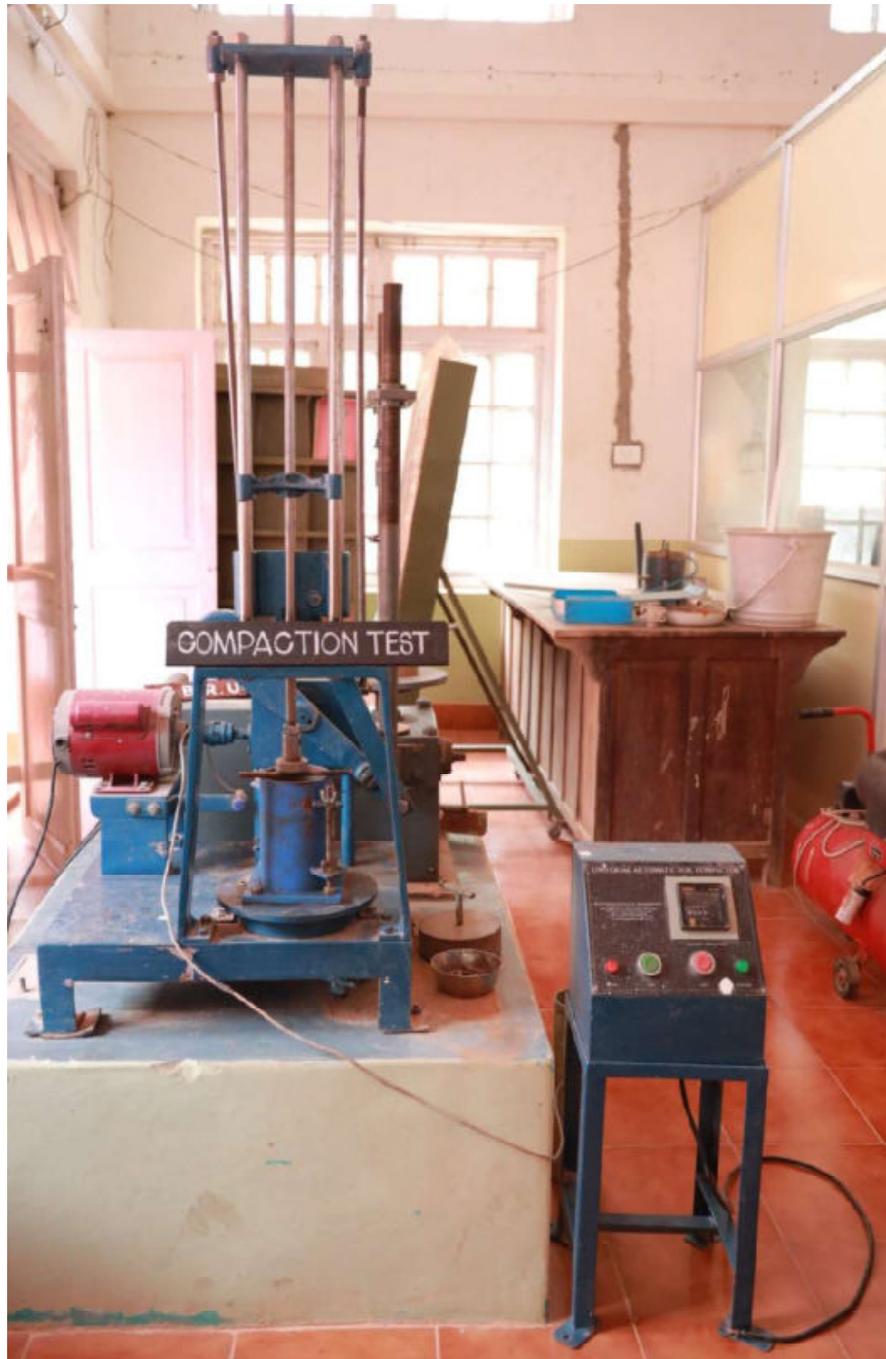
**Fig. Compaction Test Apparatus**

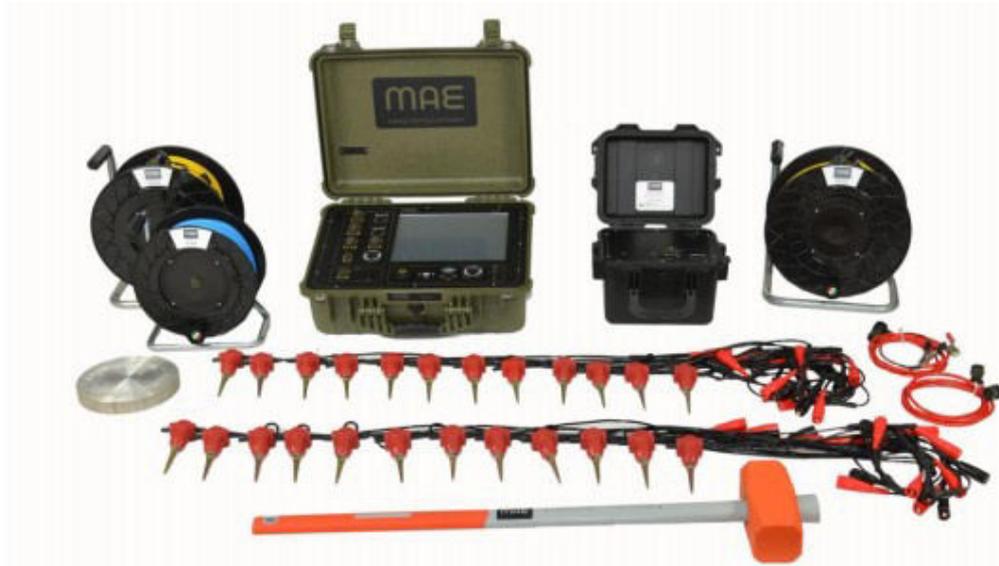
Modernizing the lab will come true with the addition of modern Instruments. This lab is equipped with Engineering Seismograph and is used for subsurface characterization by seismic refraction method.Seismograph is also used for Seismic Tomography Survey to determine compactness in dams.

**Fig. Apparatus used for Seismic Refraction Survey**

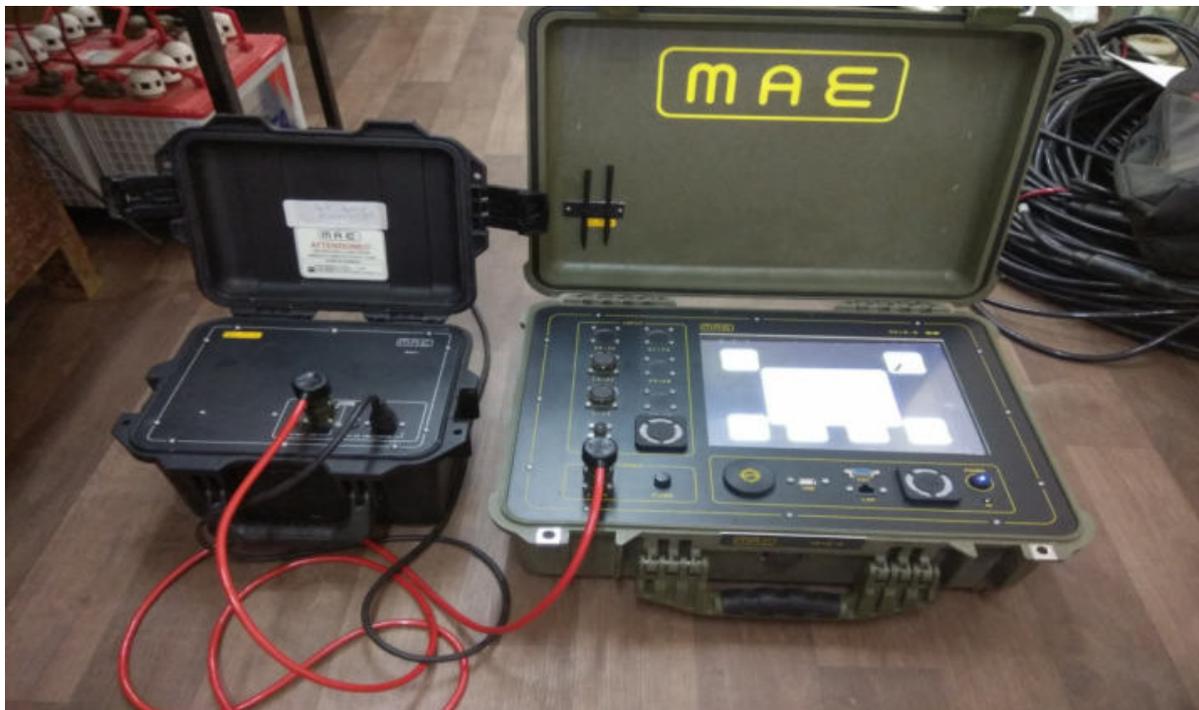
**Fig. Engineering seismograph**

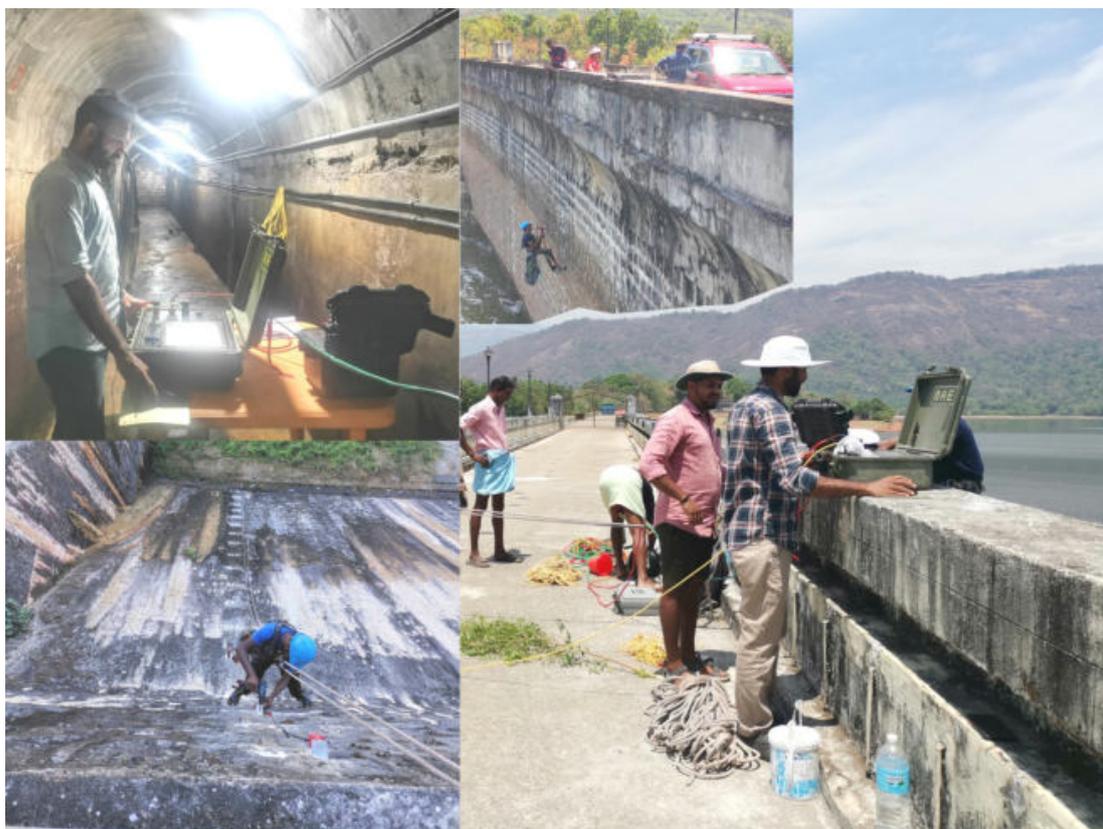
Seismic tomography survey was conducted at Kanjirapuzha Dam on a study basis during February to March 2023.

Fig. Seismic Tomography study at Kanjirapuzha Dam

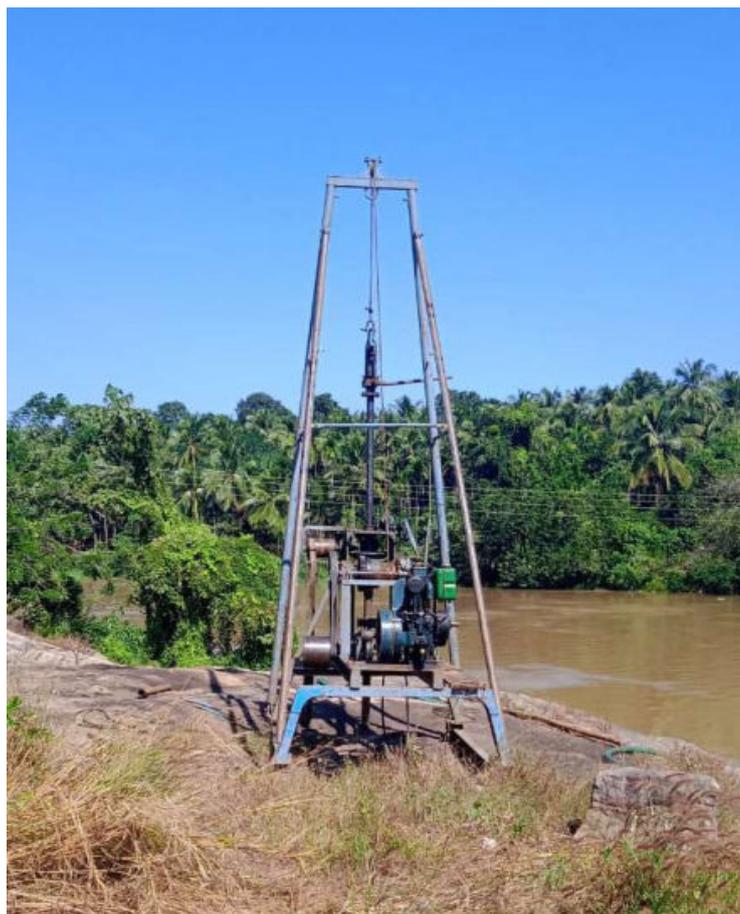
Fig a. Rotary Calyx drilling machine

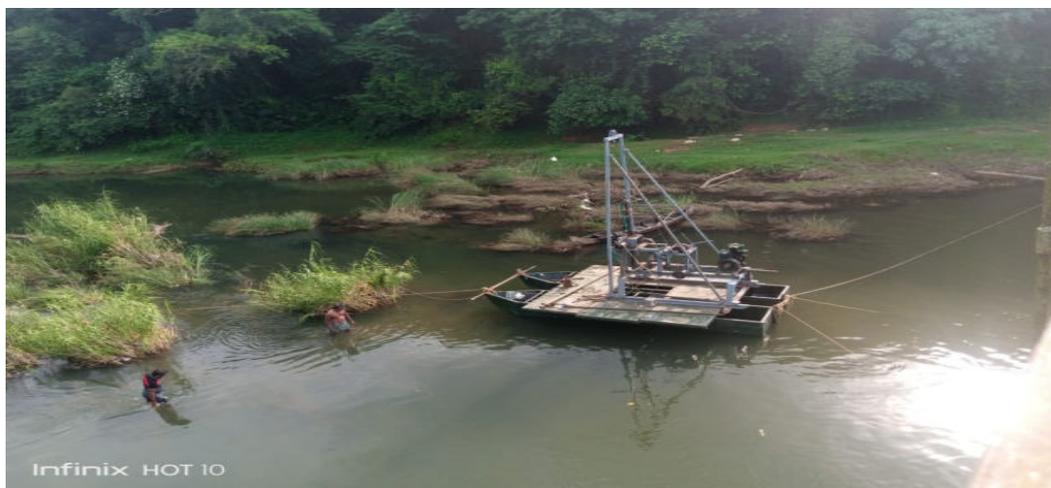
The site was situated at Pombra Kanhirayikadavu in Karimpuzha Gramapanchayath in Palakkad District. The location of the boreholes were decided after the site visit conducted by officials of Instrumentation division, KERI and the officials of Minor Irrigation Division, Palakkad, and the members of the Jilapanchayath during the site visit on 24<sup>th</sup> May 2021. The boreholes were located based on the findings of the site visit. The proposed location at Pombra Kanhirayikadavu has a total width of 95m. A total of 13 boreholes were drilled for this project. Specifically, two points were explored at the left and right abutments, while five boreholes were drilled along the stream portion. Additionally, for the construction of the retaining wall, boreholes were carried out in the upstream and downstream portions, with two boreholes on each side. Two additional boreholes were proposed in the stream portion, upstream and downstream of the alignment of the proposed structure, for the design of aprons. The estimated cost for the project is 8,26,000/-, and the total expenditure incurred for the work was Rs: 4,05,998/-.

Fig.1- Investigation for Bandhara Across Kunthipuzha

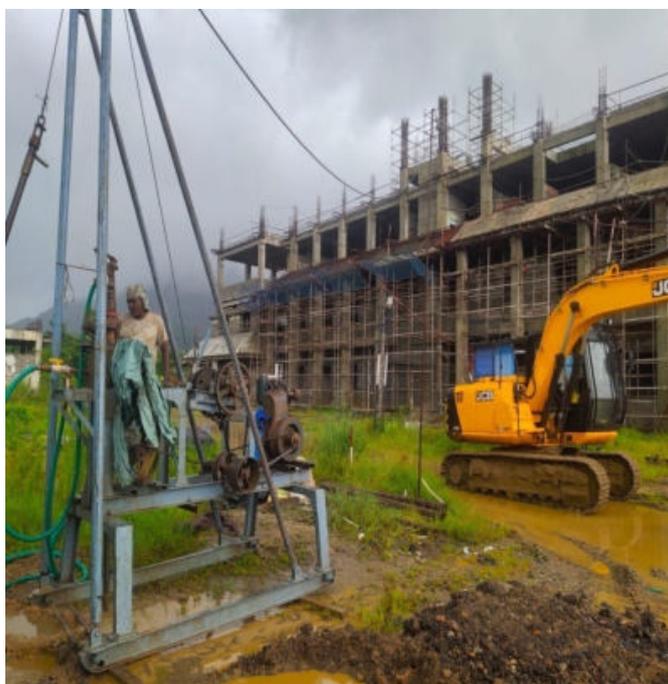
Fig.2-Soil investigation for new buildings at IIT Palakkad

The investigation works for the construction of new buildings at IIT Palakkad Campus were carried out based on a letter received with reference number IIT PKD /EWD /2021-22, dated June 24th, 2022, from Dr. V SenthilKumar, Chairman EWD, IIT Palakkad. The soil investigation was conducted by the Instrumentation Division, KERI, as per the instructions in the aforementioned letter. The investigation included activities such as boring, collection, and testing of soil samples. For soil exploration, three boreholes were drilled between July 6 and July 11, 2022. Rotary calyx-type drilling machine was used for the boring process, with the drilling conducted until reaching the hard rock level. The estimated cost for the work is 1,90,000/-, and the total expenditure incurred for the execution of the work was Rs: 1,56,728/-

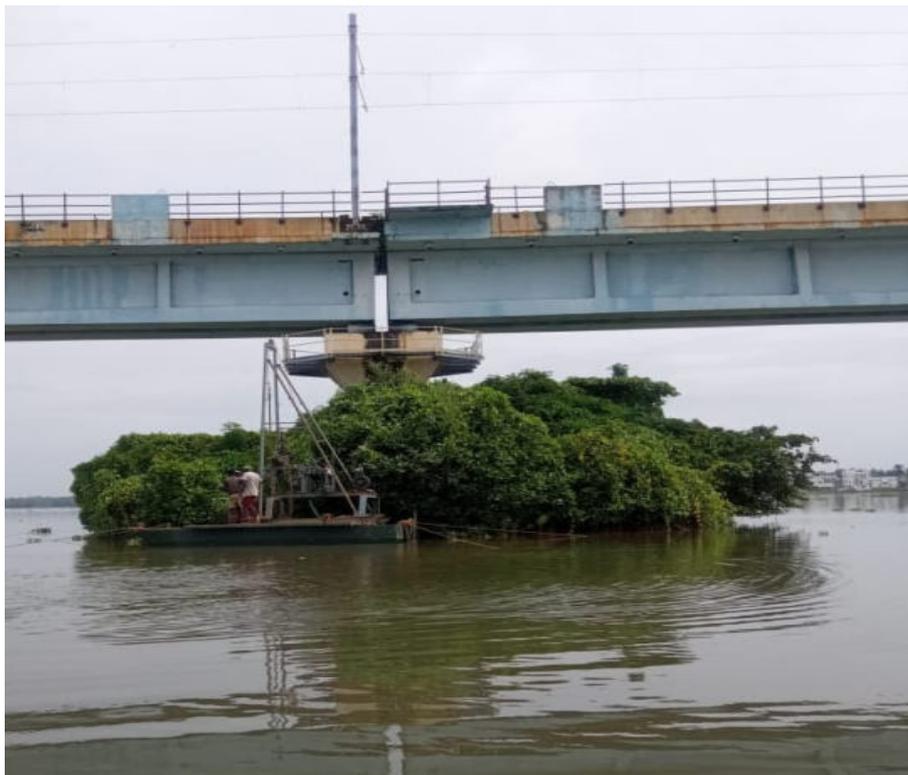
Fig.3-Soil investigation work regarding the formation of bund in Vaduthala, Ernakulam

As per the order dated 9/06/2022 of the Honourable High Court in WP (C) 24027/2021, a high level committee constituted by the G.O. (Rt) No. 520/2022/DMD dated 15-06-2022, for enquiry under chairmanship of Sri. PranabJyothiNath I.A.S, Secretary, Water Resources Department. The Chairman has entrusted KERI to conduct necessary investigations to identify the presence of bund in the river bed in presence of the High-level Committee members. 63 numbers of soil samples from various boreholes were brought to the laboratory

by Instrumentation Division for testing. The estimated amount for the work was Rs:4,00,000/- and the total expenditure incurred for the execution of work was Rs:3,29,317/-.

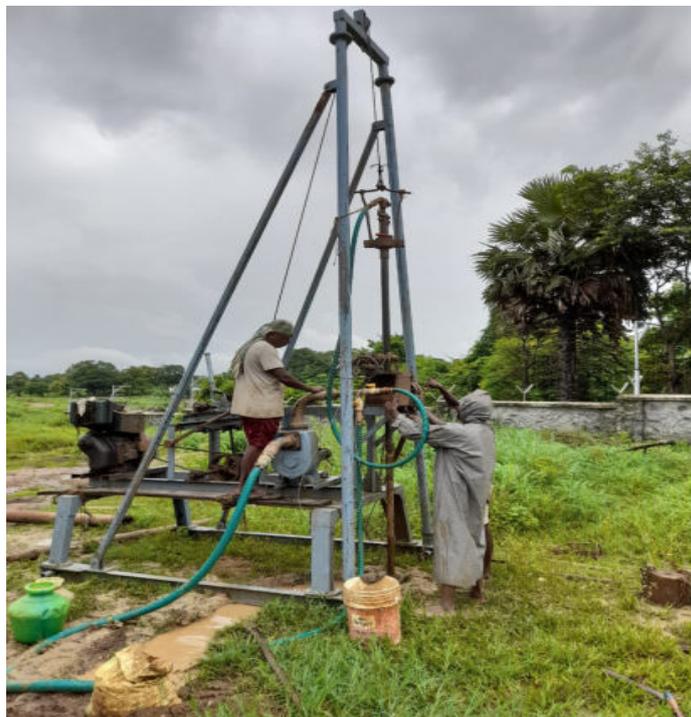
Fig.4-Soil investigation of incubator building at IIT Palakkad

As per the above-mentioned letter, The soil investigation was conducted by Instrumentation Division, KERI for the proposed work. Investigation works such as boring, collection and testing of soil samples, etc. are conducted. 3 boreholes were drilled for soil exploration. The investigation was done between July 6 and July 11, 2022. The estimated amount for the work was Rs:1,80,000/-and the total expenditure incurred for the execution of work was Rs:1,76,087 /-.

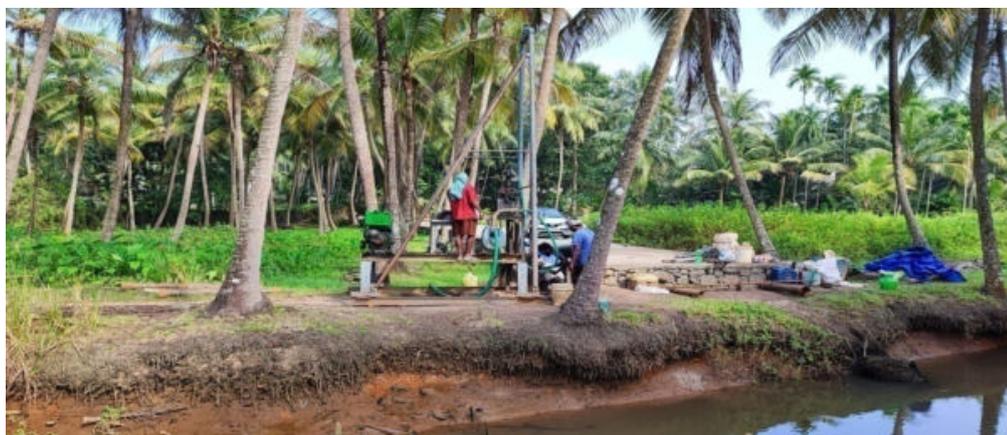
Fig.5-Soil Investigation for Construction of Bridge across Naduvathithodu

A bridge was suggested to be built in order to link the roads on the two banks of the Naduvathithodu. The present investigation works was initiated prior to the construction of the above mentioned bridge across the thodu. Director, F&AR, KERI, Peechi has received a prioritised list of investigation works from the Suprintending Engineer, Minor Irrigation Circle, Kozhikhode in accordance with Ltr No DB9-2321 /IV W/2022-23 dtd 08/11/2022. Later, Joint Director, CM& FE, KERI Peechi granted permission to conduct the investigation by including it under the action plan 2022–2023 in the title of work "soil investigation for various works of Irrigation department as per letter no. DB2/1295/2022–2023 dtd 25/11/2022. Work was undertaken in Action plan of KERI .

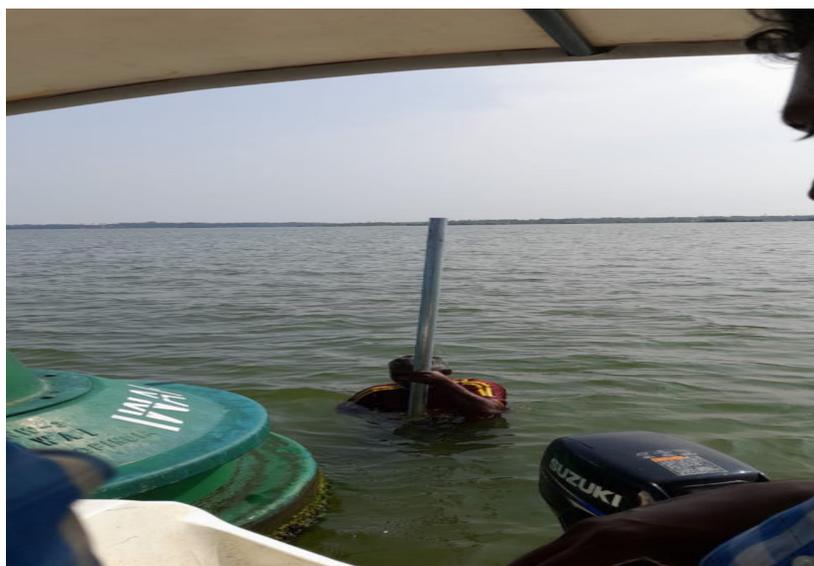
Fig.6-Soil Investigation Work In National Water Way InAshtamudiKayal, Kollam

As per the Letter no D3-2773/2022 dtd 14/11/2022 of Executive Engineer, Inland Navigation Division, Kollam, a request has been received for carrying out soil Investigation and testing of soil samples collected from National water way in AshtamudiKayal. Accordingly, The Director F&AR, KERI Peechi and Joint Director, CM&FE Division gave the instructions to Instrumentation division of KERI to carry out the soil investigation in the mentioned area. Subsequently a joint site inspection was conducted by KERI team with the officials of various departments such as Inland Navigation Division Kollam, Revenue Department, NHAI, IWAI on 17<sup>th</sup> November 2022. Officials from Sivalaya Construction Company Ltd, Kollam were also present. After discussion, it was decided the location where from samples to be collected and samples were collected from AshtamudyKayal for testing the soil parameters

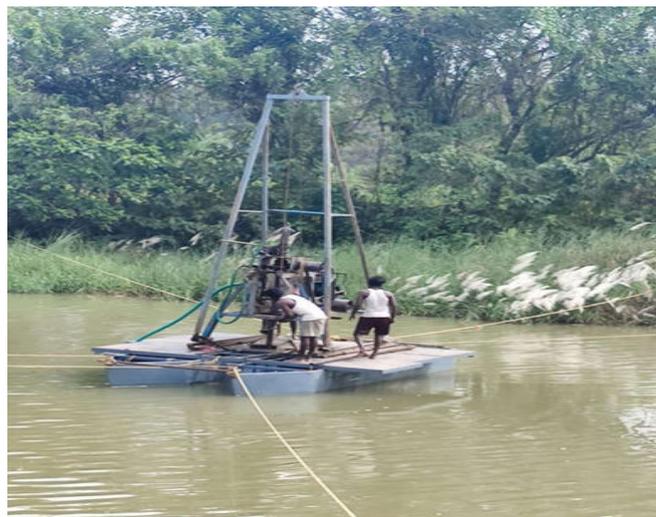
Fig.7-Soil Investigation work for of check dam across Mangalamriver at Plazhy.

This investigation was done based on letter No.D6/General/ 2020, dtd 17/11/2022 received from Executive Engineer, Additional Irrigation Division, Thrissur for the proposed check dam across Mangalam River at Plazhy in Pazhayannur Grama Panchayath in Thrissur District. The total width of the stream at the proposed location (Mangalam River) is 40 m. Two points were explored at the left and right abutments. Three boreholes were to be drilled along the stream portion. Four boreholes were excavated for retaining wall upstream and

downstream portion on the left bank and right bank. Work was undertaken in Action plan of KERI.

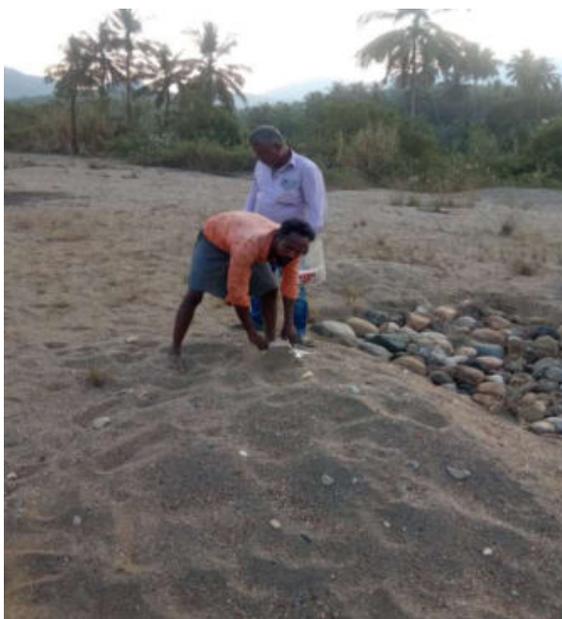
Fig.8 .Collection of soil samples from Agricultural land at Pothukallu village Nilambur Taluk , Malappuram

The Director of KERI received a letter, numbered I/211262/2023 and dated 18/01/2023, from the District Collector of Malappuram. According to the letter, the Instrumentation Division of KERI collected five disturbed soil samples. These samples were taken to the Soil Mechanics laboratory for the purpose of determining the grain size distribution of each sample.

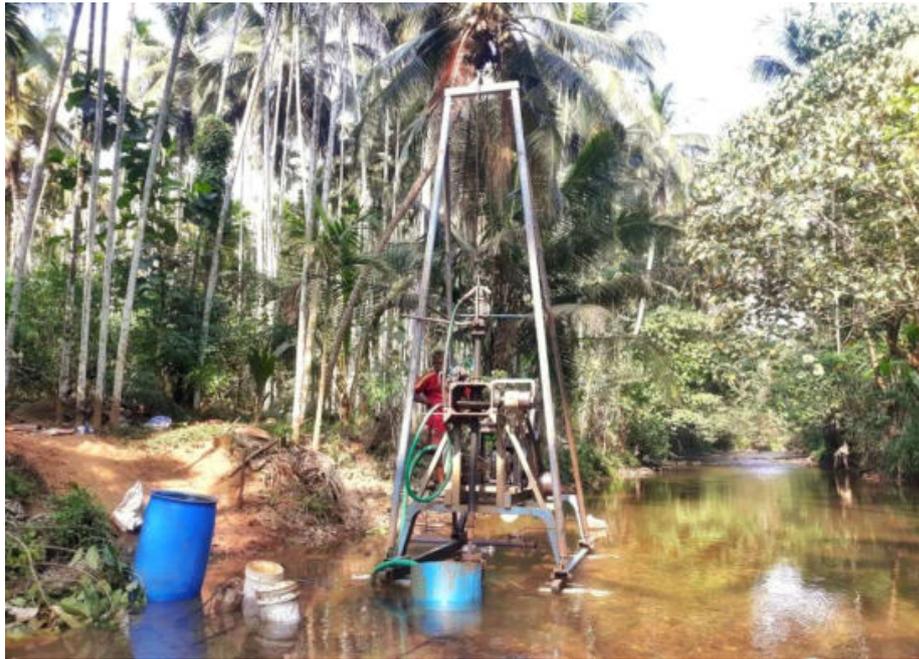
Fig.9-Soil Investigation work for New VCB cum Bridge near Marutha at Vazikadavu

The soil investigation for the "New VCB cum Bridge near Marutha at Vazhikkadav Gramapanchayath in Malappuram District" was conducted based on letter No.D2-General/2022, dated 24/12/2022, received from the Executive Engineer, Minor Irrigation, Malappuram. The proposed location is near the Poorappuzha river, with a total width of 13m. The work was undertaken as part of the Action plan of KERI.

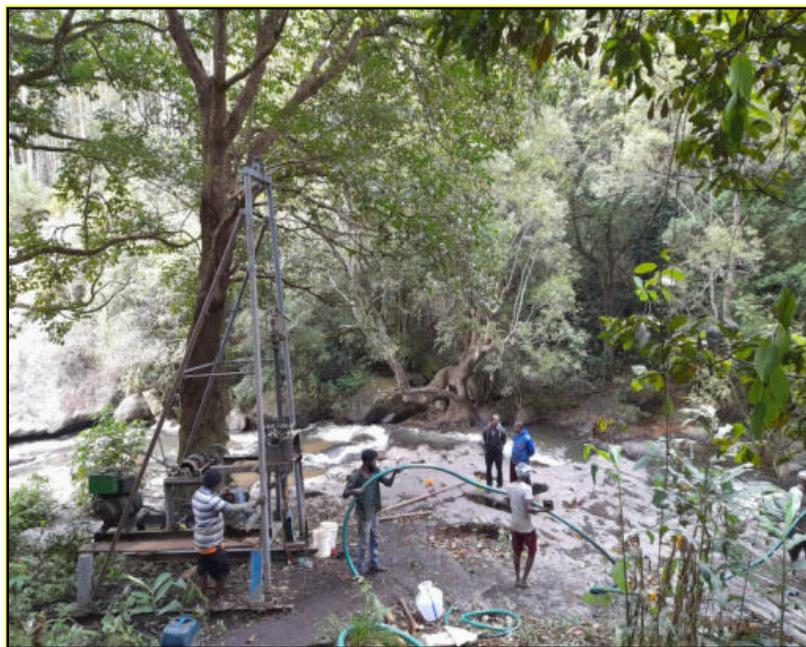
Fig.10-Soil Investigation for JJM Water supply scheme to Vattavada Panchayath

This investigation was prepared based on letter No.AEE/JJM/Vattavada /2021-2022 dated 14/10/2022 received from Executive Engineer, Project Division Kattapana, Vellayamkudy requesting a soil investigation for the proposed check dam across Chilanthiyar Waterfalls at Vattavada Grama Panchayath in Idukki District. This report presents the geotechnical characterization of the ground based on field and lab tests at bore hole locations of the proposed construction. The total width of the stream at the proposed location is 22 m. Three borehole was drilled along the stream portion. Two boreholes were excavated for retaining wall upstream portion (on the right bank). The estimated amount for

the work was Rs:5,00,000/-and the total expenditure incurred for the execution of work was Rs:2,79,297/-.

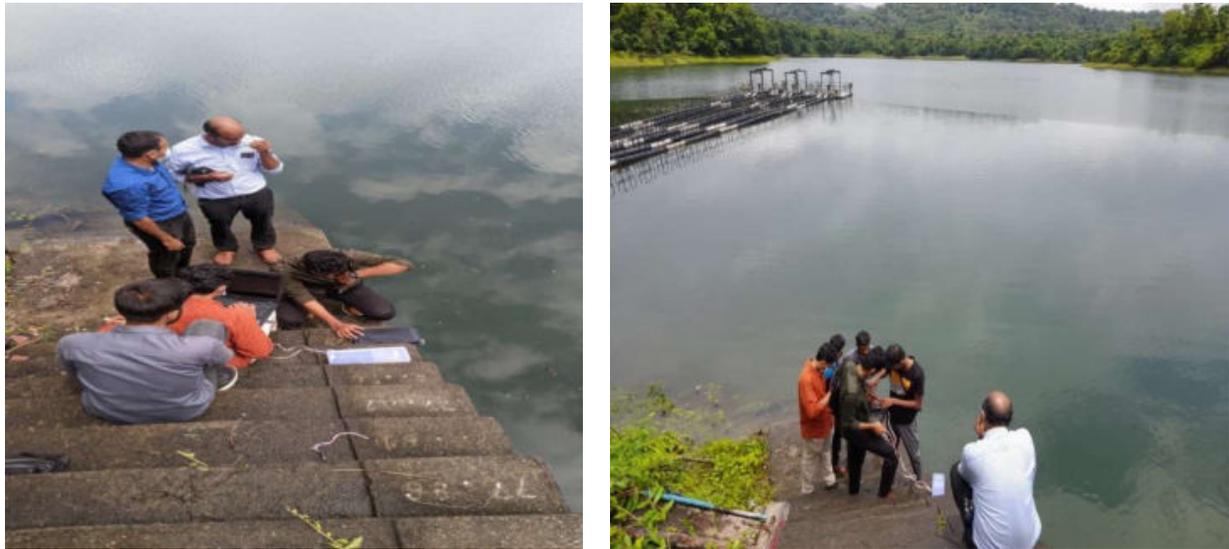
A trial study was conducted at Peechi Dam to assess the performance of the sensor setup for real-time water level monitoring. Continuous monitoring was carried out for two weeks at Peechi Dam to evaluate the feasibility of deploying the same setup at selected locations. Five different locations were chosen, including three along the Chalakudy River and two along the Manali River, for the installation of the sensor system.

Fig. 11 Trial study at Peechi Dam to assess the performance of the sensor setup by KERI and SIMAT

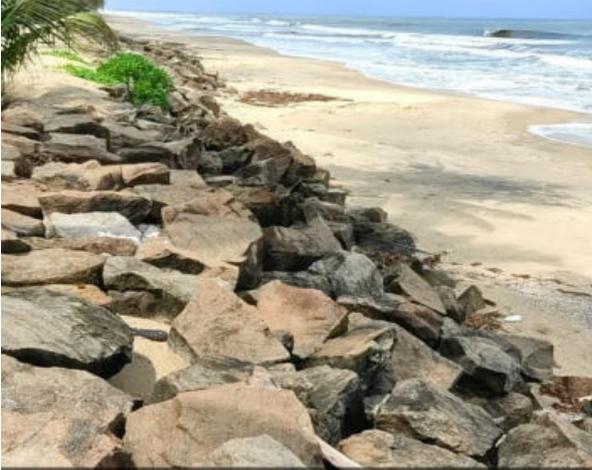
Coastal Damages occurred within the jurisdiction, were closely monitored and were reported every week during the monsoon. Details of coastal damages are reported once every month during off-monsoon months. During this year moderate coastal damages and heavy coastal erosion were reported from Thanky(Ottamassery) (921-929). Near Thanky in Ottamassery between CP 922 & 923, one building fully collapsed and near CP 929, one bathroom slipped and fell down and more than seven houses partially damaged. More than 13 coconut trees overturned and fell down. Due to heavy wave attack, the beach eroded for a width of about more than 9m from CP 921 to 922 and CP 928 to 929 .In Kattoor, coastal damages considerably reduced during the last year. Between CP 839 & 855 severe coastal erosion and beach loss occurred. As groynes with tetrapods have been constructed from CP 839 to 853, beach erosion has been reduced and beach formation noticed. In Chennaveli, no considerable damages were noticed during the last year. However moderate to severe coastal erosion and beach loss occurred.

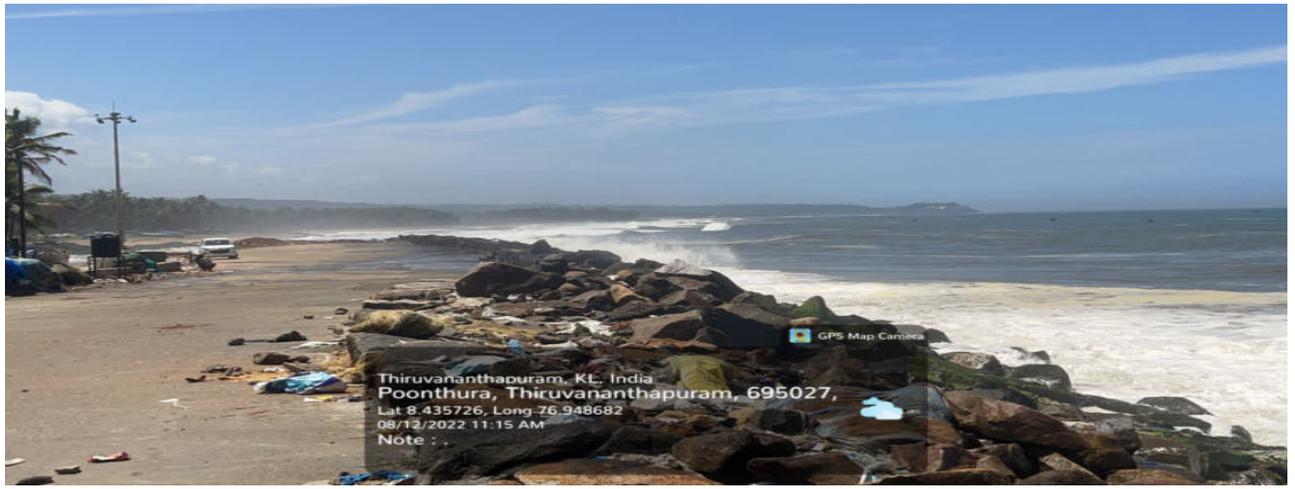
Damaged sea wall at poonthur

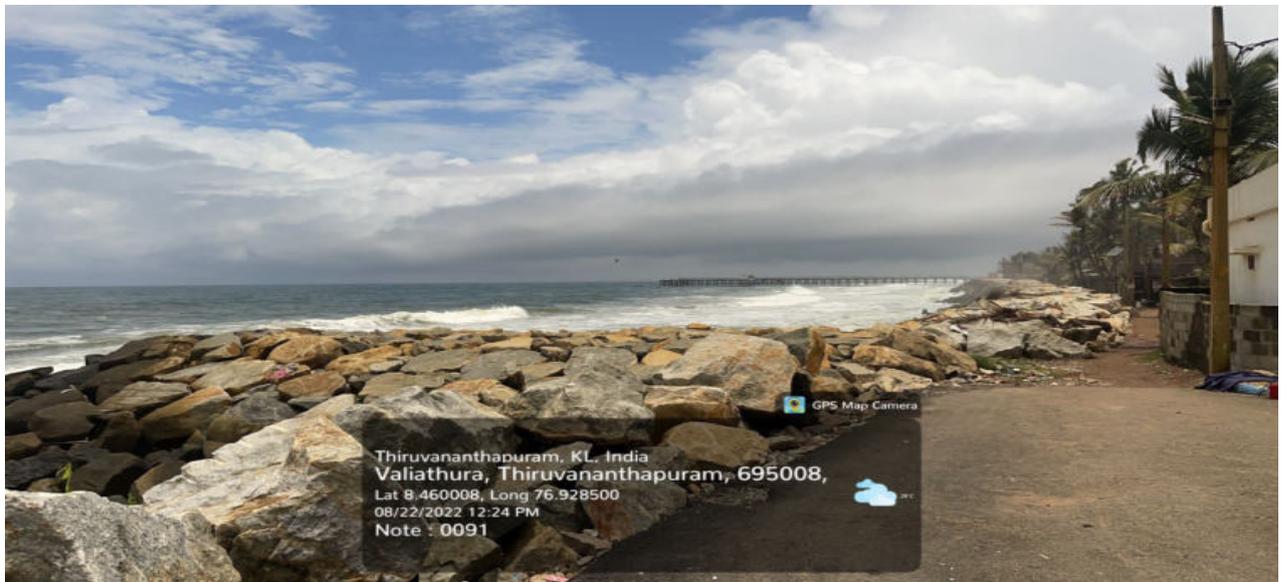
Damaged Sea wall at Valiathura

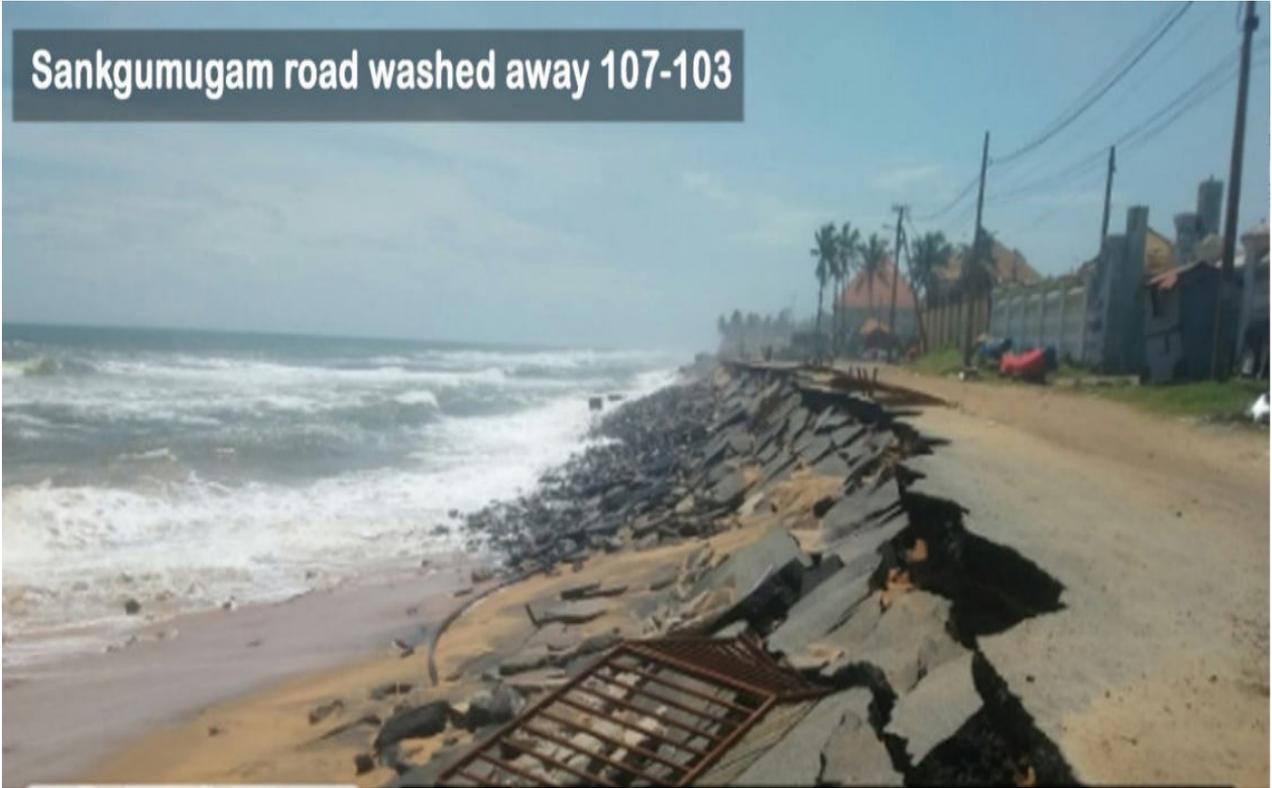
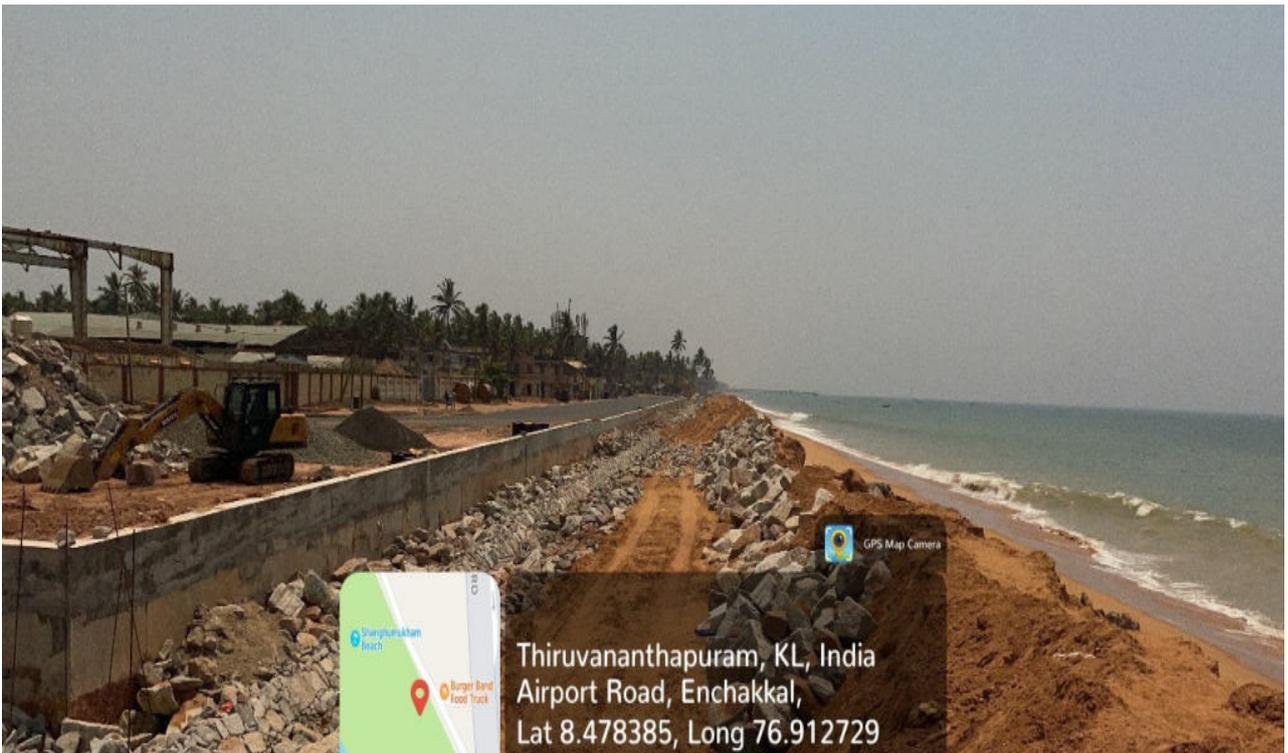
Sangumukham Beach Road -Before & After construction of RCC Diaphragm Wall  
Reach 3- Thumba to Perumathura (CP No 0137 to 0211).
