# KERALA ENGINEERING RESEARCH INSTITUTE

## ANNUAL REPORT 2022-23

***Kerala Engineering Research  
Institute, Peechi***

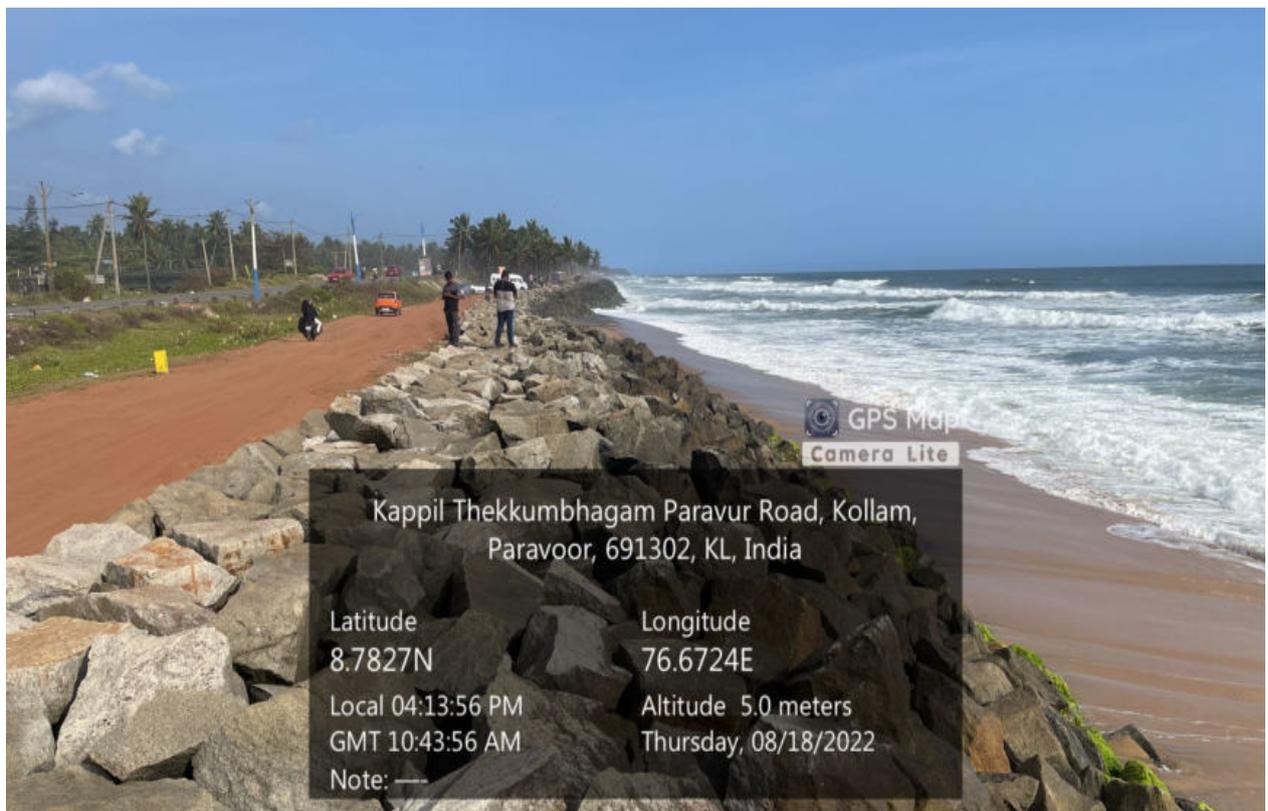
Damaged and collapsed sea wall at Edava

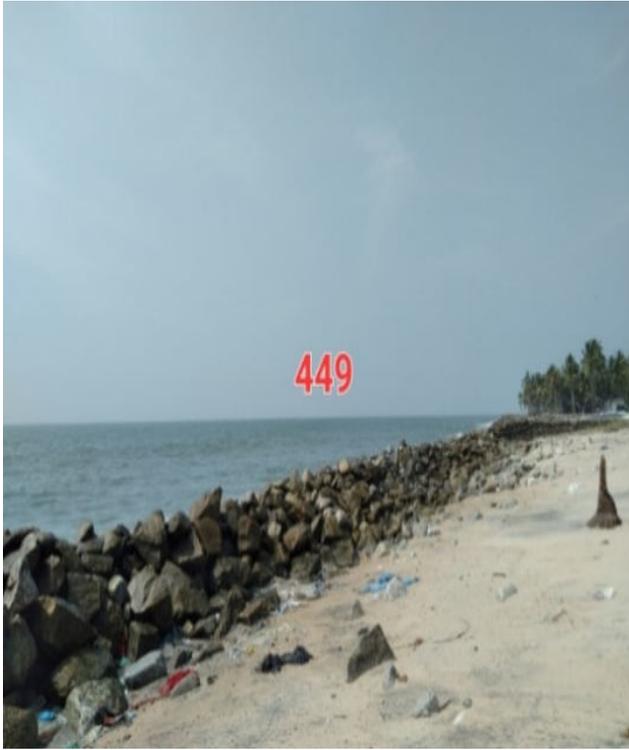
CP 449 (Pandarathrth)

During the month of January 2023, seawave attack occurred along the coast of Alappad Gramapanchayth (Parayakadavu to Azheekal pozhi) and caused to heavy overtopping over seawall and water entered nearby land and houses.

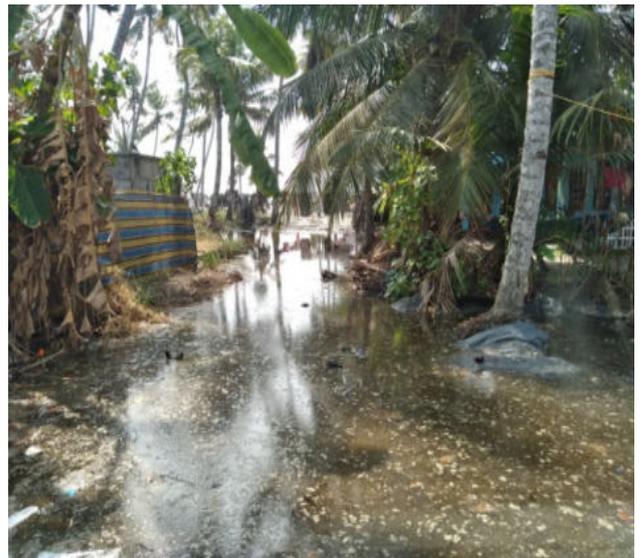
CP 469 (Parayakadavu)during high sea wave attack

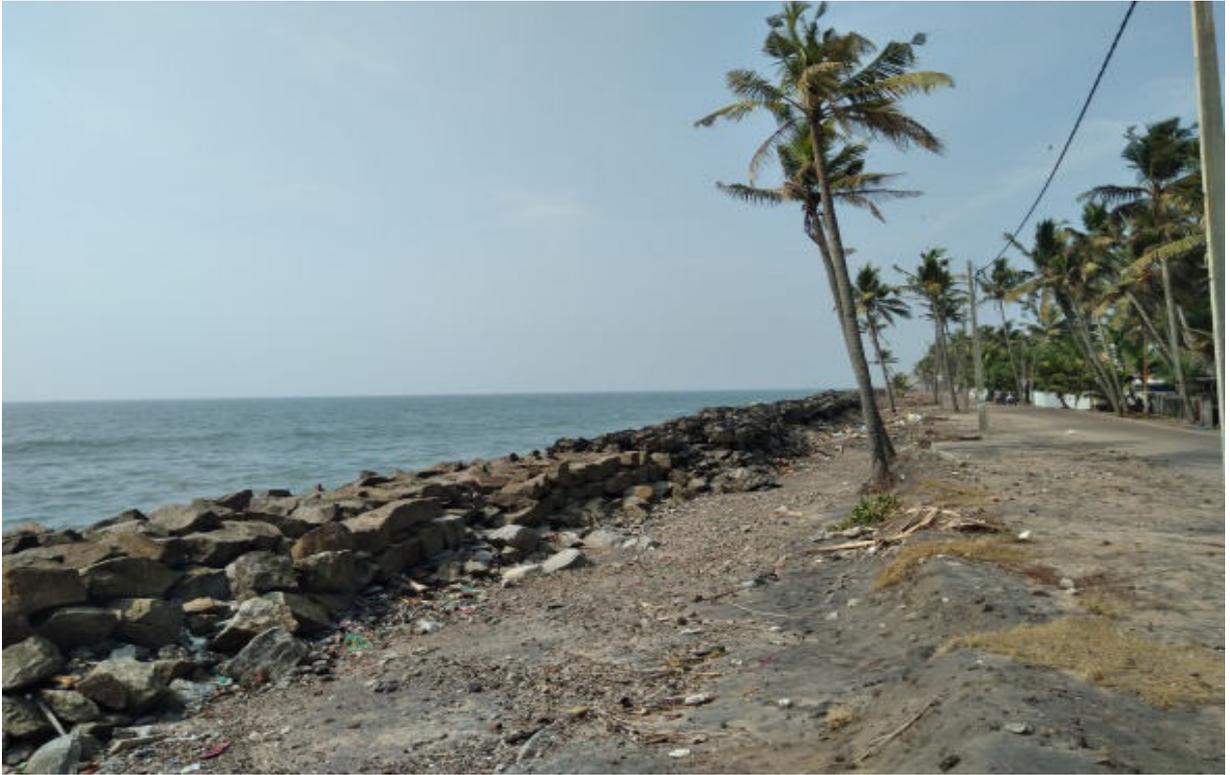
CP 475-476 (Sraikad) during sea attacks

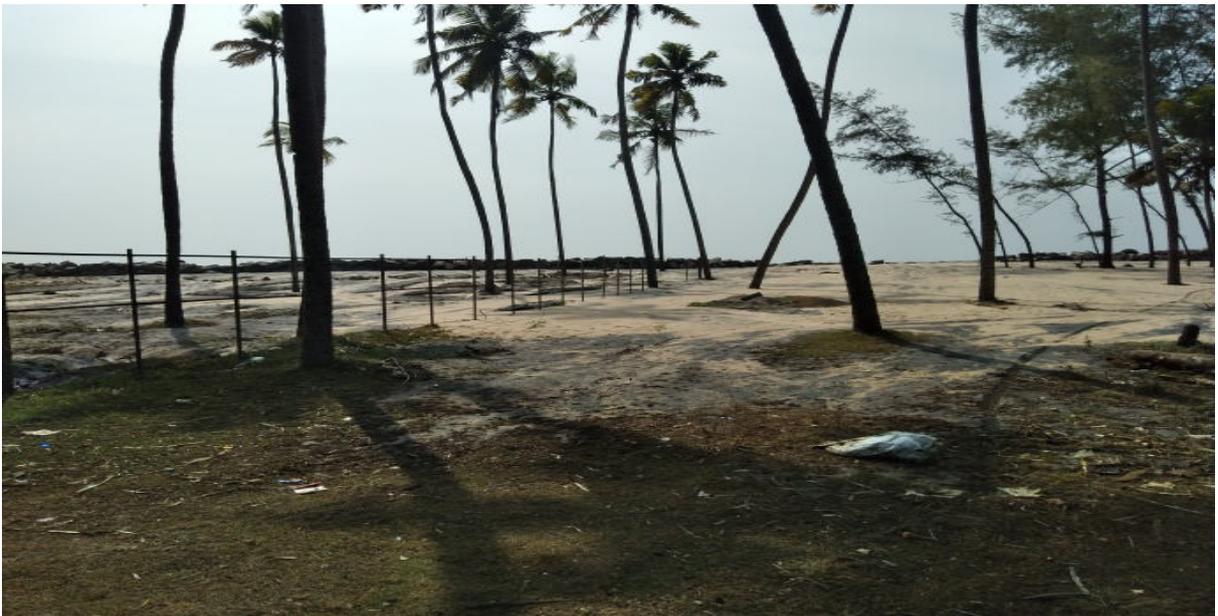
CP 489 (Azheekal) sand entered land along with waves

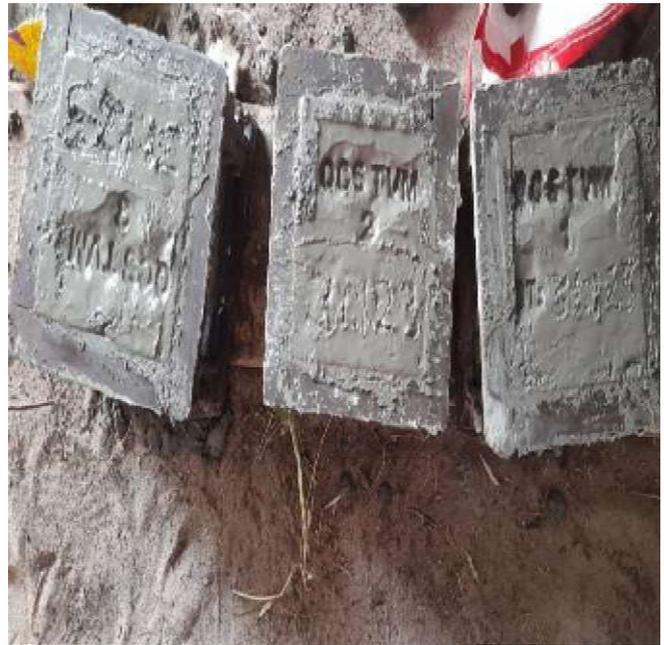
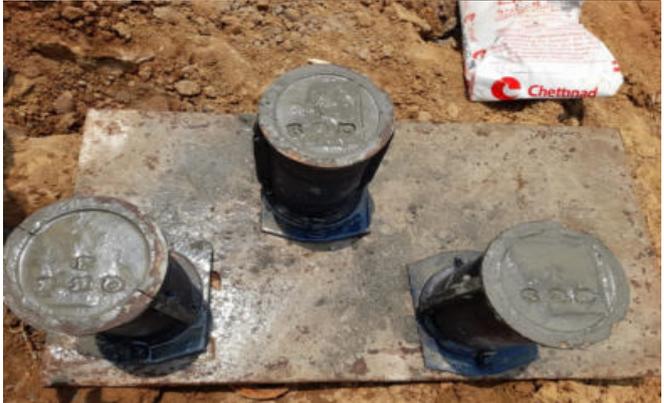
Cube and Cylinder samples

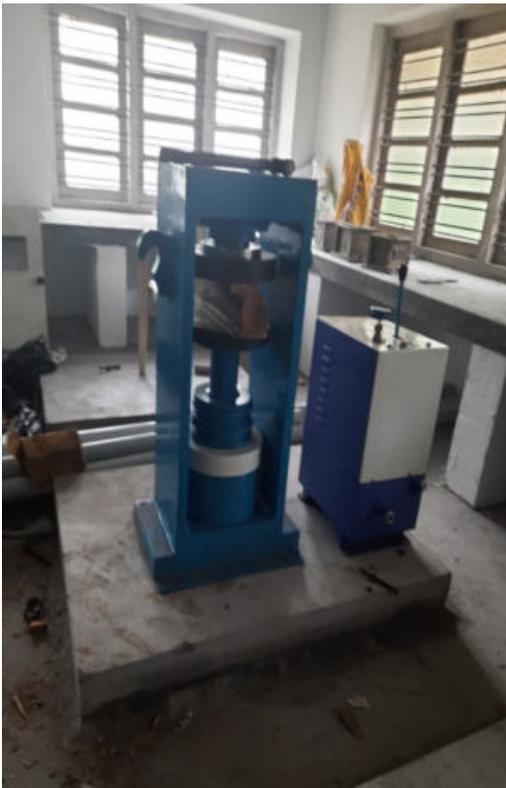
Compression Testing Machine

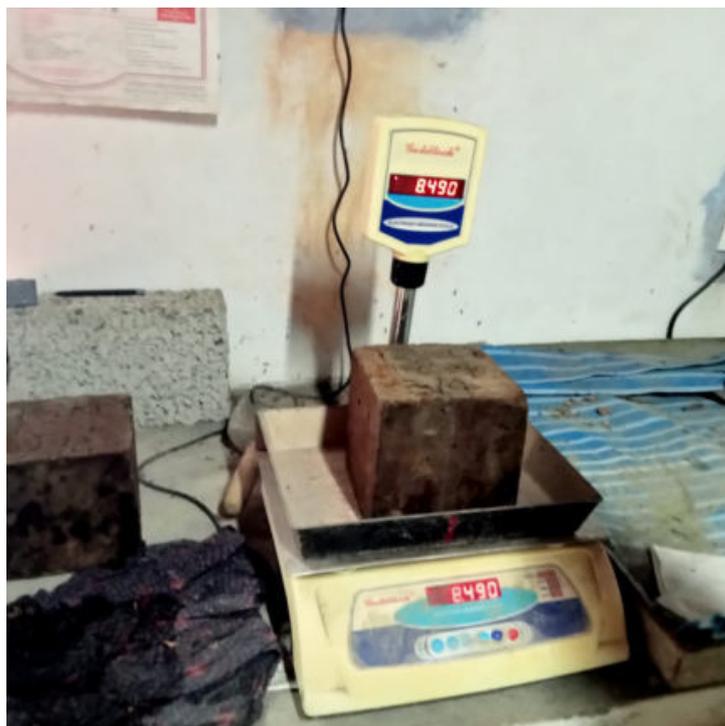
Cube weighing machine
